US 60 AND CAMPBELLS CREEK DRIVE

ROAD SAFETY ASSESSMENT

Regional Intergovernmental Council

June 2022

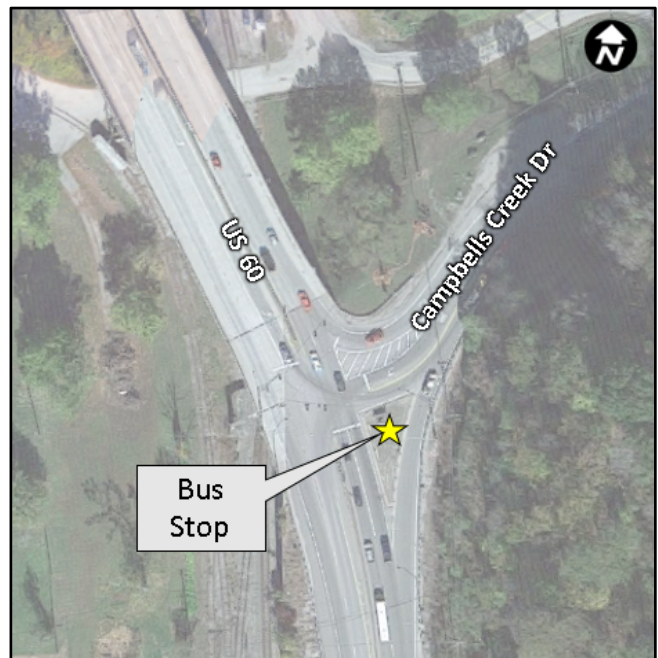
Figure 3: Bus Stop Location

- **Coordinate with KRT to relocate or remove the KRT bus stop.** The current bus stop is in the raised island between the northbound through lanes and the channelized northbound right-turn lane, with no pedestrian accommodations at the intersection. This bus stop should be removed or relocated to improve pedestrian safety and prevent future collisions from occurring. Coordination with KRT will be necessary to modify the bus stop location. Per conversations with KRT, there are no ridership numbers for this stop, but bus drivers for this route will be asked for anecdotal information about ridership and the frequency of passengers boarding or alighting at this location.

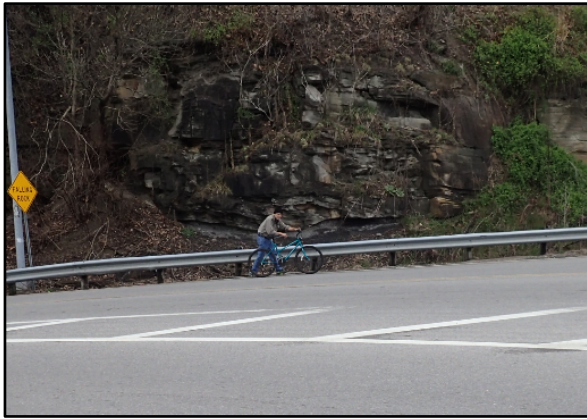
Photo 2: Bicyclist Traveling Through the Intersection

- A few pedestrians and bicyclists were observed traveling through the intersection, shown in **Photo 2**.
 - When observing the traffic count camera footage, a pedestrian was also seen wandering around and into the center of the intersection at night, shown in **Photo 3**.

- The Deputy indicated that pedestrians and bicyclists occasionally use US 60 to travel from the residential areas along Campbells Creek Drive to the communities located south of the intersection.

- **Enhance police enforcement in the area.** Due to the pedestrian and bicycle activity observed along US 60, a high-speed facility, enhanced enforcement is recommended in the area to dissuade impaired users from walking and biking in the roadway.

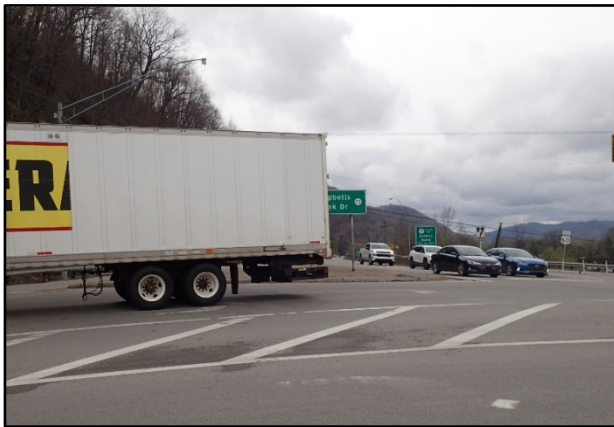
Photo 4: Semi-Truck Traveling Through the Intersection

- Semi-trucks and large vehicles turning left from the southbound approach were observed driving over the left-turn lane due to its close proximity to the receiving lane, shown in **Photo 4**.

- **Restripe the Campbells Creek Drive approach to widen the receiving lane for left-turning trucks.** While performing the field review, trucks were tracking over the westbound left-turn lane at Campbells Creek Drive. Restriping the approach will allow more space for vehicles to turn into Campbells Creek Drive. The layout of the restriping is shown in **Figure 8**.

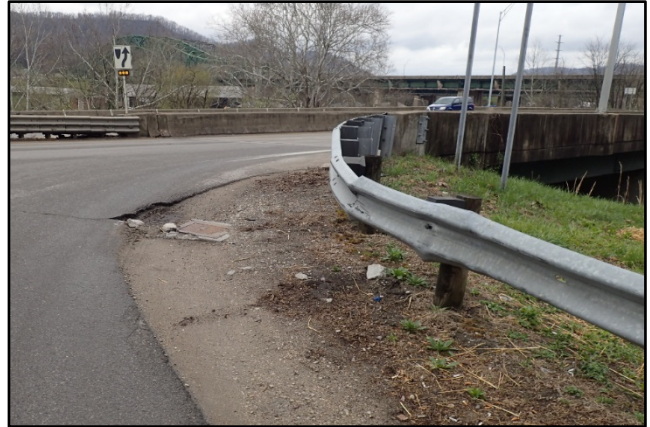
Photo 5: Guardrail on Northern Corner of Intersection

- The lane-use and stop bar pavement markings on the westbound approach on Campbells Creek Drive were faded.
- The guardrail on the northern corner of the intersection was bent from a previous collision, shown in **Photo 5**.
