10th Street between Myers Ave and Grosscup Ave

ROAD SAFETY ASSESSMENT

Regional Intergovernmental Council

September 2022

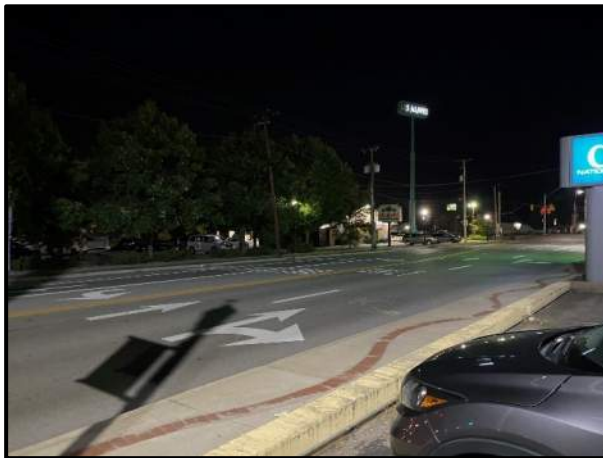
Photo 1: Lighting North of Myers Avenue

- **Coordinate with the City of Dunbar to repair lighting on 10th Street:** During the site visit, one of the light poles along the sidewalk on 10th Street was missing a lightbulb, while another was not operational. These light poles should be repaired to improve pedestrian visibility in the area.

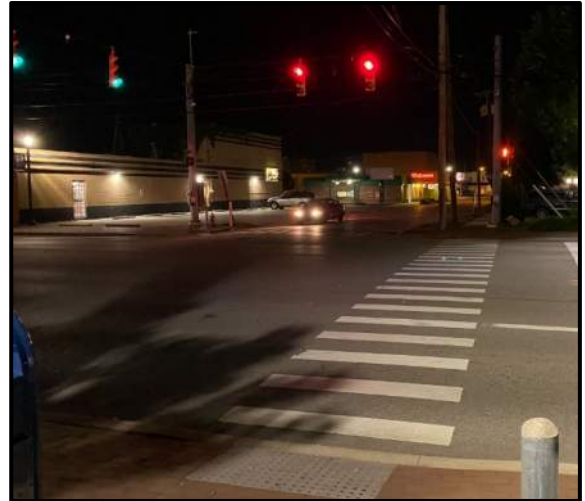
Photo 5: Crosswalk on North Leg of 10th Street and Myers Avenue

Out of the 10 pedestrian collisions in the study area, six occurred in the northern crosswalk of the intersection. The largest crash pattern was due to eastbound vehicles on Myers Avenue failing to yield to pedestrians in the crosswalk as they were turning left onto northbound 10th Street. One of the pedestrian collisions in this crosswalk involved an individual using an electric wheelchair and another involved a driver under the influence of a controlled substance.

- **Consider relocating the crosswalk to the southern leg:** There is currently a crash pattern of eastbound vehicles on Myers Avenue, turning left and striking pedestrians in the northern crosswalk. The left-turn volume of westbound vehicles turning left out of Fletcher Square is less than the volume of eastbound vehicles turning left off of Myers Avenue, decreasing the possible number of conflicts in the southern crosswalk. Additionally, with the addition of the curb bump out, the crossing distance would be shorter with a southern crosswalk compared to the existing crosswalk location.

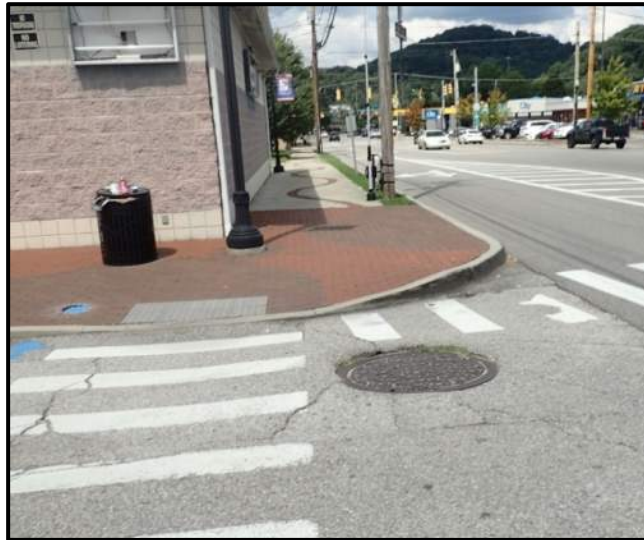
Photo 7: Northwest Corner of Grosscup Avenue

The crosswalk across 10th Street on the northern side of the Grosscup Avenue intersection does not connect to the sidewalk with a curb ramp on the west side of the roadway. Generally, vehicles would not stop for pedestrians in the crosswalk. Instead, pedestrians had to be very vigilant while crossing 10th Street.

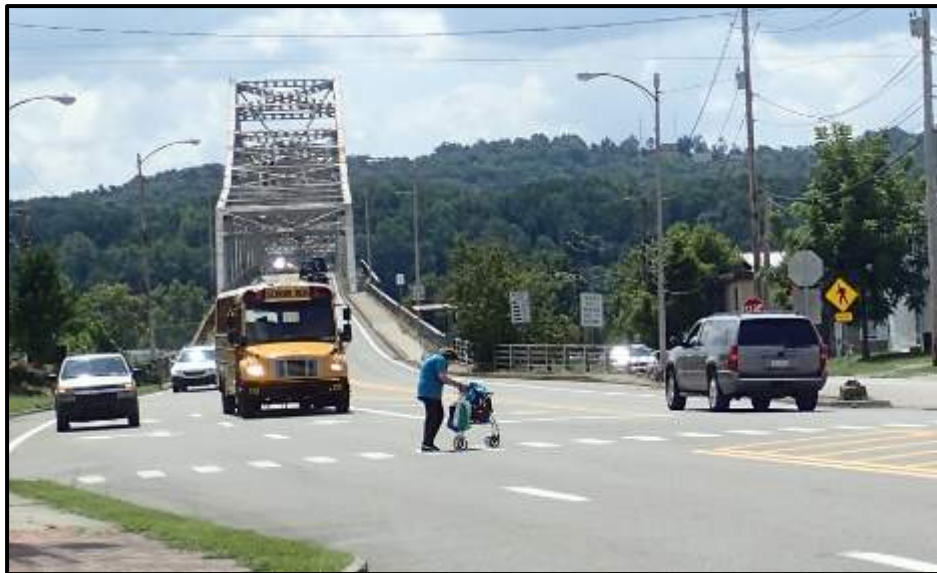
Photo 8: Pedestrian Crossing 10th Street at
Grosscup Avenue

There was one pedestrian collision at this intersection in the northern crosswalk across 10th Street. The pedestrian was walking east across 10th Street in the crosswalk while the vehicle was sitting at the stop sign on Grosscup Avenue facing east. The vehicle then made an illegal left turn onto northbound 10th Street, striking the pedestrian in the crosswalk.

- Consider adding pedestrian refuge islands with Rectangular Rapid Flashing Beacons (RRFB) on the southbound approach:** These modifications will improve pedestrian safety and increase the overall comfortability when crossing the long crosswalk across 10th Street. Pedestrians would have two different refuge areas to stop and look for vehicles before they continue crossing. A layout of this improvement is shown in **Figure 9**. Adding the raised median where there is currently paint will also help channel vehicles into their appropriate lanes, along with helping prevent prohibited movements at the intersection, such as the eastbound left-turn movement. An ADA project is currently in progress for the Grosscup Avenue corridor. These improvements to the medians and crosswalks, along with the RRFB and ADA-compliant curb ramps, could be integrated into the current project.
