TEAYS VALLEY ROAD AND MOUNT VERNON ROAD

ROAD SAFETY ASSESSMENT

Regional Intergovernmental Council

BURGESS & NIPLÉ

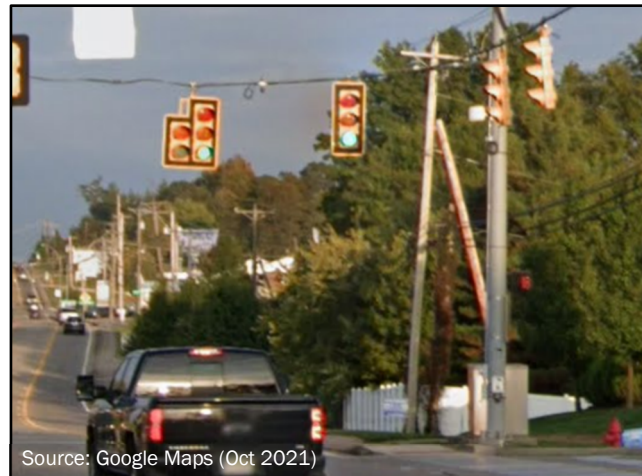
- Because of the east/west configuration of Teays Valley Road, sun glare affects visibility of the signal heads during the morning and evening commute. Backplates are provided on the east and west leg signal heads; however, they are still difficult to see during sun glare conditions as illustrated in **Photo 1**.

Photo 1: Signal Visibility Issues on Eastbound Approach

- **Modify the signal heads by installing wider reflective borders for improved visibility.** Rear end collisions are the most common crash pattern and occur on Teays Valley Road. They generally happen during morning and evening periods when the sun glare makes the signal heads difficult to see. Installing wider reflective borders may assist motorists during times of sun glare.

- **Install side-mounted supplemental signal heads on the near side signal poles.** Side-mounted signal heads are mounted at a different height than overhead signal heads which may make them easier to see when sun glare is an issue. A secondary benefit to installing these signal heads is providing visibility around large trucks that may block the view to the overhead signals.

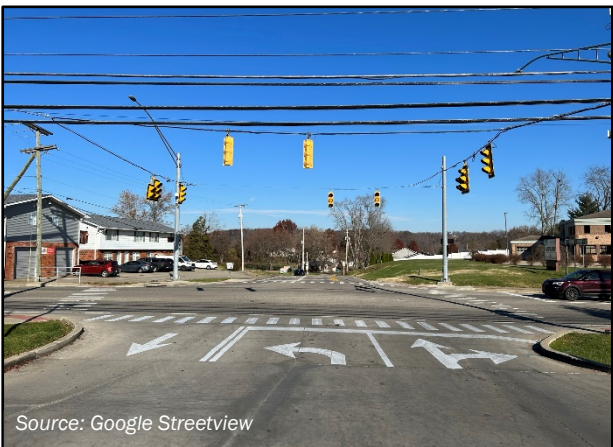
- Pedestrian facilities are provided across all legs of the intersection (see **Photo 2**). However, the pedestrian push buttons did not actuate the pedestrian signal. This was reported to WVDOH for repair.

Photo 2: Pedestrian Crosswalk along South Leg

- **Repair non-functional pedestrian push buttons and signal heads.** WVDOH was notified that the pedestrian signal heads were not functioning during the field visit, but they should be repaired so pedestrians can safely traverse the intersection.

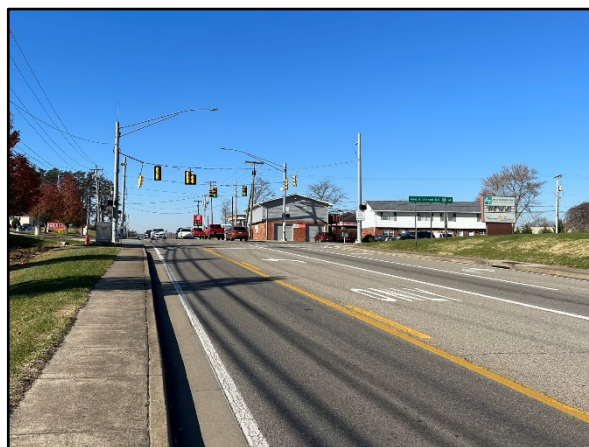
- The intersection is situated at a high point along the vertical crest of the roadway reducing sight distance as motorists approach from the east and west directions as indicated in **Photo 3**.

Photo 3: Crest Vertical Hill on Westbound Approach
