# WASHINGTON STREET AND LEE STREET ROAD SAFETY ASSESSMENT Regional Intergovernmental Council

March 2024

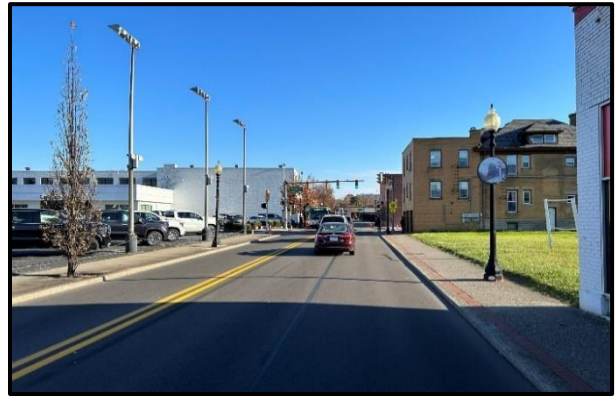
- Between Morris Street and Ruffner Avenue, the roadway is approximately 30 feet wide with two travel lanes, shown in **Photo 1**. The northwestbound lane is 11 feet wide while the southeastbound lane is 19 feet wide. The wide southeastbound lane can promote speeding and increase the crossing distance for pedestrians.
- There is a distance of nearly 800 feet between marked, signalized crosswalks along Washington Street between Morris Street and Bradford Street and between Bradford Street and Ruffner Avenue. This distance incentivizes pedestrians to cross the street at unmarked locations throughout the corridor and increases the potential for vehicle and pedestrian conflicts.

**Photo 1: Wide Southeastbound Lane between Morris Street and Bradford Street**

- Strip a parking lane on Washington Street between Morris Street and Ruffner Avenue.** This short-term improvement will narrow the wide lane along Washington Street in an effort to better delineate the roadway lanes and slow traffic speeds. This stripe can be installed without any additional modifications to other pavement markings. If on-street parking is not desired in certain sections, the area could be striped as a buffer or large planters could be installed to add a vertical narrowing of the roadway. Flex post delineators could be installed on the lane lines but would also need to be maintained as they are often easily damaged and require replacement. None of these modifications would require changes to drainage or curb lines. The typical section of Washington Street with this proposed marking is illustrated in **Figure 11**. A plan view layout of this configuration is provided in **Appendix C**.

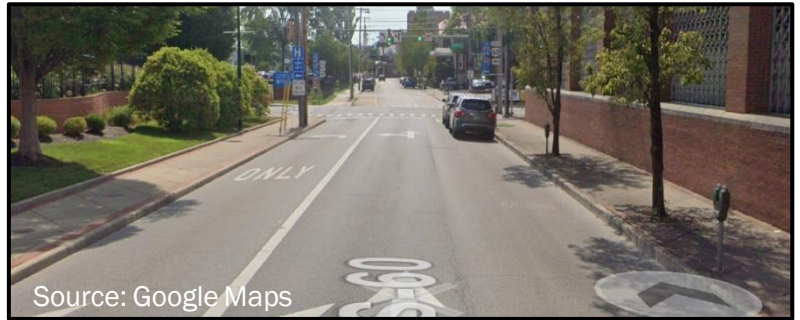
Between Leon Sullivan Way and Brook Street, Lee Street in this segment is a one-way roadway with two lanes and a posted speed limit of 30 mph. This segment borders the Clay Center. Metered on-street parking is provided on the southeast side of Lee Street, shown in **Photo 2**. Sidewalks and lighting are provided along this segment. Per WVDOT 2020 count information, Lee Street carries approximately 4,700 vehicles per day.

**Photo 2: Clay Center and Parking Along Lee Street**

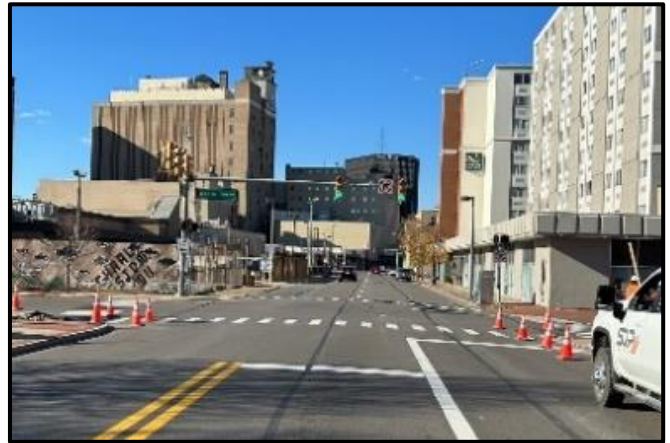
The lane configuration for this signalized intersection is illustrated in **Figure 2**. All signal heads are mounted on mast arms. Without backplates or reflective borders, the signal heads can be difficult to see, especially in the northwestbound direction with other visual clutter (buildings, etc.) is present as illustrated in **Photo 3**. Pedestrian push buttons, signal heads and high visibility crosswalks are provided on each corner of the intersection. Pedestrians are served through an exclusive phase if the push button is actuated. Overhead lighting is not provided at the intersection.

Photo 3: Inconspicuous Signal Heads at Washington Street and Leon Sullivan Way

- **Install new reflective backplates on the signal heads.** Backplates are proposed on all signal heads to improve signal visibility and help reduce red-light running. None of the intersections in the corridor currently have backplates on the signal heads. In some cases, the existing signal supports cannot accommodate the additional weight and wind load of backplates. Calculations would be required to determine if a new signal support would be required to make these improvements.

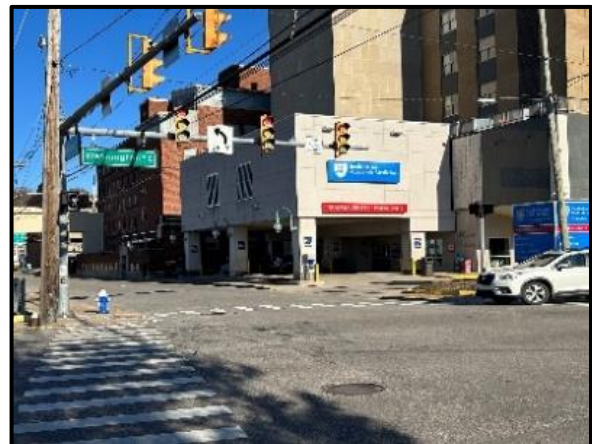
The lane configuration for this signalized intersection is illustrated in **Figure 3**. All signal heads are mounted on mast arms. Sun glare obscured the view of the signal heads, particularly those for the Brooks Street approach as shown in **Photo 4**. Backplates are not provided on any of the signal heads. Pedestrian push buttons, signal heads and high visibility crosswalks are provided on each corner of the intersection. An exclusive pedestrian phase is provided within the current signal timing plan. Overhead lighting is provided. While it is a viable movement, left-turns are not permitted from southeastbound Washington Street onto Brooks Street as indicated through signage. Signs also prohibit right-turn on red from Brooks Street.

Photo 4: Sun Glare Affecting Signal Head Visibility at Washington Street and Brooks Street

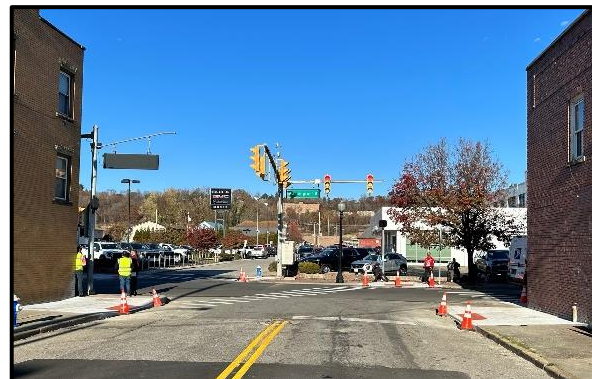
The lane configuration for this signalized intersection is illustrated in **Figure 5**. All signal heads are mounted on mast arms and do not have backplates. Pedestrian-level lighting is provided at the intersection. Pedestrian push buttons, signal heads and high visibility crosswalks are provided to cross Washington Street and the northeast leg of Bradford Street. The signal is programmed for an actuated exclusive pedestrian phase. The signal is currently programmed to serve both legs of Bradford Street concurrently. Nearby buildings coupled with the offset Bradford Street approaches creates sight distance obstruction and results in driver confusion when vehicles are on both Bradford Street approaches. Additionally, the sun glare reduces the conspicuity of the signal heads as illustrated in **Photo 5**.

**Photo 5: Offset Intersection at Bradford Street and Sun Glare Impacting Signal Head Visibility**

- **Modify the signal timings at the intersection of Bradford Street and Washington Street to provide an exclusive phase for each Bradford Street approach (split-phased) and ensure coordination with the other signals along Washington Street.** The sight distance obstructions from the buildings adjacent to the intersection coupled with the offset Bradford Street

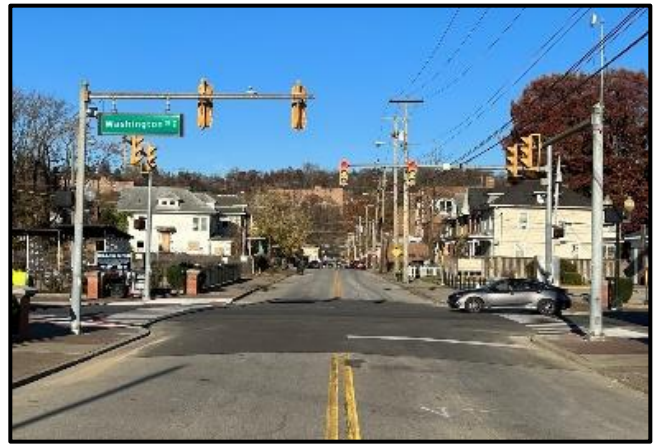
The lane configuration for this signalized intersection is illustrated in **Figure 6**. All signal heads are mounted on mast arms and do not have backplates. Sun glare and resulting signal head visibility was also noted to be a challenge at this intersection. All left-turns operate under permissive phasing. Pedestrian push buttons, signal heads and high visibility crosswalks are provided to cross the Washington Street approaches. No pedestrian facilities are available to cross Ruffner Avenue as shown in **Photo 6**. Pedestrian-level lighting is provided at the intersection.

**Photo 6: Lack of Pedestrian Crossings on Ruffner Avenue and Sun Glare Impacting Signal Head Visibility**

- **Provide pedestrian accommodations to cross Ruffner Avenue at the intersection with Washington Street.** Currently, pedestrian accommodations (crosswalks, signal heads, push buttons, curb ramps, etc.) are not provided to cross Ruffner Avenue. Given the amount of pedestrian traffic in the corridor and the pedestrian crash that occurred at the intersection, these improvements are recommended.

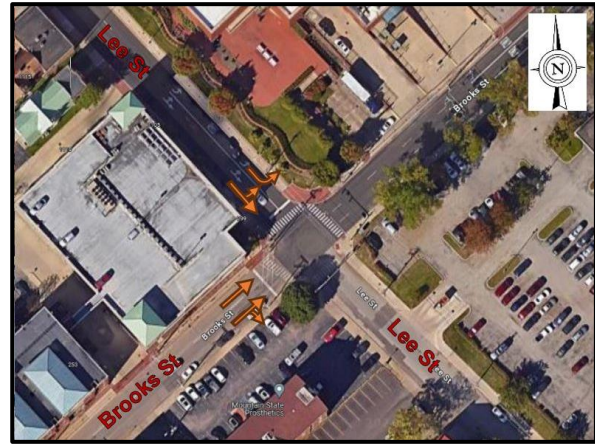
Figure 8: Lee Street and Brooks Street

The lane configuration for this signalized intersection is illustrated in **Figure 8**. All signal heads are mounted on mast arms and do not have backplates. Pedestrian push buttons, signal heads and high visibility crosswalks are provided on each corner of the intersection with pedestrians accommodated through an exclusive phase of the signal. Overhead lighting is provided at the intersection. Field reviews uncovered driver confusion relating to the two left-turn lanes from Lee Street and three receiving lanes on Brooks Street. No markings are provided through the intersection.

In total, ten sideswipe crashes occurred at this intersection, none of which resulted in injury. In all instances, the crashes were caused by vehicles turning left from Lee Street onto Brooks Street. With two turn lanes and three receiving lanes, drivers are not maintaining their lane through the turn because of confusion regarding appropriate lane configurations. Three of these crashes involved vehicles changing lanes on the approach, prior to making the turn, which can also be a sign of driver confusion.

- **Provide dotted lane line extensions for the left-turn lanes from Lee Street onto Brooks Street.** Based on the crashes occurring at this intersection, drivers are confused with the lane configuration especially with two turning lanes and three receiving lanes. It is proposed that striping be provided to better delineate these movements and reduce driver confusion.
