US 60 BETWEEN MILE BRANCH RD AND HULL AVE

ROAD SAFETY AUDIT

Regional Intergovernmental Council

BURGESS & NIPLE

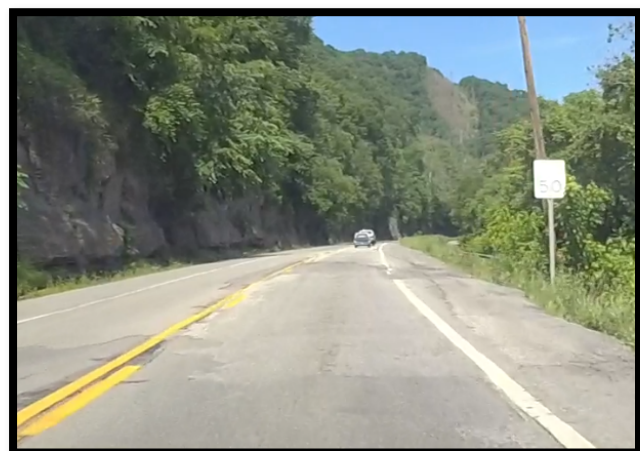
US 60 is a two-lane rural freeway with a speed limit of 50 mph. The eastbound direction transitions into two lanes to allow for passing approximately 500 feet west of Hull Avenue. This passing lane then continues for about a half mile to the east. US 60 then transitions to a four-lane divided freeway east of Hull Avenue. Railroad tracks run parallel to US 60 along the south side of the roadway. A rock face is located on the majority of the north side of the roadway and signs are present warning drivers of falling rocks. The pavement is washed out near Mile Branch Road, as seen in **Photo 1**. Signs are present before this section of roadway to warn drivers of the rough road and to lower their speed to 35 mph. US 60 has 10-foot shoulders on either side of the roadway from Mile Branch Road to William Street that become

Photo 1: Washed Out Pavement on US 60

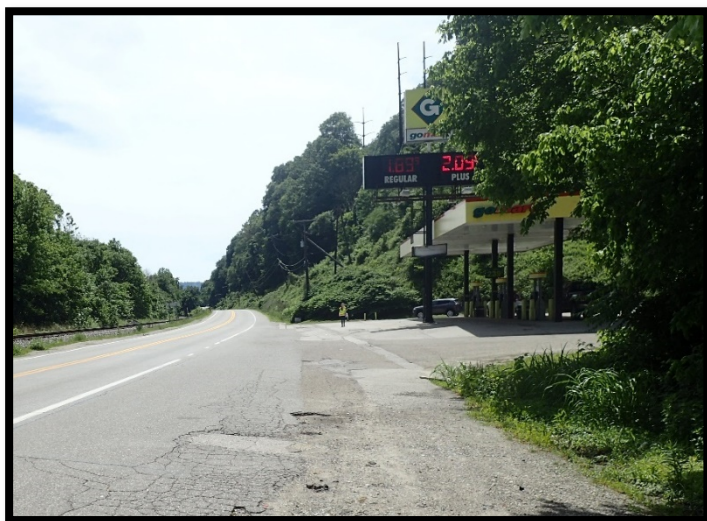
The intersection of US 60 and Mile Branch Road is a three-leg, minor road stop-controlled intersection. The lane configuration is shown in **Figure 2**. There is no stop sign located at Mile Branch Road, and the entrance is slightly hidden by the Go-Mart gas station located on the northwest corner of the intersection. The driveway for the Go-Mart does not have a clearly defined exit or entrance as illustrated in **Photo 2**. The pavement along the road is cracked and damaged in areas along the driveway. The intersection is not lit. Trees on either side of Mile Branch Road obstruct visibility of the intersection and gas station from US 60.

Photo 2: Go-Mart Driveway

- **Add flex posts along the Go-Mart driveway.** Adding flex posts will provide clear access points into Go-Mart, thus reducing possible conflict points.

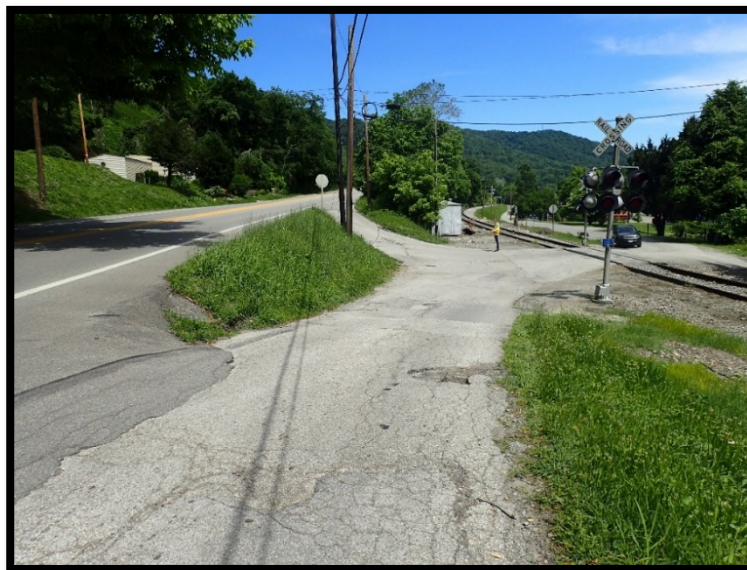
The lane configuration for the unsignalized intersection of US 60 and William Street is shown in **Figure 3**. Railroad tracks are located just south of the intersection on William Street as illustrated in **Photo 3**. The uneven asphalt between US 60 and Hull Avenue creates a rough transition between the two roads. Warning lights are provided at the railroad crossing and overhead lighting is located at the intersection. There are no turn lane pavement markings, stop signs or yield signs provided. Vehicles were observed to block the west leg of William Street while waiting to turn left onto US 60. Both entrances/exits on William Street are wide enough for only one vehicle, which increases the potential for conflicts at the intersection. However, observations showed that most drivers were familiar with the area and this condition and yielded to other vehicles. There is also poor sight distance for vehicles attempting to turn left due to the skewed angle of the intersection and the steep grade from Hull Avenue to US 60. The add lane from the east leg of William Street creates a weave along US 60 between William Street and Hull Avenue. Field observations showed very low traffic volumes along this segment which reduces the potential of conflicts created by the weave.

Photo 3: US 60 & William St. Pavement

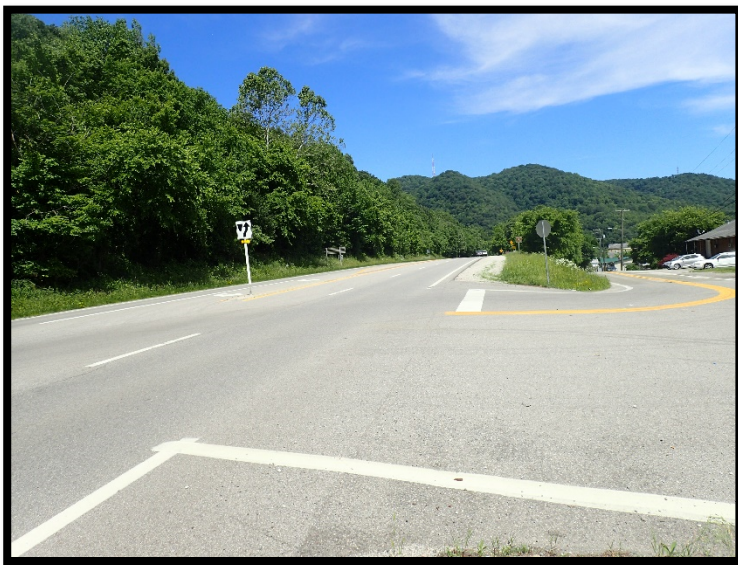
US 60 and Hull Avenue is a three-leg, minor-road stop-controlled intersection with the lane configuration shown in **Figure 4**. The eastbound right-turn lane is channelized with a raised concrete island. The movement is presumed to be yield-controlled but there is no signage or pavement markings that indicate this condition. The speed limit on Hull Avenue is 25 mph and provides access to a residential area in the town of Cedar Grove. There is poor sight distance for vehicles turning left onto US 60 from Hull Avenue due to the angle of the northbound approach as shown in **Photo 4**. A three-foot concrete median separates travel directions along US 60. The pavement and pavement markings are in good condition. There is no overhead lighting present at the intersection. US 60 widens to two lanes in the eastbound direction about 500 feet west of the intersection. Field reviews and stakeholder comments indicated that faster moving vehicles speed up to pass slower vehicles as soon as the second lane is formed on US 60. As a result, the vehicles in the right through lane obstruct the sight distance to vehicles in the left through lane for vehicles on Hull Avenue.

Photo 4: US 60 & Hull Ave Pavement

- **Install “DO NOT ENTER” signs (R5-1) facing Hull Avenue at the junction with the eastbound right-turn slip lane.** Vehicles approaching US 60 from Hull Avenue are aligned with this right-turn slip lane and no signage is provided to alert motorists that this leg is one-way. This intersection could be confusing to drivers who are not familiar with the area. These signs would likely prevent a wrong-way crash from occurring.

- **Install yield signs for the right-turn movement from eastbound US 60 to Hull Avenue.** Field observations indicated that signage was not provided to indicate the control for this lane. While it does not likely happen often because of the low traffic volumes, conflicts could occur between left-turning vehicles from westbound US 60 and right-turning vehicles from eastbound US 60. Left-turning drivers are focused on finding an acceptable gap in eastbound US 60 through traffic and the right-turn lane is separated from the intersection which results in drivers not seeing conflicting right-turning traffic. If right-turning vehicles yielded to the left-turning vehicles, the potential for conflicts is reduced.
