WV 34 FROM I-64 TO GREAT TEAYS BOULEVARD

ROAD SAFETY AUDIT

Regional Intergovernmental Council

November 2020

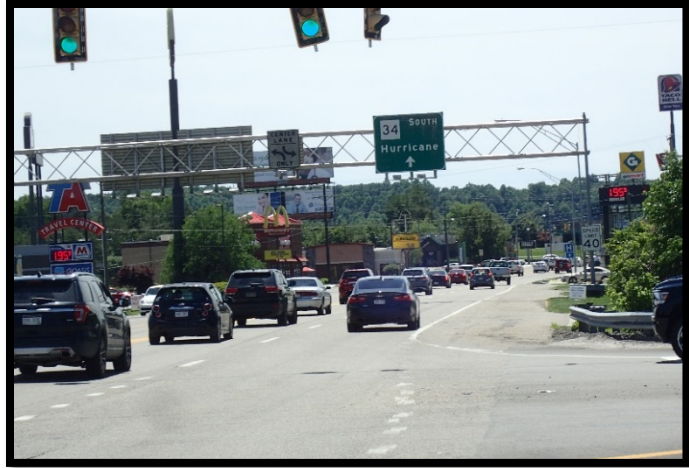
Photo 1: Traffic Along WV 34 Corridor

The land use in the study area is primarily commercial. This section of WV 34 provides access to restaurants, banks and other commercial properties on both sides of the roadway. WV 34 is a four-lane north-south minor arterial with a two-way left-turn lane (TWLTL) and a speed limit of 40 mph. This section of WV 34 has a high truck volume due to the large truck stop and I-64 Interchange located on the northern end of the study area. Overhead lighting is provided in the study area and sidewalks are located on both sides of the roadway from Great Teays Boulevard to the northern leg of Grille Lane. **Photo 1** shows the southbound traffic volume in the corridor during the early afternoon. Some vehicles were observed to experience significant delays (well over a minute) while waiting for a gap in traffic along WV 34 to turn left out of driveways. This delay caused many drivers to accept smaller, less desirable gaps when turning from driveways.

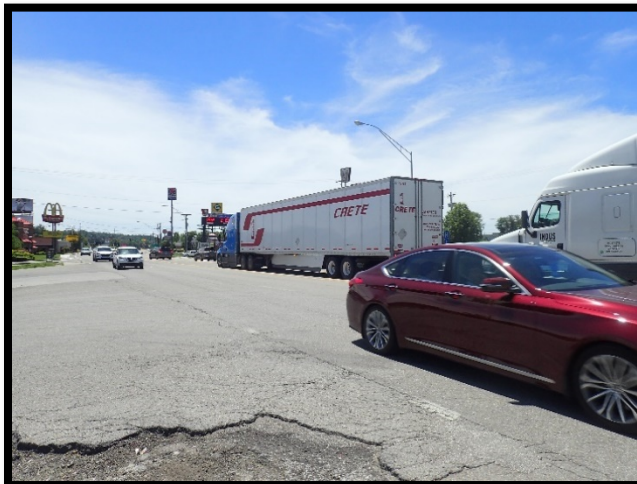
Photo 2: Semi-Trucks Waiting to Turn Left in Truck Stop

In front of the TA Travel Center, southbound semi-trucks were observed to queue in the TWLTL while waiting to turn into the truck stop as shown in **Photo 2**. Semi-trucks traveling out of the truck stop would occasionally stop traffic as they slowly exited the driveway as shown in **Photo 3**. The TA Travel Center driveway is set up such that the vehicles exit on the left-most driveway and enter on the right-

- Check vehicular clearance intervals.
- Implement coordinated signal timing along WV 34.
- Work with the TA Travel Center to reverse the circulation and reduce confusion and conflicts at the entrance and exit on WV 34.

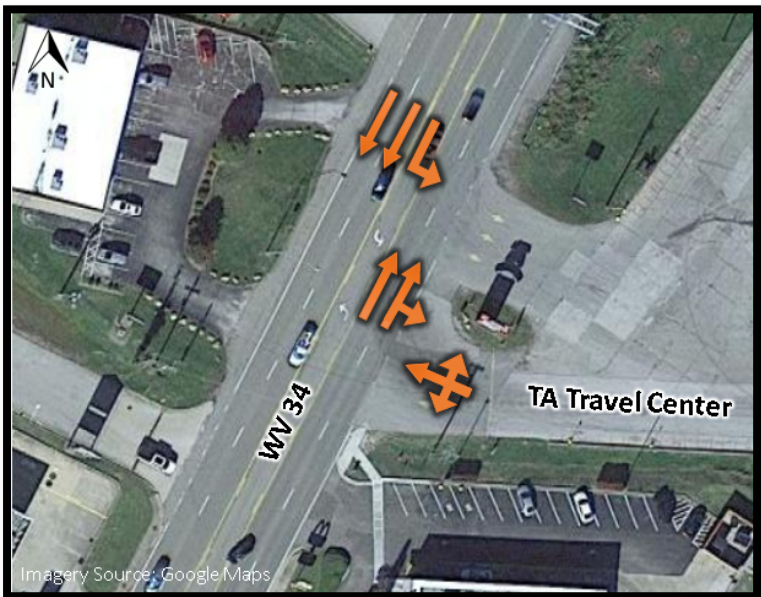
Figure 2: TA Travel Center Driveway Lane Configuration

most driveway as illustrated in **Figure 2**. This configuration leads to more potential conflicts as incoming turning traffic must yield to traffic leaving the TA Travel Center which is not typical.

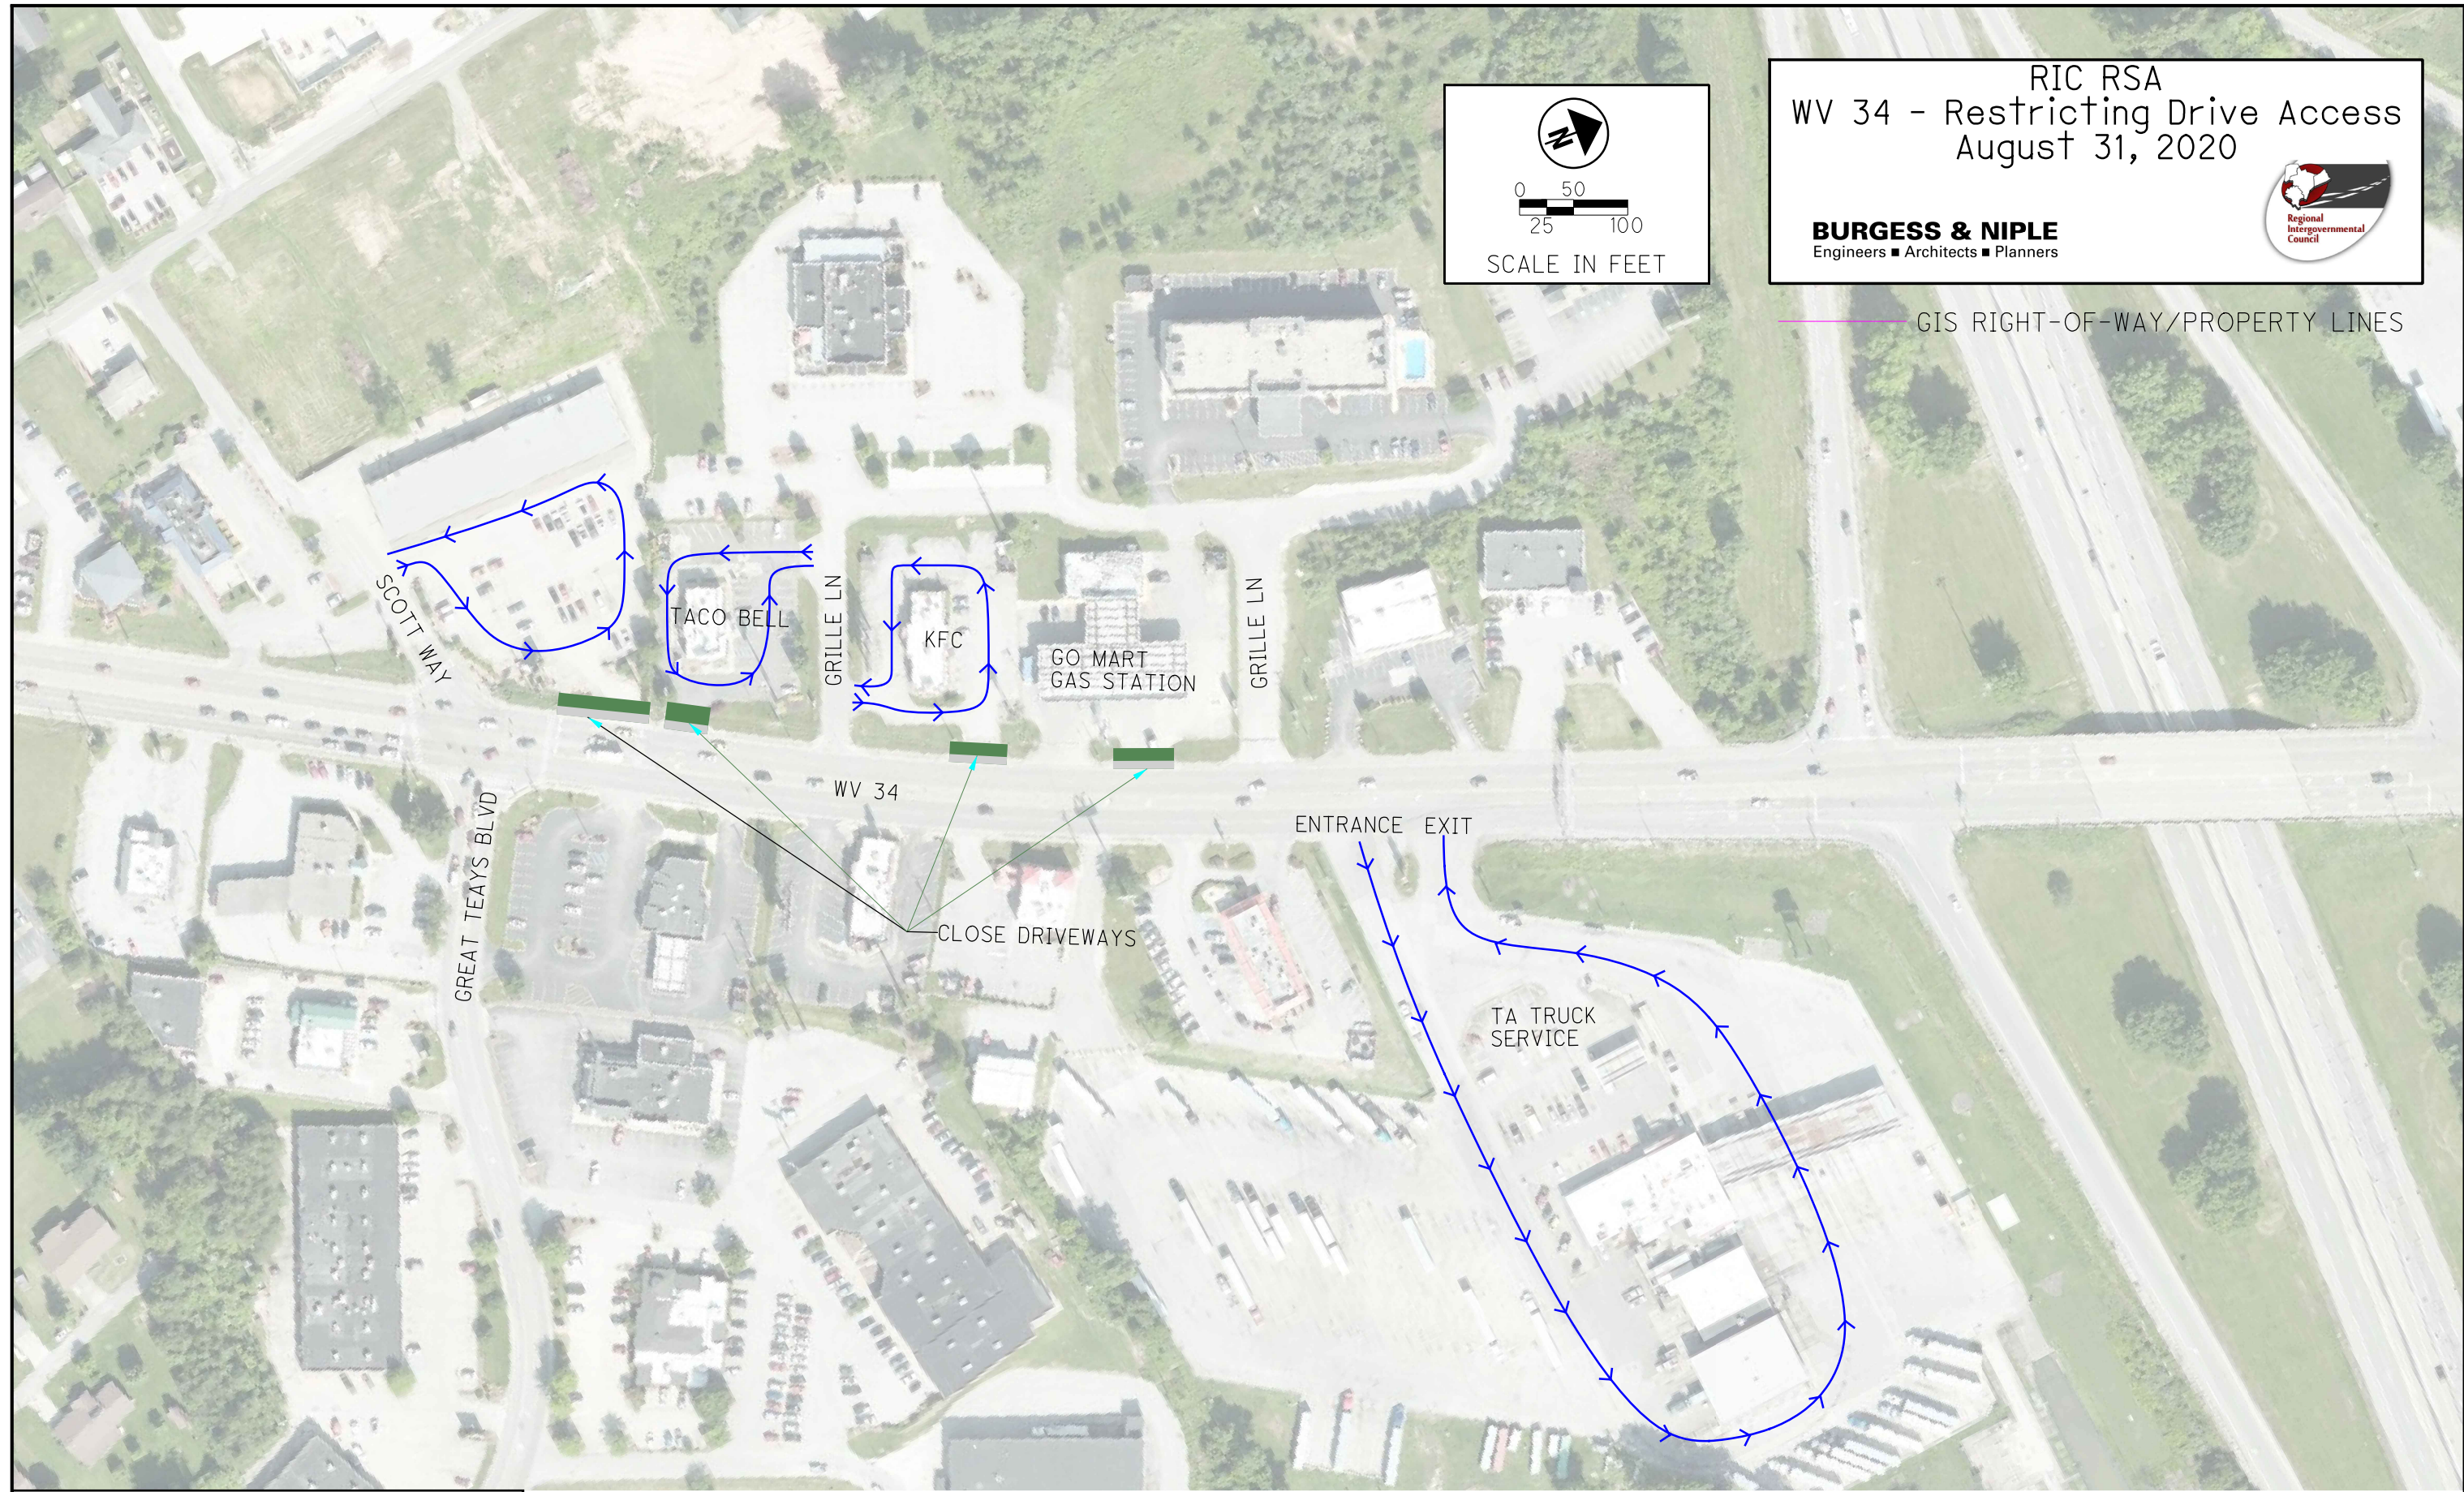
FIGURE
 10

- **Access Modification:** With every driveway along a corridor, the potential for conflicts increases. Fewer driveways spaced further apart result in fewer conflict points and fewer challenges for drivers to navigate with entering and exiting traffic at driveways. Closing the driveways along WV 34 at the Go-Mart, KFC, Taco Bell, and Scott Junction Plaza will reduce the number of driveways along WV 34 (see **Figure 10**). These businesses all have access through other driveways along WV 34 or Grille Lane. While the driveways along the east side of WV 34 would ideally be closed or consolidated, the lack of provided cross access or a backage road restricts the feasibility of access modifications to these businesses. Additionally, to prevent the confusion and conflicts at the TA Travel Center, the circulation into and out of the driveways could be reversed to provide a more typical configuration. The parking area behind the TA Travel Center would need to be reversed. This reconfiguration may result in left-turning traffic blocking outbound left-turning traffic. However, given the proximity to I-64, most of the exiting traffic is expected to turn right from the TA Travel Center. All of these modifications would require coordination with the businesses being affected. Curb and sidewalk would be constructed across the closed driveways.

Construction Cost Estimate: \$150,000
 Notes:
 - Cost estimate does not include right-of-way or utility relocations

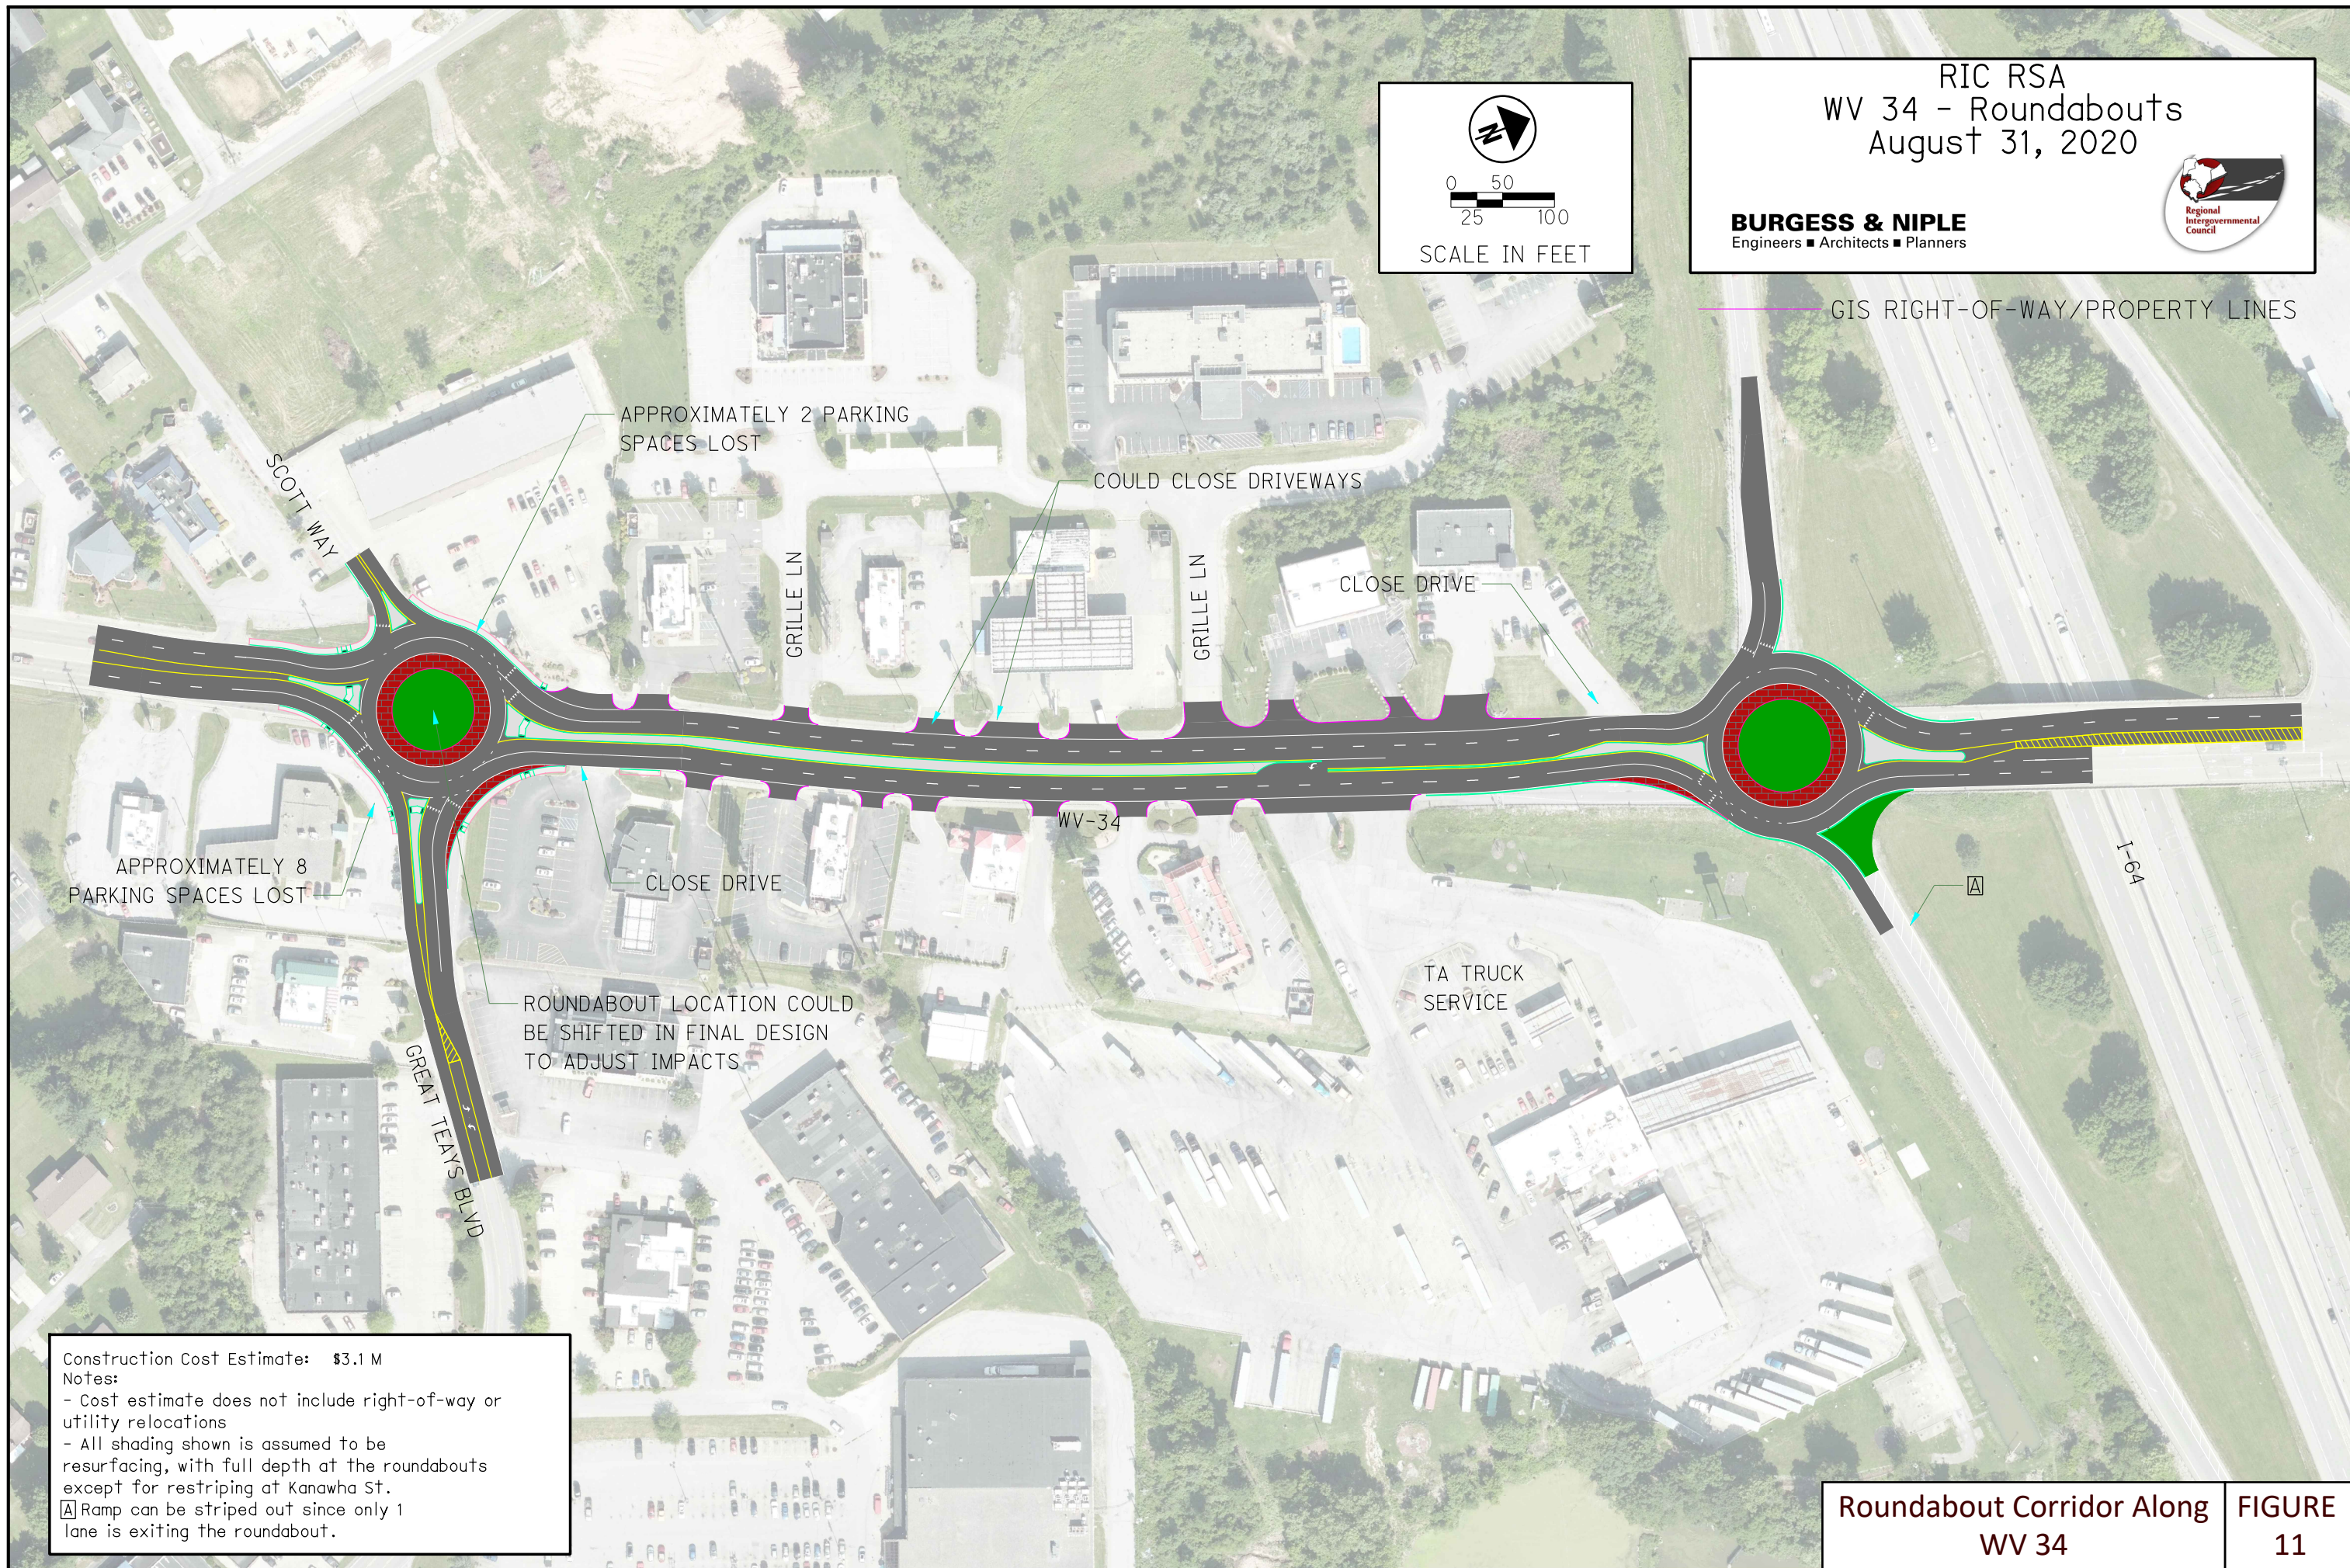
FIGURE
11

- **Roundabout Corridor:** Given the amount of crashes in the corridor occurring at the many driveways, wholesale access management improvements would mitigate several crashes. Converting all driveways to right-in/right-out (RIRO) configurations through the construction of a median down the center of WV 34. To facilitate left-turns, roundabouts would be constructed at the I-64 Eastbound Ramps and Great Teays Boulevard as illustrated in **Figure 11**. The roundabouts at these intersections would also mitigate the number of crashes at these signalized intersections. However, there will be property impacts including the loss of some parking spaces in the northwest and southeast corners of the Great Teays Boulevard intersection. These impacts could be refined in final design to minimize the loss of parking spaces. Rather than requiring semi-truck traffic to use the Great Teays Boulevard roundabout to make a U-turn to access the TA Travel Center, a left-turn lane will be constructed to

facilitate left-turn movements into the TA Travel Center. However, left-turns out of the TA Travel Center will use the roundabout at the I-64 Eastbound Ramps. The access management improvements previously detailed along the west side of WV 34 could still be implemented with this improvement to minimize the number of conflict points along WV 34.

Construction Cost Estimate: \$3.1 M
Notes:
- Cost estimate does not include right-of-way or utility relocations
- All shading shown is assumed to be resurfacing, with full depth at the roundabouts except for restriping at Kanawha St.
Ⓜ Ramp can be striped out since only 1 lane is exiting the roundabout.

Construct roundabout corridor. This alternative has the most potential to reduce crashes and improve operations in the corridor. While this improvement is costly, the benefit-to-cost ratio is 5.61. While securing funding for this improvement, the access management modifications that close the Go-Mart, KFC, Taco Bell, and Scott Junction Plaza could be implemented to improve safety in the interim.
