# MONTROSE DRIVE AND MACCORKLE AVENUE ROAD SAFETY AUDIT

Regional Intergovernmental Council

**BURGESS & NIPLE**

December 2020

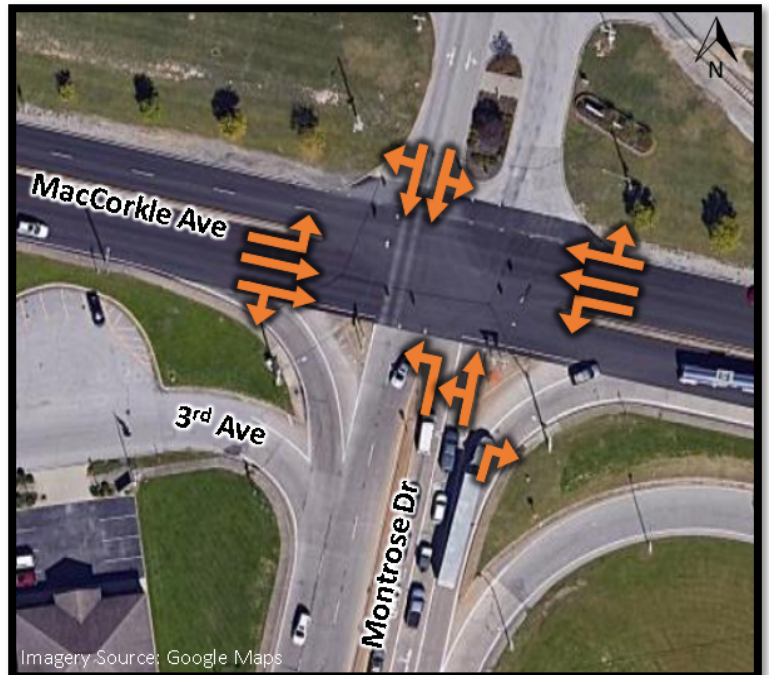
Figure 2: Lane Configuration

The intersection of MacCorkle Avenue and Montrose Drive is a four-legged signalized intersection with a box span configuration. Backplates are provided on the eastbound and westbound signal heads at the intersection. The lane configuration is shown in **Figure 2**. Overhead lighting is provided at this intersection. Pedestrian push buttons and pedestrian signal heads were present for crossing all legs but the south leg of the intersection. The pedestrian signal heads for the east leg of the intersection are set back from the intersection as seen **Photo 1**. During the field review it was observed that the pedestrian signal heads were not operating correctly as the walk symbol never appeared even after actuated. There were no crosswalks provided at the intersection.

The northbound and southbound approaches are split phased due to the shared through and left-turn lane on the northbound approach. The left-turn phases for eastbound and westbound approaches both operate protected-permitted.

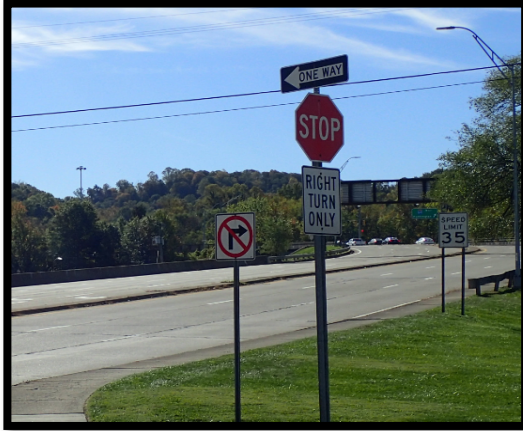
Photo 2: 3<sup>rd</sup> Avenue Signage

Access from 3rd Avenue to Montrose Drive is provided approximately 90 feet south of the intersection. While this access is one-way from 3rd Avenue to Montrose Avenue and a “NO RIGHT TURN” (**Photo 2**) and a “DO NOT ENTER” (**Photo 3**) sign are posted, some vehicles were observed to disregard the signs and turn right onto 3rd Avenue from Montrose Drive.

- **Close access from 3<sup>rd</sup> Avenue to Montrose Drive** (Improvement D on **Figure 6** and **Figure 7**): The current configuration of 3<sup>rd</sup> Avenue results in collisions because of limited sight distances and large amounts of conflicting traffic turning onto Montrose Drive from MacCorkle Avenue. With this closure, vehicles would be instead re-routed to B Street and MacCorkle Avenue, and then to the intersection of MacCorkle Avenue and Montrose Drive. If this option is implemented, observations should be conducted at the intersection of B Street/4<sup>th</sup> Avenue and MacCorkle Avenue to ensure that the added traffic volumes will not create operational or safety issues.

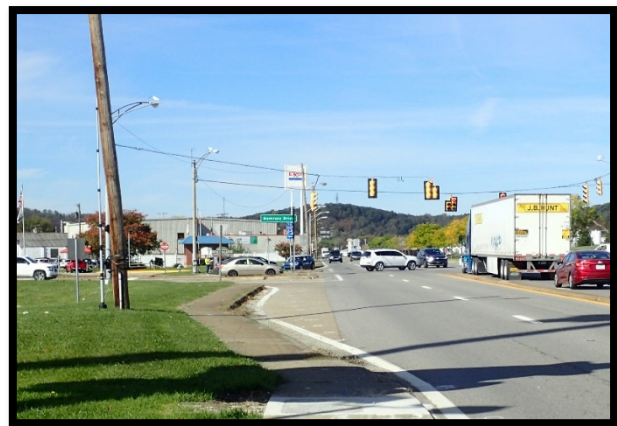
Photo 4: Acceleration Lane for Northbound Right-Turn

At the yield-controlled northbound channelized right-turn lane, a short 100-foot acceleration lane is provided, shown in **Photo 4**. The majority of vehicles making this movement did not use the acceleration lane to merge onto MacCorkle Avenue and instead waited for the eastbound lanes to clear before making their turn from Montrose Drive.

- **Remove the channelization northbound right-turn slip lane and control the right-turn movement by the signal** (Improvement A on **Figure 6** and **Figure 7**): By removing the yield control and controlling the movement by the signal, many of the rear end collisions would be mitigated as vehicles would not be stopping and starting in an attempt to find a gap on MacCorkle Avenue. In order to improve traffic operations, this movement can also be served with an overlap phase to operate concurrently with the westbound left-turn protected phase.

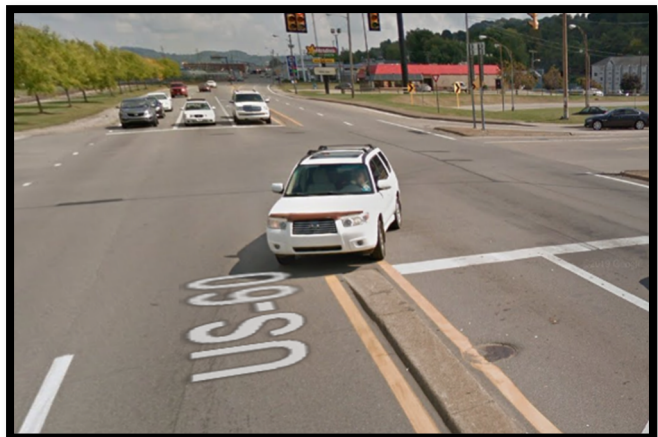
Photo 5: Northbound Left-Turning Vehicle

Northbound left-turning vehicles were observed driving over the concrete median as they turned onto MacCorkle Avenue, shown in **Photo 5** and as evidenced by the deteriorating and broken concrete observed in the field.

- **Add dotted pavement markings for northbound dual-left turn lanes** (Improvement B on **Figure 6** and **Figure 7**): Dotted pavement markings are recommended to delineate the path of each turn lane. This improvement will prevent vehicles from driving over the concrete median.

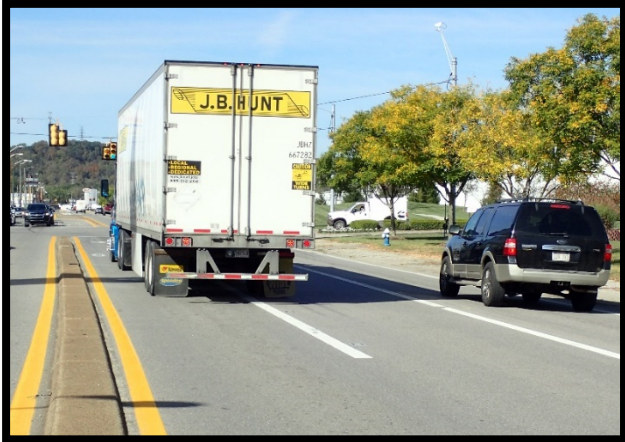
Photo 6: Large Truck in Westbound Left-Turn Lane

The westbound left-turn lane is only 10 feet wide, causing trucks and large vehicles to travel into the adjacent through-lane, as shown in **Photo 6**.

- **Remove concrete median on west and east legs of intersection to widen the left-turn lanes** (Improvement E on **Figure 6** and **Figure 7**): By removing the median, the width of the eastbound and westbound approaches will be increased. The portion of median removed will not affect the access management in the corridor. The wider median further from the intersection will remain to control access into and out of adjacent businesses.

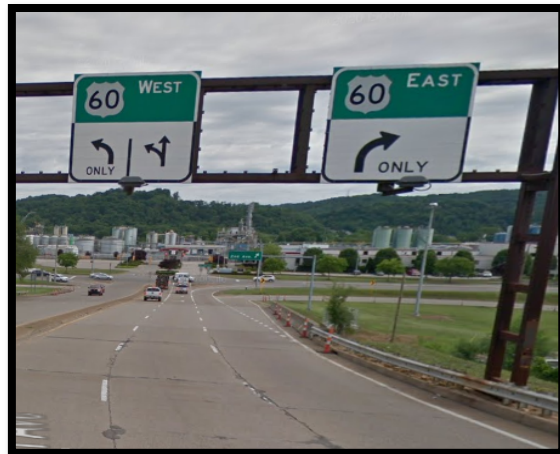
Photo 7: Overhead Lane Use Signs

As northbound vehicles approach the intersection on Montrose Drive, overhead lane-use signage is provided as illustrated in **Photo 7**. However, the right sign appears to indicate that the off-ramp to 2<sup>nd</sup> Avenue provides access to US 60 east and does not provide direction to 2<sup>nd</sup> Avenue

- **Revise the overhead sign along Montrose Drive for US 60 East:** The overhead sign on Montrose Drive for northbound appears to indicate that the off-ramp to 2<sup>nd</sup> Avenue leads to US 60 east. It is proposed that the sign be revised to include a second right-turn arrow indicating that 2<sup>nd</sup> Avenue is the first right-turn while MacCorkle Avenue is the second right-turn (see **Figure 8**).

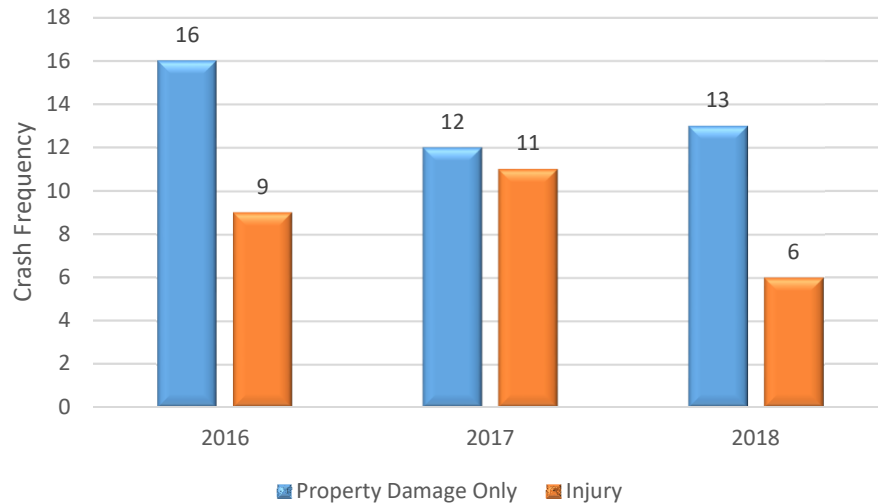
**Figure 4: Frequency of Crashes by Year and Severity**

Crash data from January 1, 2016 to December 31, 2018 was downloaded from the ReportBeam website. Each crash report was reviewed to determine potential factors contributing to crashes. A collision diagram that shows crash patterns by illustrating the approximate location of each reported crash is provided in **Appendix B**. In the three-year study period, there were 67 crashes with 41 (39 percent) resulting in injury. No fatalities occurred in the study period. The majority of crashes occurred on dry pavement (79 percent) and during the daylight (82 percent). **Figure 4** shows the crash breakdown per year by severity.

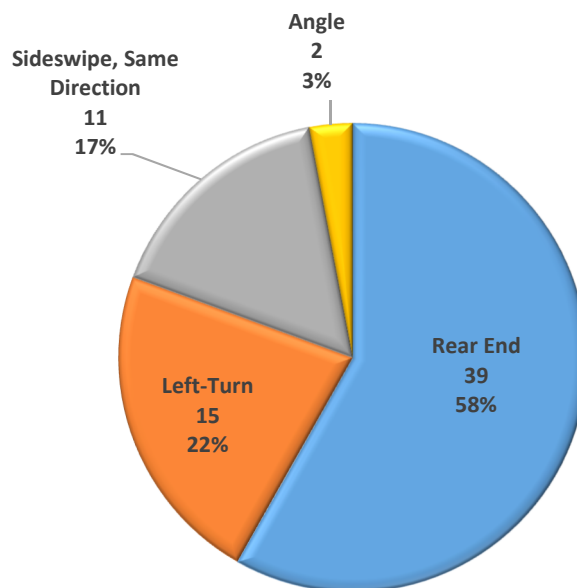
**Figure 5: Crash Frequency by Crash Type**

**Figure 5** illustrates the crash frequency by type of crash. The majority of the crashes at this intersection were rear end collisions (58 percent). One of the main rear end crash patterns was in the northbound right-turn lane. This pattern of rear end crashes likely occurs when a right-turning vehicle begins to accelerate after finding a gap in traffic along MacCorkle Avenue. The driver then

realizes that the gap is not adequate, abruptly brakes and is rear ended by the vehicle behind them. The six rear end crashes on 3<sup>rd</sup> Avenue likely resulted from the same situation, especially due to the short distance between the eastbound right-turn lane and the 3<sup>rd</sup> Avenue intersection.

Another main crash type at this intersection was left-turn collisions (22 percent). All the left-turn collisions at the intersection involved a westbound left-turning vehicle and an eastbound through vehicle. The majority of these collisions were caused by westbound vehicles failing to yield to vehicles traveling eastbound. Out of the 15 left-turn collisions, 10 (67 percent) resulted in injury. Some of the crash reports indicated that the westbound vehicle turned because they thought the opposing eastbound vehicle was turning right.
