# 1<sup>st</sup> AVENUE AND CENTER STREET ROAD SAFETY ASSESSMENT Regional Intergovernmental Council

Prepared by:

**BURGESS & NIPLÉ**

June 2022

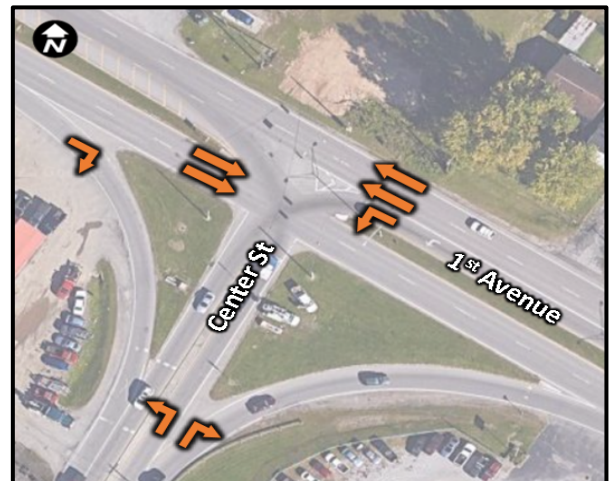
Figure 2: Lane Use Configuration

1<sup>st</sup> Avenue is a two-way four-lane divided roadway with a speed limit of 45 mph around the functional area of the intersection. Approximately 950 feet west and 1,150 feet east of the intersection with Center Street, 1<sup>st</sup> Avenue transitions into a two-way two-lane roadway with a center two-way left-turn lane (TWLTL). Center Street is a two-way four-lane divided roadway with a speed limit of 25 mph. Sidewalk is not provided along 1<sup>st</sup> Avenue and is only provided along the west side of the bridge on Center Street to the south of the intersection. An active railroad crossing is located approximately 275 feet south of the intersection.

The intersection of 1<sup>st</sup> Avenue and Center Street is a three-legged signalized intersection. The westbound left-turn approach has protected/permissive left-turn phasing as shown in **Photo 1**. Backplates are provided on the signal heads for the eastbound and westbound approaches. The lane configuration is illustrated in **Figure 2**. Channelized right-turn lanes are located on the northbound and eastbound approaches. The eastbound right-turn lane has an exclusive receiving lane on Center Street; however, this lane ends just north of the bridge which is approximately 360 feet from the channelized right-turn. The northbound right-turn lane is yield-controlled and does not have an acceleration lane along 1<sup>st</sup> Avenue. Pedestrian facilities (i.e., crosswalks, pedestrian push buttons, pedestrian signal heads and sidewalk) are not provided at the intersection. Overhead lighting is provided at the intersection. One of the overhead light poles on the west side of the intersection was struck several years ago and has not been replaced.

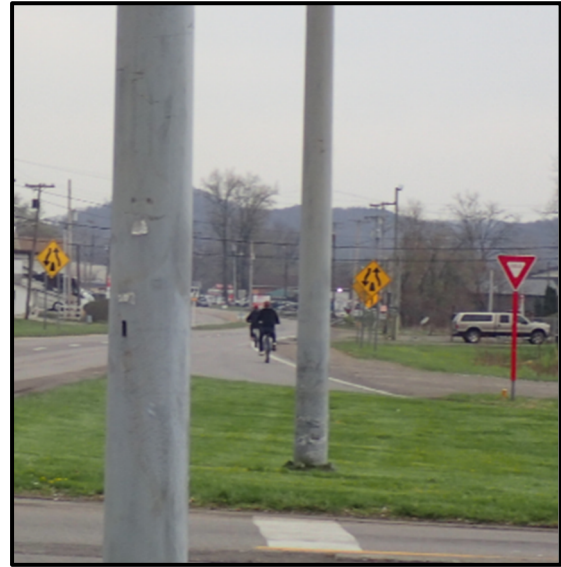
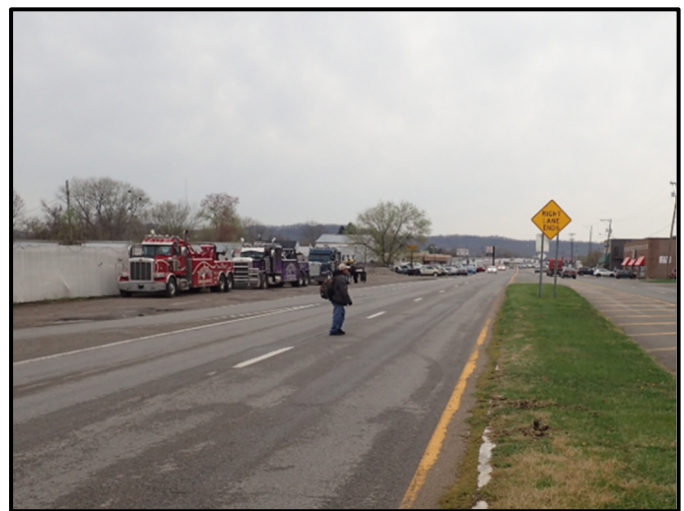
- Bicyclists and pedestrians were observed traveling through the intersection, shown in **Photo 2** and **Photo 3**.
- The signal pole on the southeast corner of the intersection is frequently struck as part of a secondary collision or as a result of vehicles avoiding another collision and running off the road. The damaged pole is shown in **Photo 4**.

**Photo 2: Bicycle traffic along Center Street**

**Photo 3: Pedestrian Traffic along 1<sup>st</sup> Avenue**

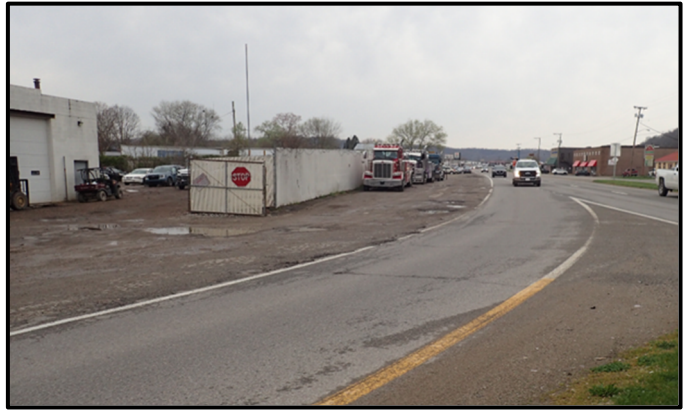
Photo 5: Driveway of Abbott's Wrecker

- The driveway of Abbott’s Wrecker is located on the eastbound channelized right-turn lane, shown in **Photo 5**. The truck traffic has resulted in some pavement damage along the turn lane.

- The Abbott's Wrecker driveway will need to be modified/relocated with this improvement.

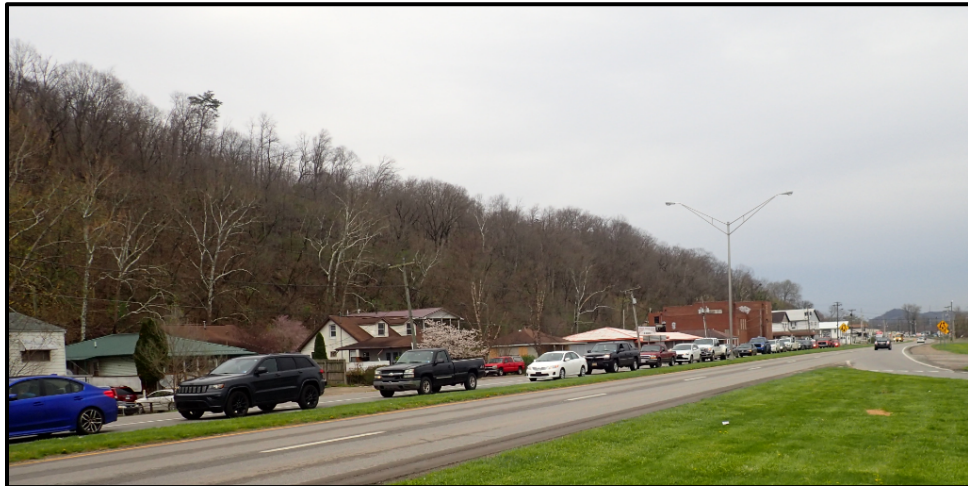
Photo 6: Westbound Left-Turn Queueing

- During a few signal cycles, vehicles in the westbound left-turn lane would queue outside of the storage length of the turn lane, shown in **Photo 6**. However, the majority of the queued traffic was able to get through the intersection within one cycle.

The existing condition analysis shows that the intersection of 1<sup>st</sup> Avenue and Center Street operates at level of service (LOS) C or better for all approaches and movements during both peak periods. The westbound left-turn 95<sup>th</sup> percentile queue is longer than the existing storage length. During field observations, the queues were occasionally spilling out of the westbound left-turn lane and into the through lanes.

- **Consider installing a protected-only westbound left-turn signal phase with lengthened storage lane.** This signal modification would eliminate the need for westbound left-turning drivers to assess and select adequate gaps in traffic along eastbound 1<sup>st</sup> Avenue which would likely reduce many of the left-turn collisions. The westbound left-turn lane would need to be lengthened to accommodate the additional queueing. There is adequate space in the

grass median to accommodate the turn lane. The current 230-foot lane will be lengthened to approximately 300 feet. This layout is shown in **Figure 7**.

- **Consider installing a protected-only westbound left-turn signal phase with dual westbound left-turn lanes.** Adding the dual left-turn lanes would help to accommodate more volume with the protected-only left-turn phasing as well as provide more storage for vehicles to queue without impact the through lanes. In addition to adding the dual left-turn lanes, the eastbound right-turn lane would be brought into the intersection and signalized to operate as an overlap with the northbound left-turn movement. This right-turn movement would also have the right-of-way when the westbound through movement is served. The layout of this improvement is shown in **Figure 8**.

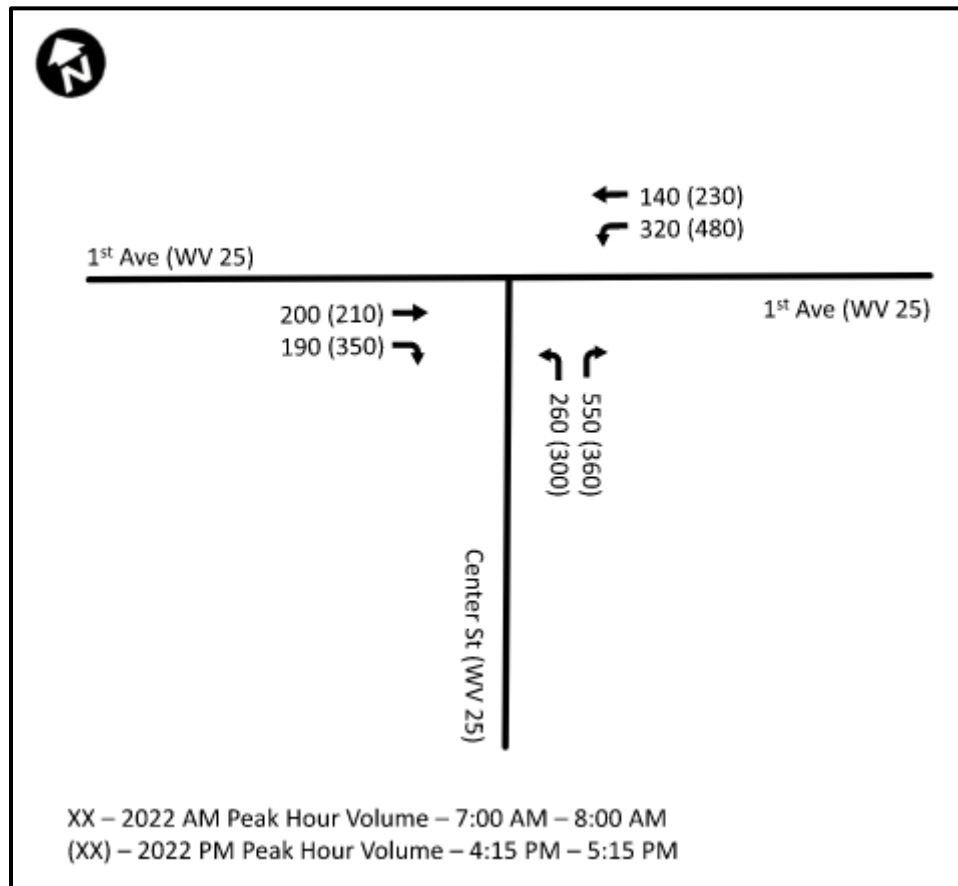
Figure 3: 2022 Adjusted Peak Hour Volumes

Turning movement counts were collected for 24 hours on Tuesday, April 7<sup>th</sup>, 2020 for the intersection of 1<sup>st</sup> Avenue and Center Street. The peak hours were determined to be 7:00 AM to 8:00 AM and 4:15 PM to 5:15 PM. The volumes were adjusted to account for the changes in traffic volumes due to the COVID-19 pandemic using existing 24-hour 2019 counts. An adjustment factor of 2.05 and 1.61 was used for the AM and PM peak, respectively. The final adjusted 2022 rounded peak hour counts are shown in **Figure 3**. Raw traffic counts are provided in **Appendix A**.

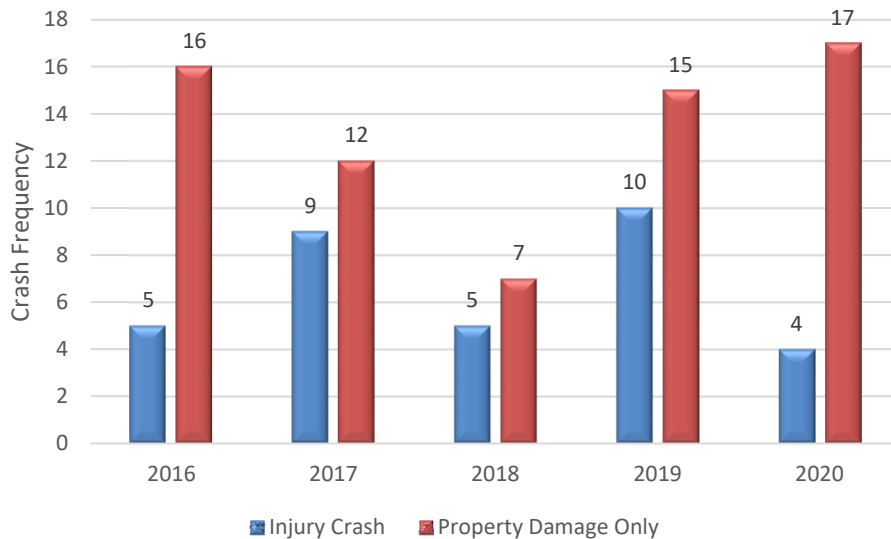
**Figure 4: Frequency of Crashes by Year and Severity**

Crash data from January 1, 2016 through December 31, 2020 was downloaded from the ReportBeam website. Each crash report was reviewed to determine potential factors contributing to crashes. A collision diagram that shows crash patterns by illustrating the approximate location of each reported crash is provided in **Appendix C**. In the five-year study period, there were 100 collisions with 33 (33 percent) resulting in injury. Three of the injury collisions were serious injury collisions. No fatalities were reported in the study area. **Figure 4** shows the frequency of crashes by severity per year.

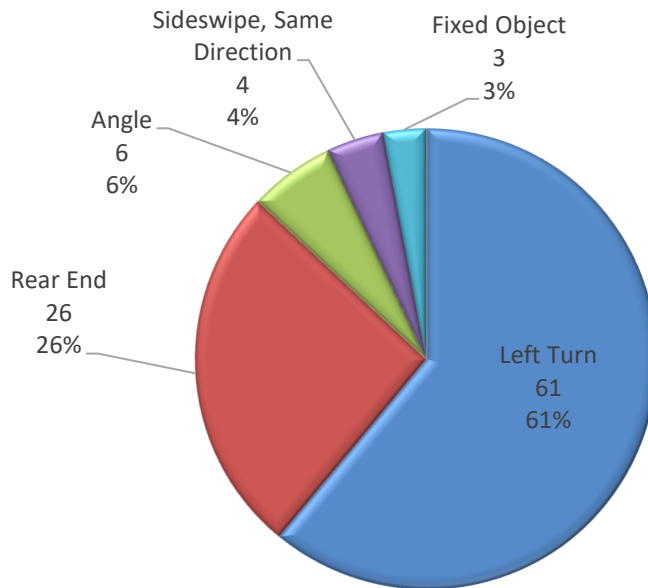
Figure 5: Frequency of Crashes by Crash Type

**Figure 5** shows the crash frequency in the study area by the crash type. Left-turn collisions were the most prominent crash type, accounting for 61 total collisions with 28 (46 percent) resulting in injury. Out of the 61 left-turn crashes, 59 crashes resulted from westbound left-turning vehicles failing to yield to eastbound vehicles on 1<sup>st</sup> Avenue. These collisions were likely due to driver confusion reading the protected/permissive signal head as well as drivers just not selecting an appropriate gap. Some drivers may think the green ball on the protected/permissive signal head indicates that they have the right-of-way, especially if the green ball follows a green arrow. If the vehicles in front of them are continuously turning left, drivers may continue to follow them after the light switches from a green arrow to a green ball.

Rear end collisions were next most common crash type, with the highest crash pattern occurring in the westbound left-turn lane. This crash pattern likely occurred due to congestion and drivers unexpectedly stopping when the westbound left-turn traffic signal changes from protected to permissive.

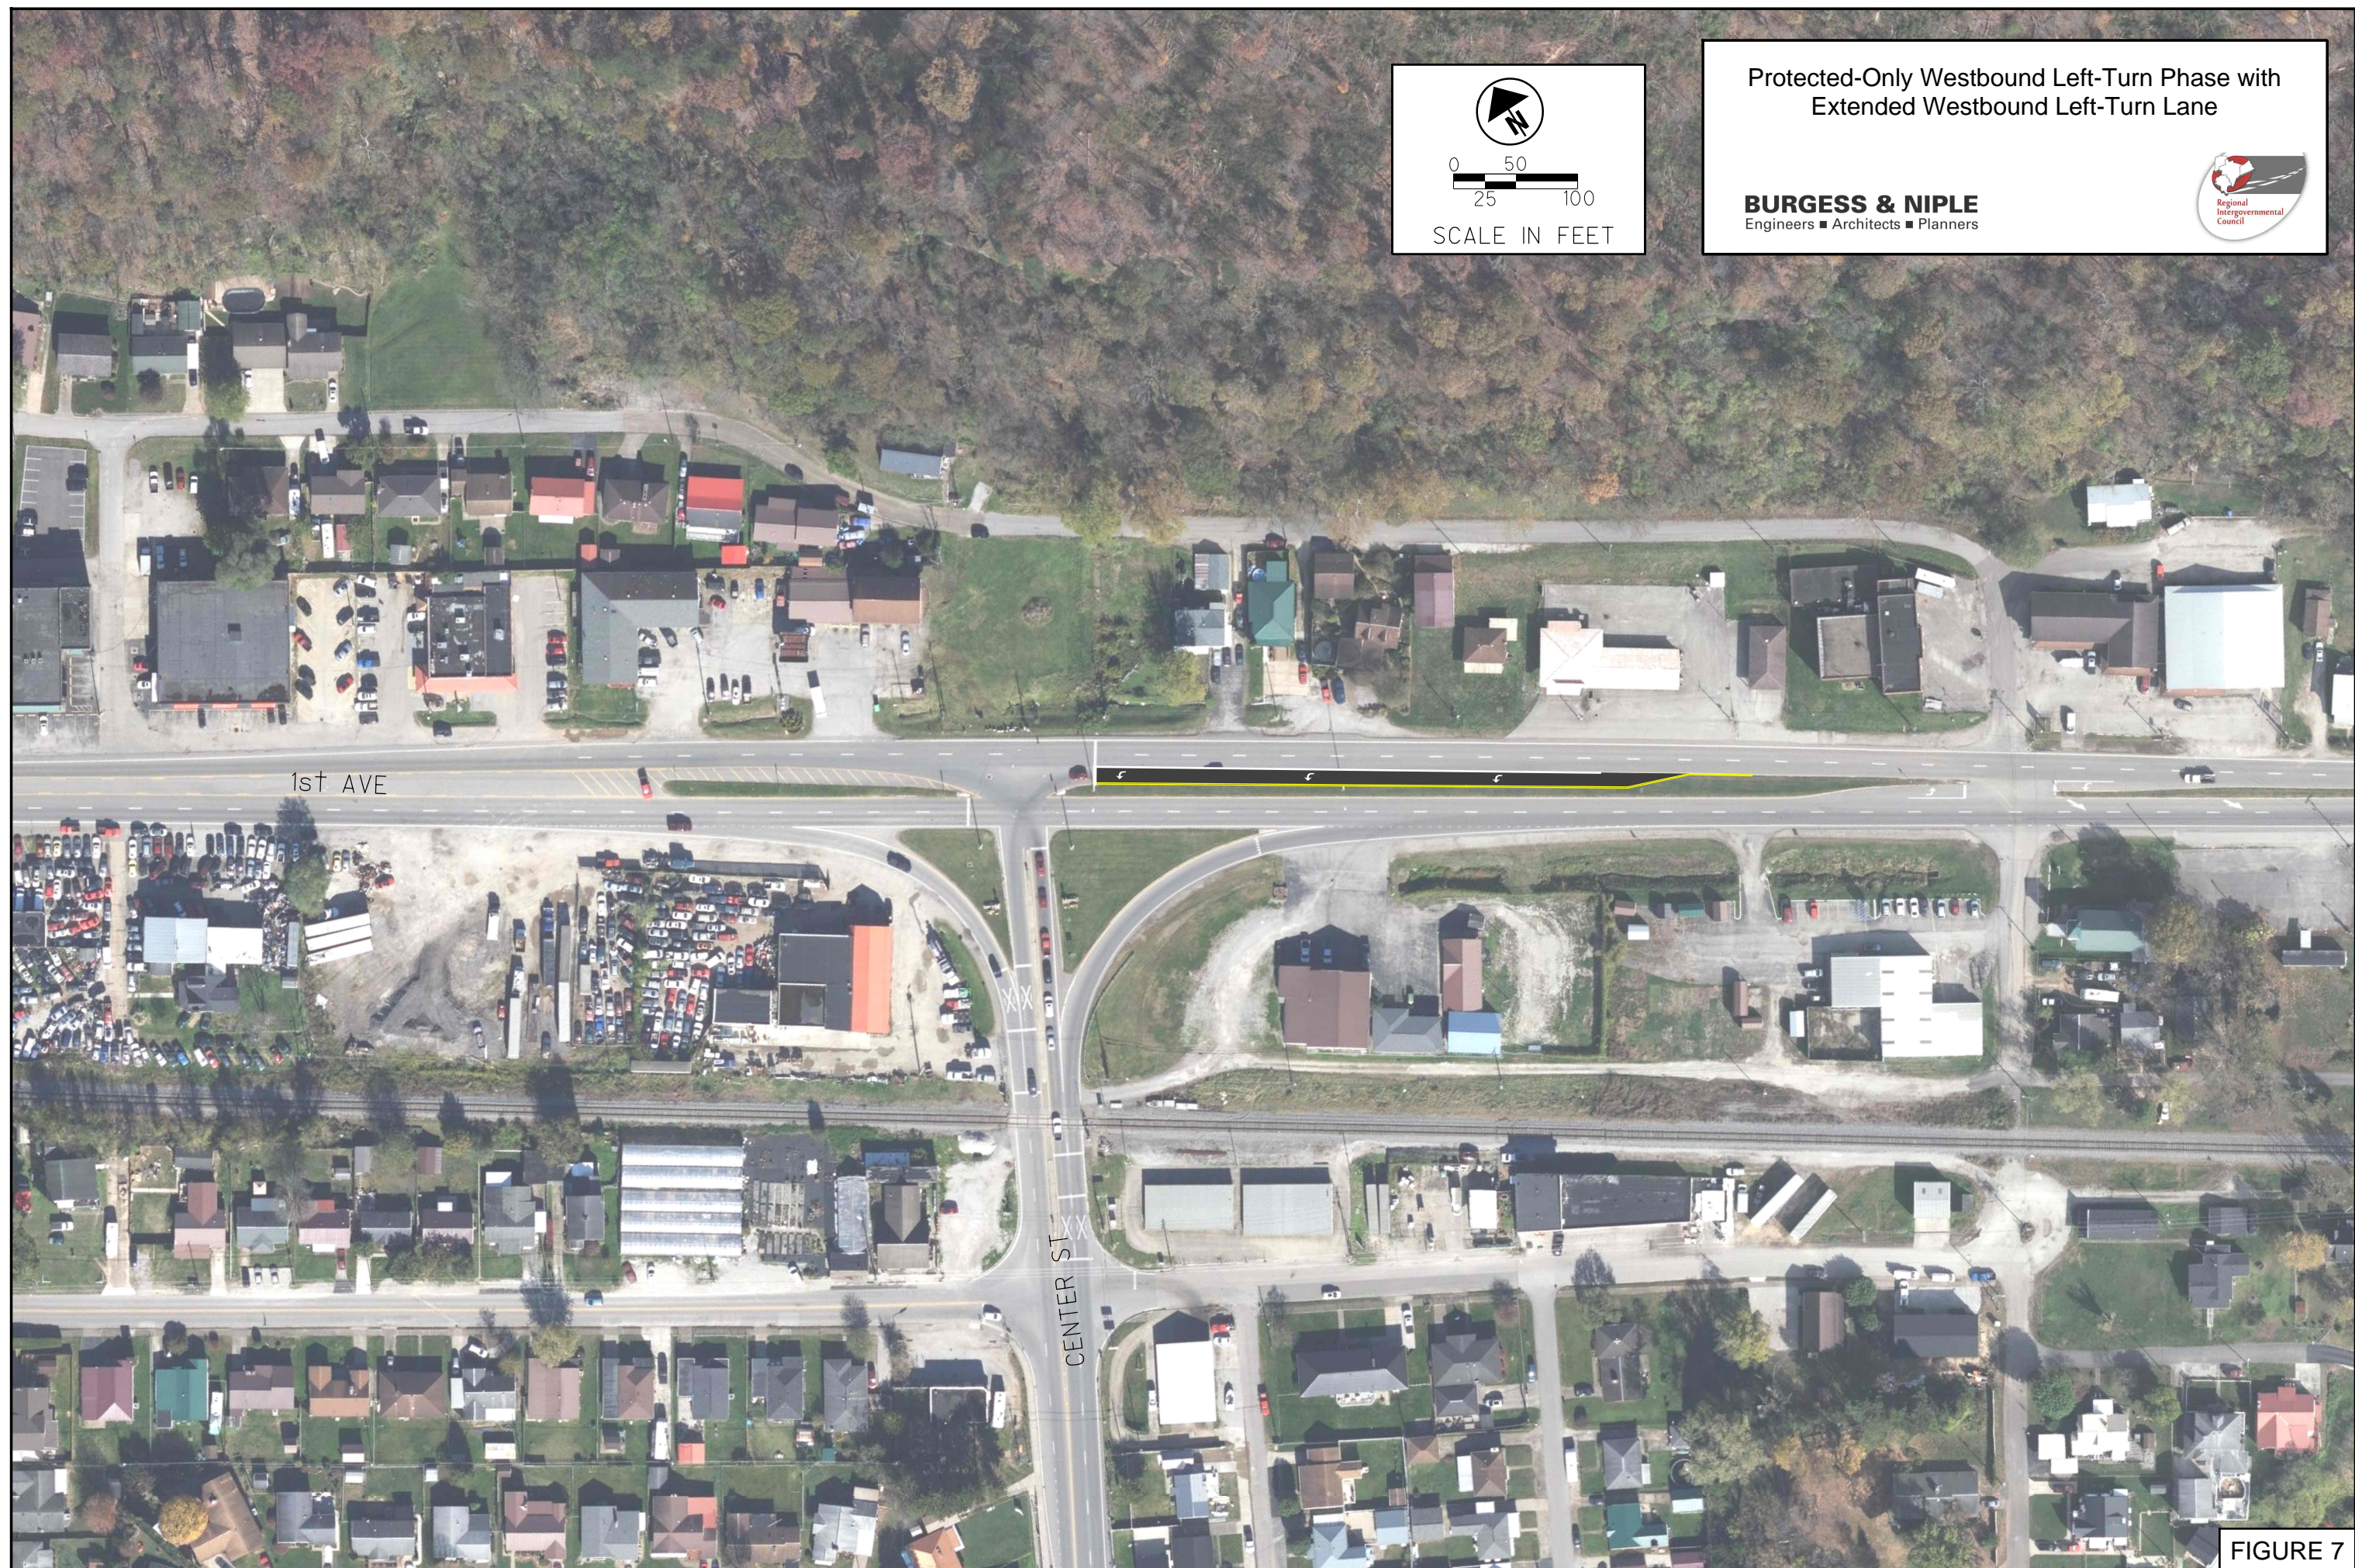
FIGURE 7

Protected-Only Westbound Left-Turn Phase with  
Extended Westbound Left-Turn Lane

All movements will operate at level of service (LOS) E or better during both peak periods. The westbound left-turn is near capacity in both the AM and the PM peak hours. The westbound left-turn lane will need to have additional storage added so that queues do not spill into the adjacent westbound through lane.

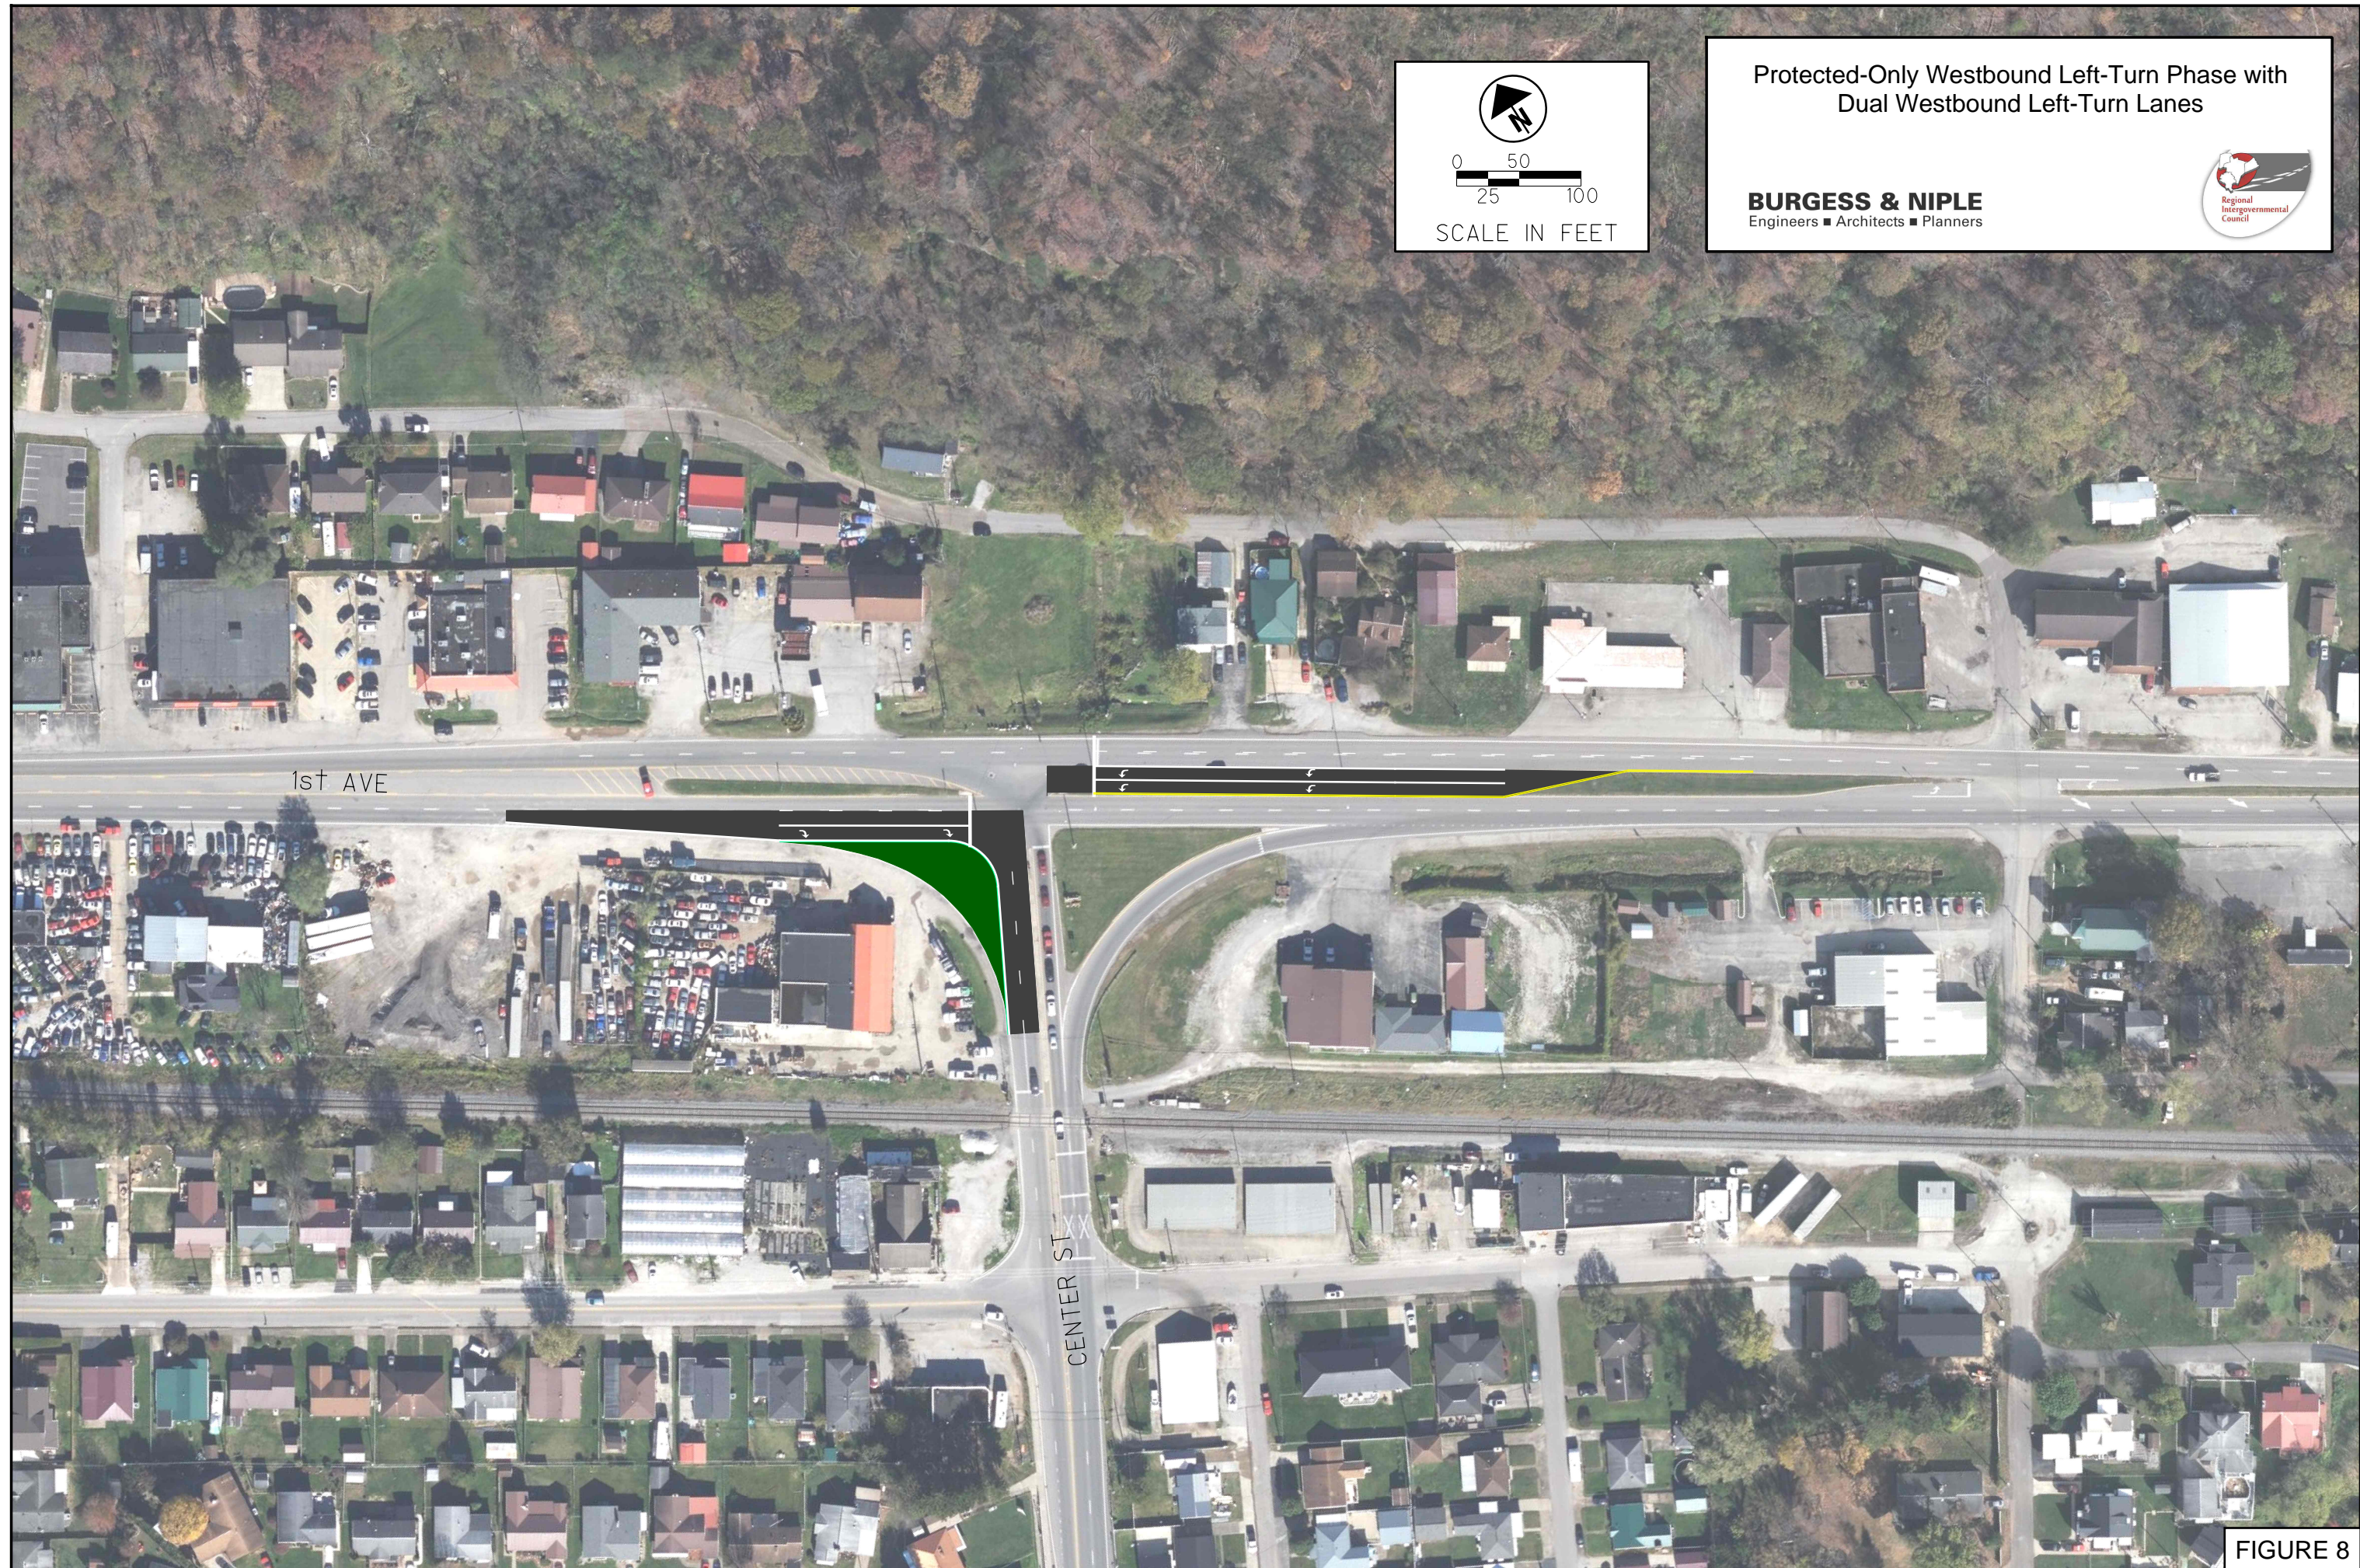
FIGURE 8

- This improvement would also benefit the flow of traffic on Center Street as eastbound right-turning traffic was often observed yielding to westbound left-turning traffic when both movements were in exclusive lanes. While the dual left-turn lanes will not be evenly utilized, there is a longer distance provided for vehicles to merge before the bridge than under current conditions.

Protected-Only Westbound Left-Turn Phase with  
Dual Westbound Left-Turn Lanes

Understanding that the dual westbound left-turn lanes will not be used evenly, a lane utilization factor of 0.57 was assumed to account for the lane imbalance. Providing dual left-turn lanes for the westbound left-turn movement improves the westbound left-turn operations over the single-lane protected left-turn alternative. The volume to capacity ratio is less than the single-lane protected left-turn but is still near capacity in the PM peak hour. Bringing the channelized eastbound right-turn into the signal will decrease the efficiency of this movement, but it will remove the merge add lane that is currently causing observed queueing at the intersection. During the PM peak, the eastbound right-turn movement operates at LOS E and is near capacity.

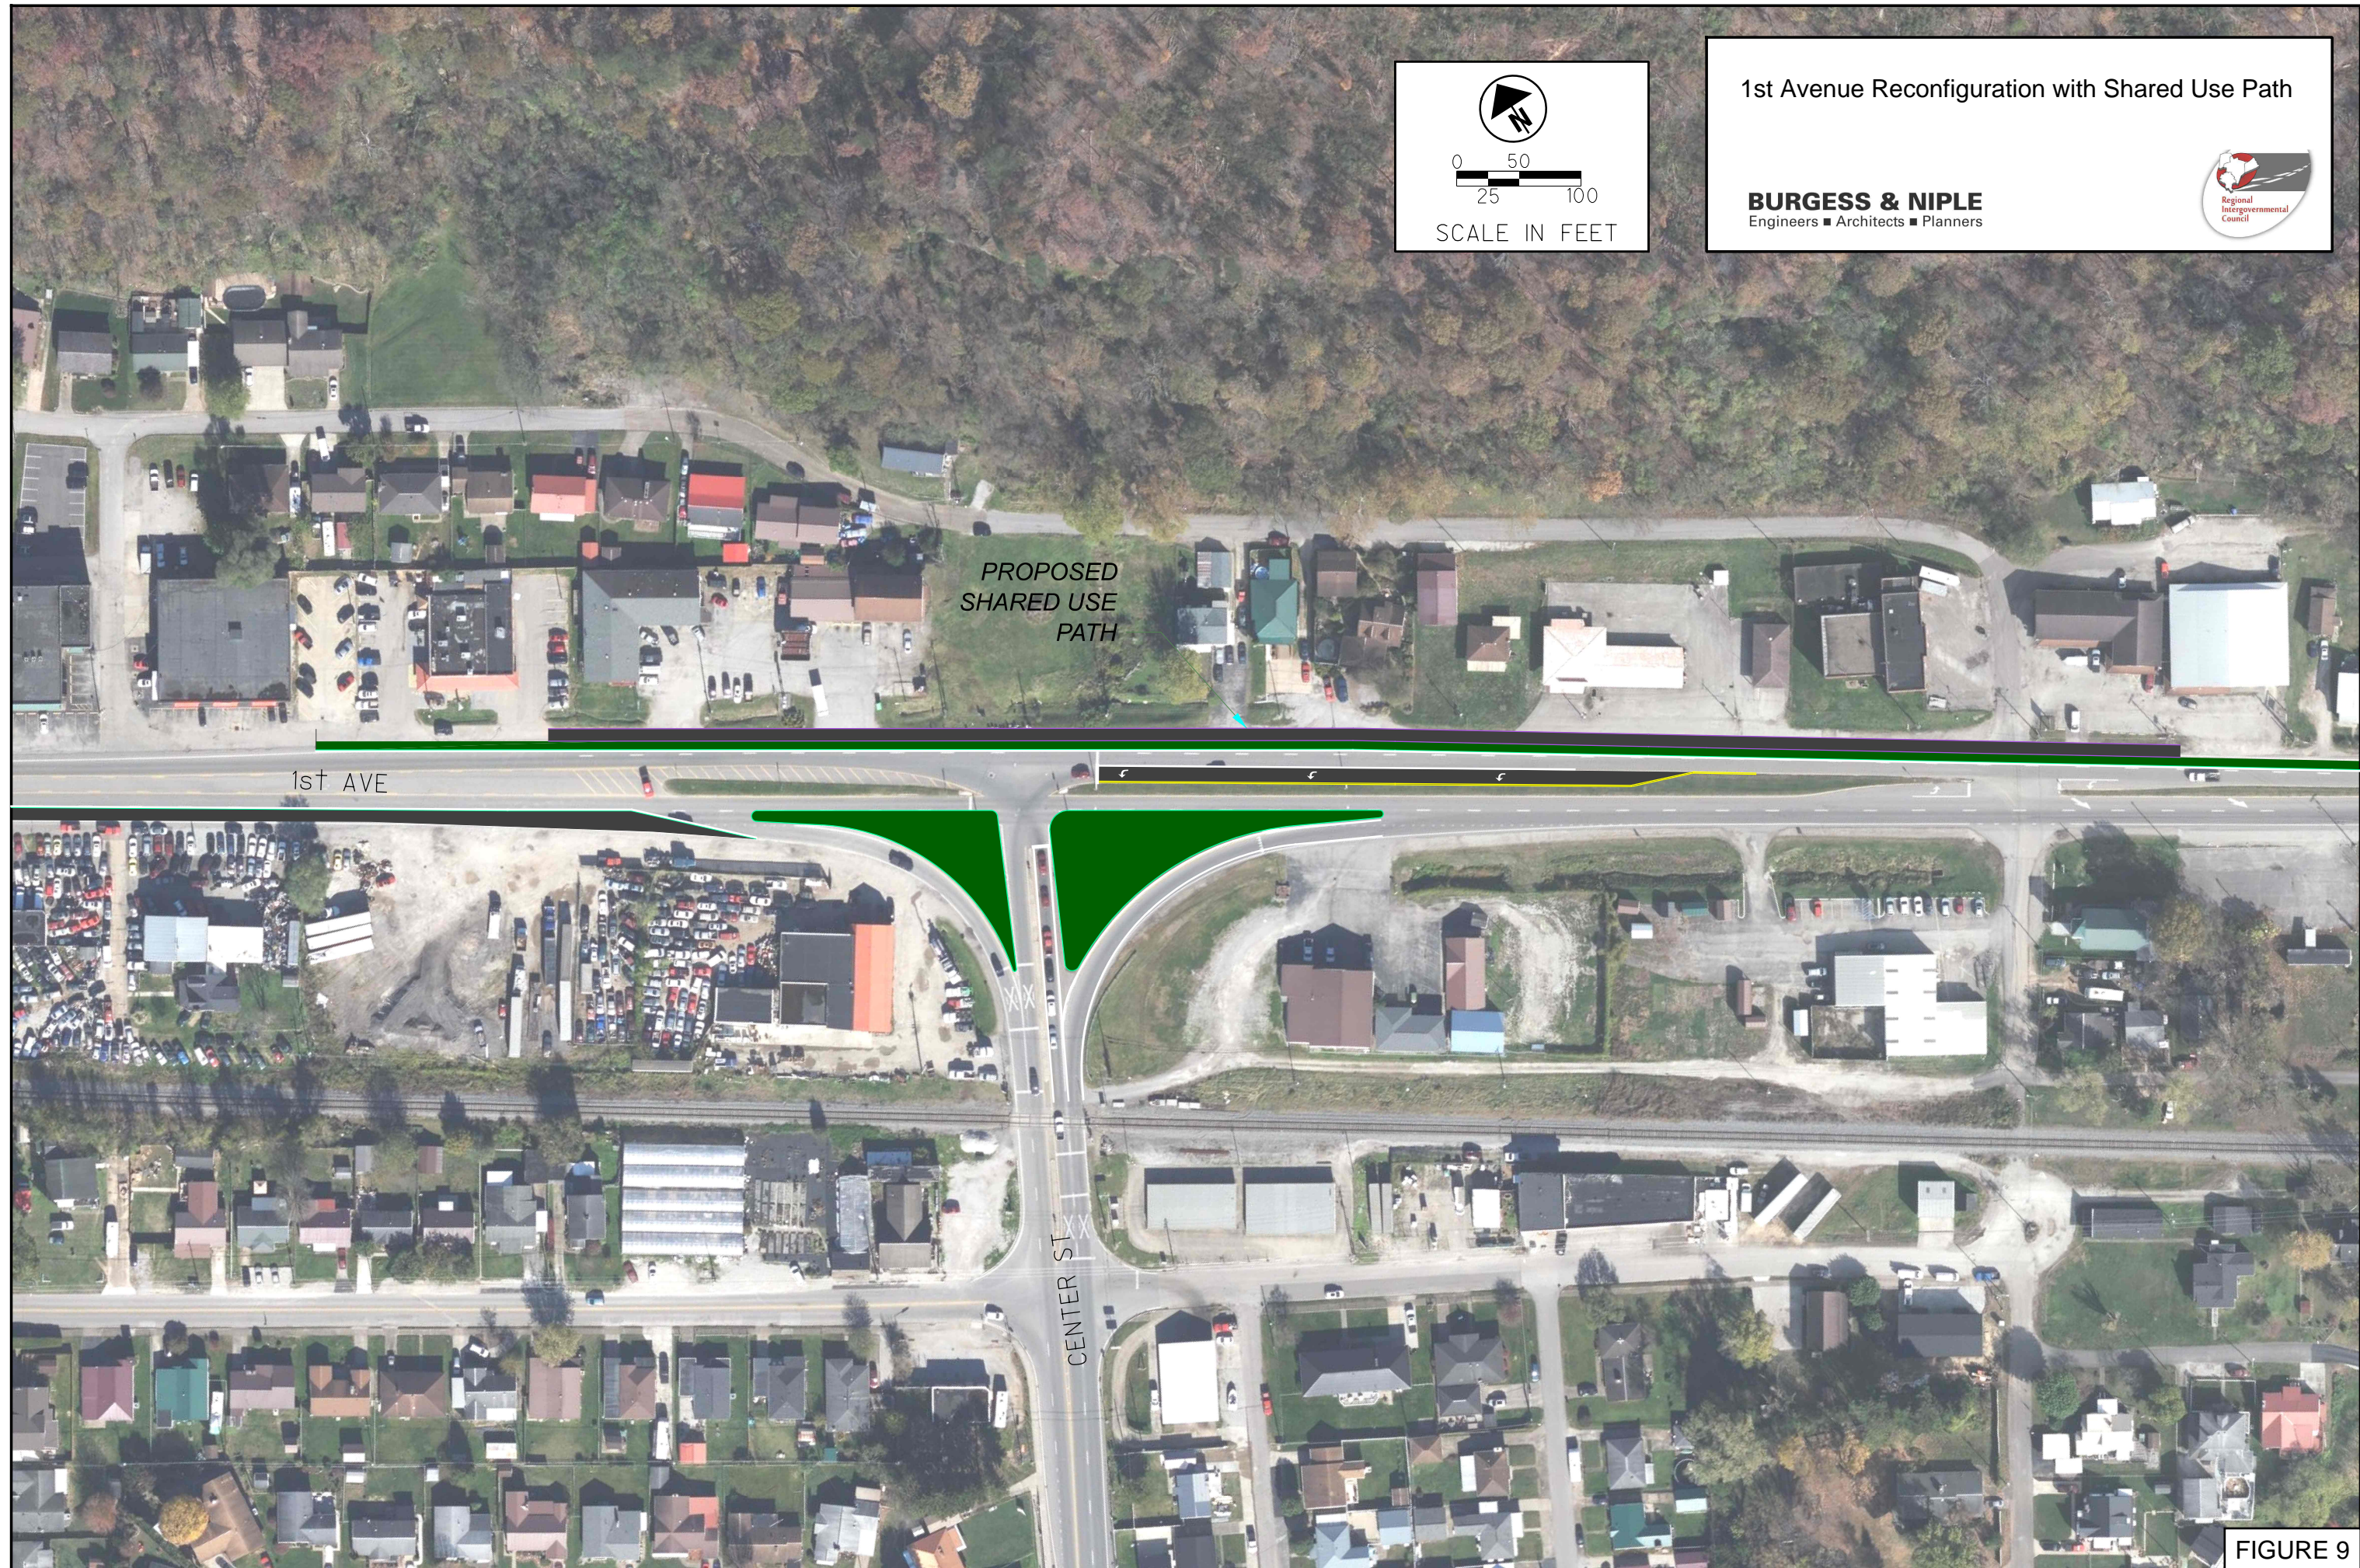
FIGURE 9

- **Consider removing one through lane in each direction and adding a shared-use path on the north side of 1<sup>st</sup> Avenue.** Based on initial capacity analysis, two through lanes in each direction on 1<sup>st</sup> Avenue are not required for acceptable intersection operations. Furthermore, the second through lane in both directions only extends a few hundred feet on either side of the Center Street intersection. As part of this improvement, the northbound right-turn lane would have an add lane which would allow northbound right-turning traffic to accelerate along 1<sup>st</sup> Avenue in an add lane before merging with traffic on 1<sup>st</sup> Avenue. Adding a shared-use path would create a better environment for pedestrians and bicyclists to travel along 1<sup>st</sup> Avenue. There are currently no sidewalks or pedestrian facilities in the area. The shared-use path would need to be part of a larger corridor connectivity project along 1<sup>st</sup> Avenue through coordination with West Virginia Division of Transportation (WVDOT). This layout is shown in **Figure 9**. While illustrated with the extended westbound left-turn lane, this reconfiguration can also be constructed in conjunction with the dual westbound left-turn lane option.

1st Avenue Reconfiguration with Shared Use Path

Removing a through lane in each direction with a protected-only westbound left-turn lane operates at LOS E or better for all movements. The westbound left turn is near capacity for both the AM and PM peak. The westbound left turn will have to be extended to store the 346 feet queue during the PM peak. The current storage length of the left-turn lane is approximately 230 feet.
