PENNSYLVANIA AVENUE NORTH AND SOUTH ROAD SAFETY AUDIT

Regional Intergovernmental Council

BURGESS & NIPLÉ

November 2020

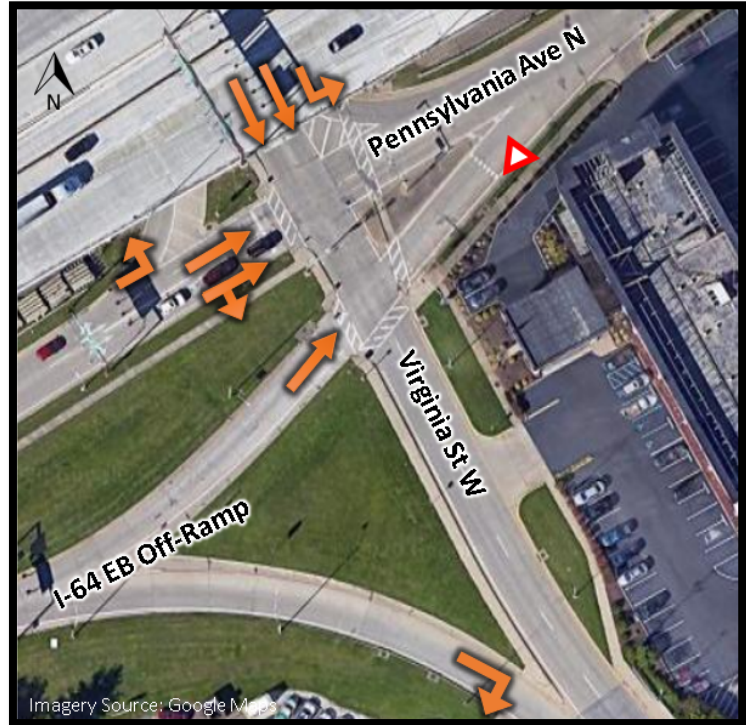
Figure 2: Pennsylvania Ave N and Virginia St W Lane Configuration

The lane configuration for this signalized intersection is summarized in **Figure 2**. The I-64 Eastbound Off-Ramp is a fifth leg of this intersection and is controlled by a separate traffic signal, shown in **Photo 1**. After vehicles exit the I-64 Eastbound Off-Ramp and continue through the traffic signal, they yield to traffic on Pennsylvania Avenue North using a short lane on the north leg of the intersection. Vehicles turning right onto Virginia Street West from the I-64 Eastbound Off-Ramp are channelized approximately 250 feet east of the intersection. Right turns on red are prohibited on the northbound approach per signing. Crosswalks are present on all legs except for the west leg. A pedestrian refuge island is provided for vehicles crossing the north leg with a pedestrian push button in the center island. Sidewalks are located on all legs. Pedestrian signal heads and push buttons with audible tones are present for crossing the west section of the north leg and the east leg of the intersection. On the eastbound approach a sign indicates that left-turning vehicles must yield to pedestrians. The pavement is in good condition, but the stop bar and lane use pavement markings were faded on the eastbound approach.

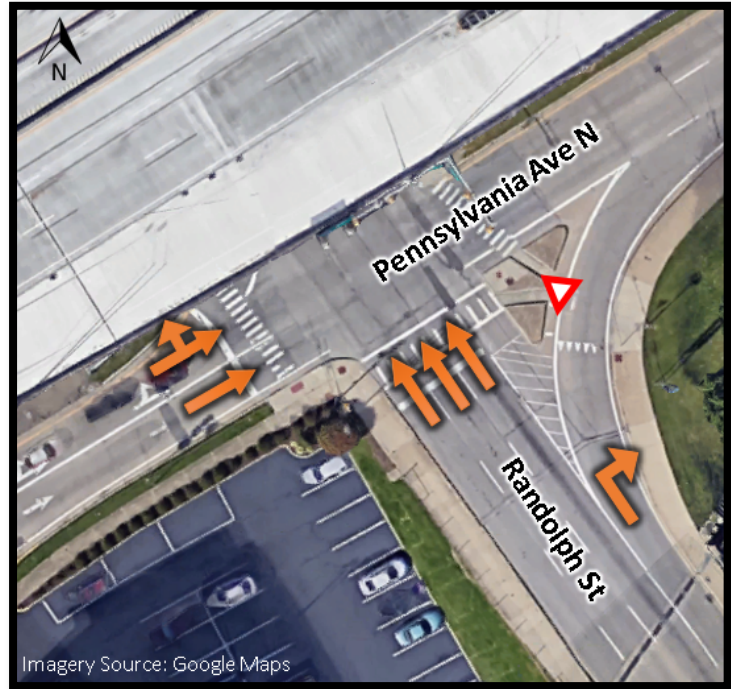
Figure 3: Pennsylvania Ave N and Randolph St Lane Configuration

The lane configuration for this signalized intersection is summarized in **Figure 3**. The westbound right-turn movement on Randolph Street is channelized and controlled by a yield sign. Crosswalks are present on all legs except for the west leg and a pedestrian refuge island is present on the north leg. The crosswalk is faded across the channelized right-turn lane, but a sign is present notifying vehicles to yield to pedestrians. Pedestrian signal heads are present for crossing all legs except the west leg. Pedestrian push buttons with audible tones are only present for crossing the north and south legs. A pedestal traffic signal is located on the left side of the westbound approach. Two other traffic signals on Randolph Street can be seen on the westbound approach, as seen in **Photo 2**. The pavement is cracked and rough through the center of the intersection and under the I-64 underpass as seen in **Photo 3**. The crosswalk and stop bar pavement markings are faded on the westbound approach. There are no lane use pavement markings on the westbound approach.

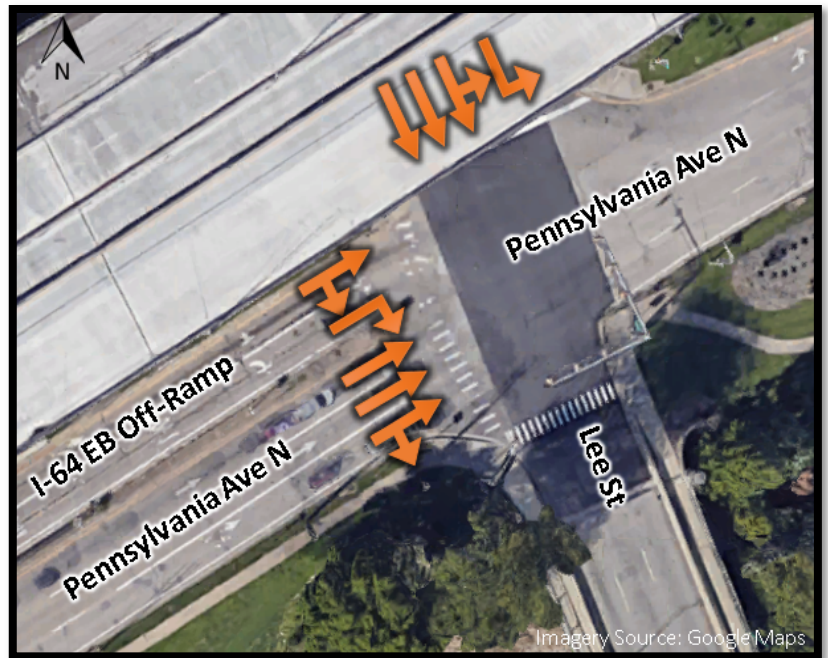
Figure 4: Pennsylvania Ave N and Lee St Lane Configuration

The lane configuration for this signalized intersection is summarized in **Figure 4**. Two traffic signals operating on separate phases are provided along the northbound direction, one for the I-64 Eastbound Off-Ramp and one for Pennsylvania Avenue North. Both traffic signals can be seen from the I-64 Eastbound Off-Ramp, shown in **Photo 4**. The signal directing traffic on the I-64 Eastbound Off-Ramp is approximately 50 feet behind the other traffic signal and has a 4-section and a 3-section signal head, both with right turn arrows. The LED signal heads at this intersection are programmable per WVDOH. However, the indications are still visible for both approaches. Crosswalks and pedestrian signal heads are provided for crossing the east and south legs of the intersection. Pedestrian push buttons with audible tones are only present for crossing the south leg. Signs are located on both signals indicating that vehicles are prohibited from turning on red. The pavement and pavement markings are in good condition. The grade difference between the two northbound approaches of the intersection is shown in **Photo 5**.

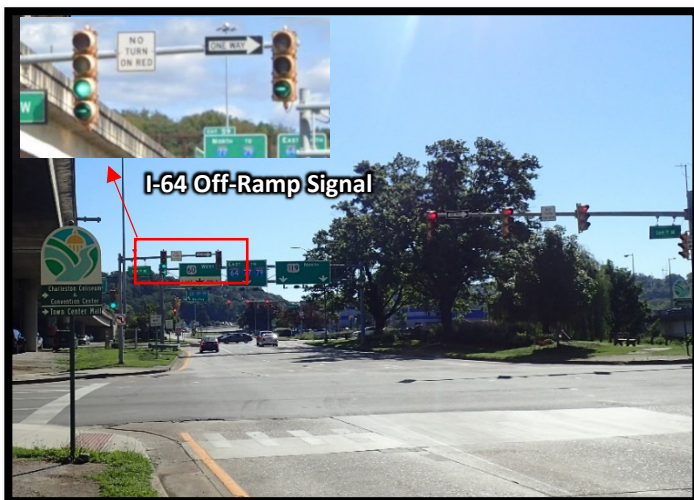
Photo 4: Northbound Signal Heads at Pennsylvania Ave North & Lee St

Another main crash pattern at this intersection occurred when northbound vehicles on the I-64 Eastbound Off-Ramp turned right in front of northbound vehicles going straight through the intersection from Pennsylvania Avenue North (13 crashes). These crashes were usually the result of vehicles running the red signal for the I-64 Eastbound Off-Ramp which operates separately from the

signal on Pennsylvania Avenue North. Some of the red-light running occurred because both traffic signals can be seen from the I-64 Eastbound Off-Ramp, which resulted in some drivers looking at the incorrect traffic signal.

- **Modify the northbound signal at Pennsylvania Avenue North and Lee Street:** Several of the crashes at this intersection resulted from drivers looking at the incorrect signal along Pennsylvania Avenue North, since both traffic signals can be seen from the I-64 Eastbound Off-Ramp. The signal for the I-64 Eastbound Off-Ramp is also about 50 feet behind the Pennsylvania Avenue North signal which adds to the confusion. In order to decrease the possibility of drivers looking at the incorrect signal, it is proposed that the I-64 Eastbound Off-Ramp signal be moved south of the intersection on the I-64 Eastbound Off-Ramp approach. The stop bar on the I-64 Eastbound Off-Ramp would then also be moved south to meet the minimum requirements for distance between the signal heads and the stop bar. Given the curb radius on the northwest corner, the signal pole is already placed as far south as possible on the north side of the intersection. Furthermore, a near-side signal head is proposed to be mounted on the left side of the I-64 Eastbound Off-Ramp to enhance signal visibility for traffic exiting I-64. Additionally, it is proposed that the mast arm for the Pennsylvania Avenue North signal be extended and a “NO TURN ON RED” sign be added to the end of the mast arm.

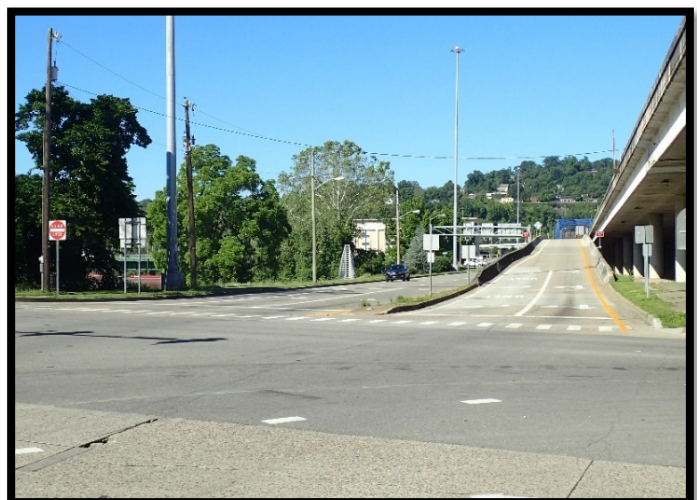
Photo 5: I-64 Ramp at Pennsylvania Ave North & Lee St

One crash pattern at this intersection involved vehicles in the right-turn only lane on the I-64 Eastbound Off-Ramp continuing straight instead of turning right (14 crashes). Right-turns onto Lee Street are allowed from both lanes on the I-64 Eastbound Off-Ramp. When vehicles in the right lane continue straight, they sideswipe a right-turning vehicle in the left lane. The geometric configuration of this intersection likely contributes to these crashes. Even though the signal is split-phased, providing the I-64 Eastbound Off-Ramp with its own signal phase, it is counter-intuitive for drivers to turn right in front of parallel traffic along Pennsylvania Avenue North.

- **Prohibit right-turns from the Lee Street I-64 Eastbound Off-Ramp:** The two main crash patterns at this intersection were related to vehicles turning right off of the I-64 Eastbound Off-Ramp onto Lee Street. This improvement prohibits right-turns from the I-64 Eastbound Off-Ramp and reroutes this movement to Washington Street as illustrated in **Figure 13**. This improvement

- Close the I-64 Off-Ramp at Lee Street (without modifying the I-64 Off-Ramp at Virginia Street West):** To eliminate the I-64 Eastbound Off-Ramp at this intersection altogether, it is proposed that the ramp be closed, forcing all eastbound I-64 traffic accessing Pennsylvania Avenue North to use the I-64 Eastbound Off-Ramp at Virginia Street West. However, the weave along I-64 eastbound between US 119 and Virginia Street West causes significant congestion and slow-downs. By closing the Lee Street ramp, more traffic will be re-routed to the Virginia Street West ramp which will exacerbate the existing congestion issues on I-64. For this improvement to be successful, the I-64 bridge over the Kanawha River would need to be widened to improve, if not mitigate, the weave along eastbound I-64.

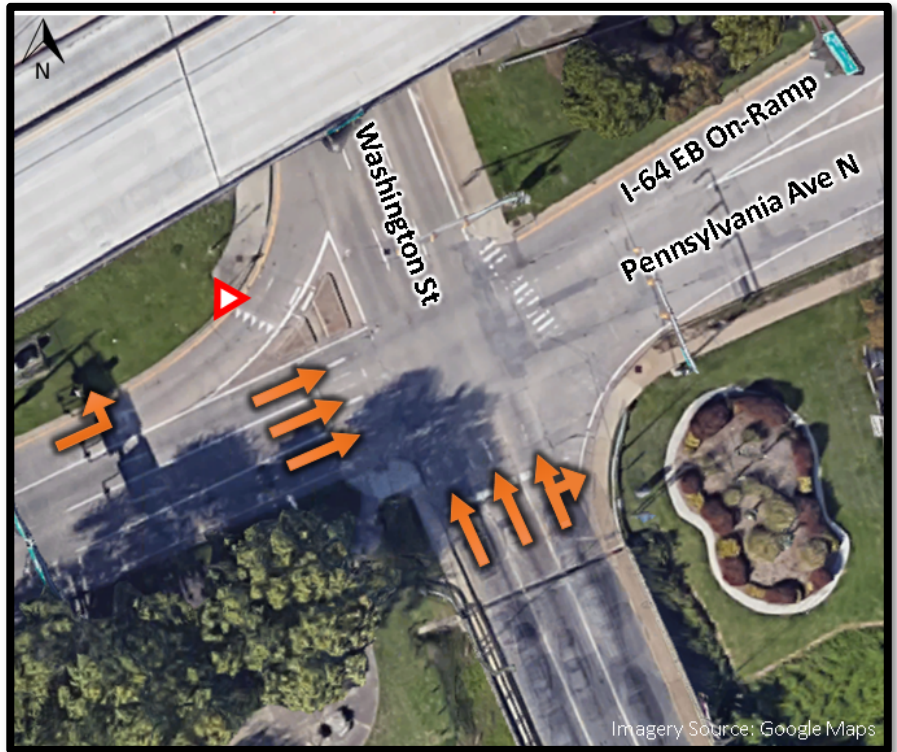
Figure 5: Pennsylvania Ave N and Washington St Configuration

The lane configuration for this signalized intersection is summarized in **Figure 5**. The I-64 Eastbound On-Ramp is located on the north leg of the intersection. A raised channelizing island is provided on the south leg between the through lanes and channelized left-turn lane. Crosswalks and pedestrian signal heads are provided for all legs of the intersection except for the west leg. Pedestrian push buttons with audible tones are only present on the north and south legs. Vehicles were observed accelerating through the intersection to enter the I-64 Eastbound On-Ramp, shown in **Photo 6**. There are no lane use pavement markings on the westbound approach. The sign for the I-64 Westbound On-Ramp is slightly obstructed by the traffic signal mast arm on the westbound approach, as seen in **Photo 7**.

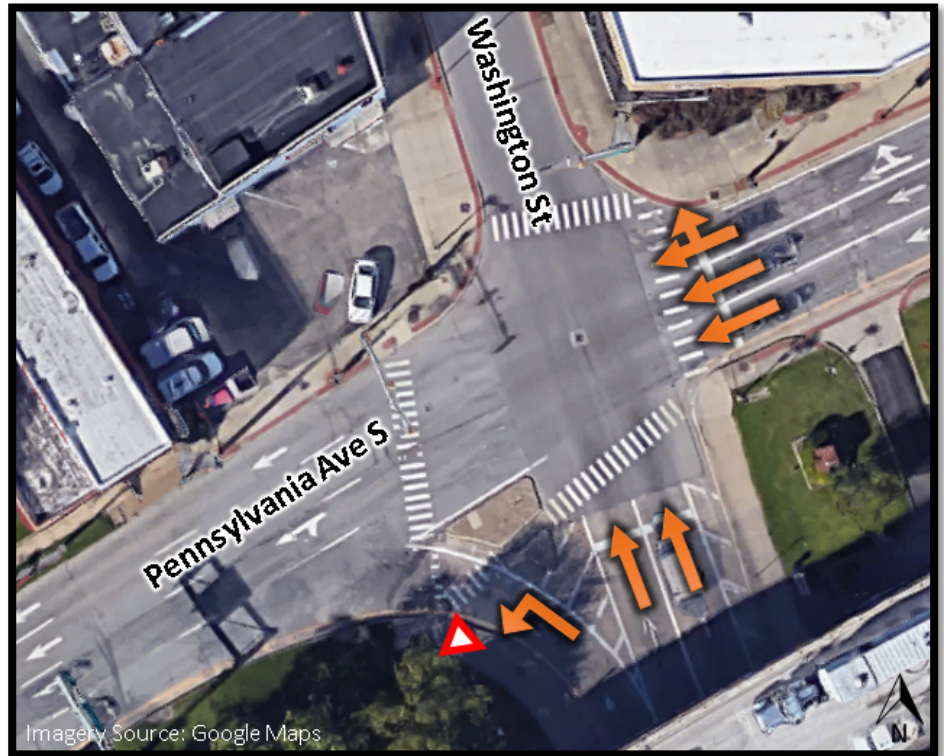
Figure 6: Pennsylvania Ave S and Washington Street Configuration

The lane configuration for this signalized intersection is summarized in **Figure 6**. Two driveways to a parking lot located under the I-64 bridge are on the north leg of the intersection. Crosswalks and pedestrian signal heads are provided on all legs of the intersection. Push buttons with audible tones are only provided to cross the north and south legs. A bus stop is located on Washington Street, approximately 50 feet east of the intersection, nearly under the I-64 overpass. The westbound left-turn lane is channelized by a raised concrete island. The yield sign for the westbound left-turn was obstructed by trees at the time of the field visit, shown in **Photo 8**. The lane use pavement markings are faded on the westbound approach. Sign clutter from overhead signs on the southbound approach is shown in **Photo 9**.

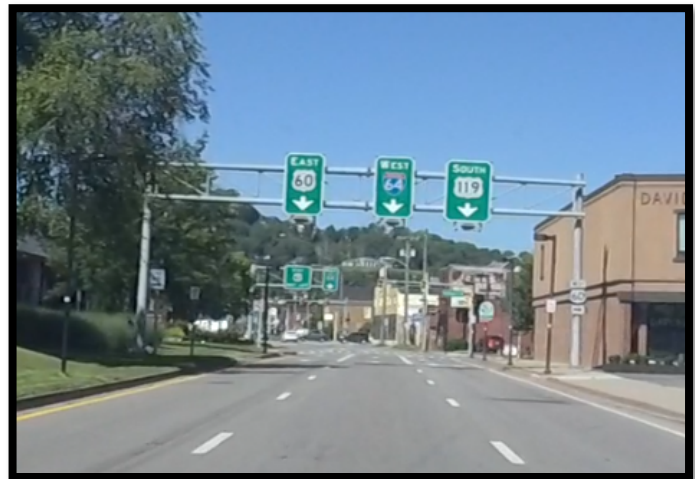
Photo 9: Sign Clutter on Southbound approach

The most prevalent crash type at this location were angle crashes (21 crashes) resulting from southbound vehicles running the red light and colliding with a westbound vehicle. This intersection is the first signalized intersection on Pennsylvania Avenue South so drivers might not be expecting to stop at a traffic signal. There is also lot of overhead signage approaching the intersection which camouflages the traffic signal. Additionally, with the number of lanes at the intersection, drivers may be more focused on ensuring they are in the correct lane for downstream movements rather than focusing on the traffic signal.

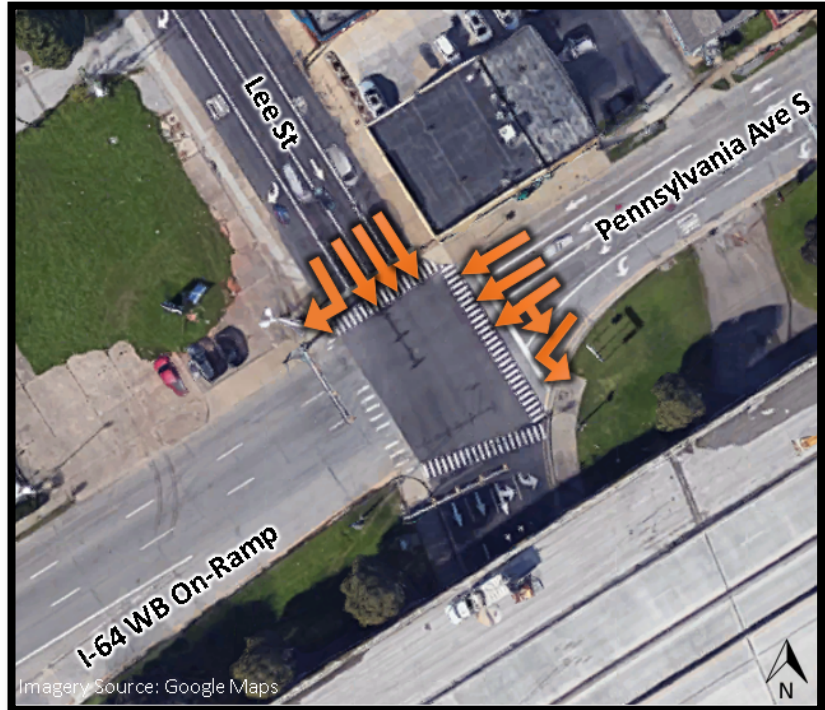
Figure 7: Pennsylvania Ave S and Lee St Street Configuration

The lane configuration for this signalized intersection is summarized in **Figure 7**. The I-64 Westbound On-Ramp is located about 100 feet south of the intersection. Vehicles were observed accelerating quickly onto the I-64 Westbound On-Ramp when the signal turned green. Crosswalks and pedestrian signal heads are provided on all legs of the intersection and push buttons with audible tones are present to cross both the north and south legs. The pushbutton on the northwest corner the intersection did not work at the time of the field visit. A bus stop is located on the southeast corner of the intersection on Lee Street.

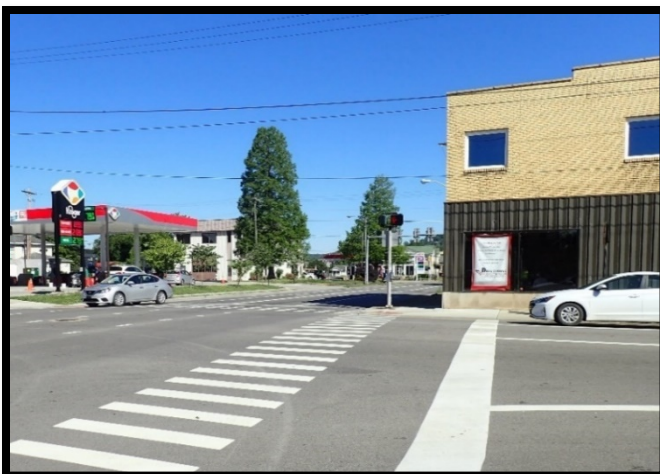
Photo 10: Building on Northwest Corner

Right-turns on red are prohibited on the eastbound approach. The proximity of the buildings on the northwest corner of the intersection obstruct visibility for the both the eastbound and southbound approach, shown in **Photo 10**. The pavement and pavement markings are in good condition. Near misses were observed between vehicles turning in the two adjacent southbound left-turn lanes when their turning paths would overlap as drivers selected the receiving lane on Lee Street without regard to the vehicle in the adjacent lane. **Photo 11** shows the overhead lane use signs provided on the eastbound approach.

Angle crashes occurred in various different directions at this intersection, with the majority resulting from red-light running. The building on the northwest corner of the intersection blocks the view of oncoming traffic for both the southbound and eastbound traffic. When a vehicle is running the red indication, the driver on the opposing approach cannot see the oncoming vehicle until it is in the intersection which contributes to these angle crashes. On the eastbound approach there is also some overhead sign clutter which could be distracting drivers away from the traffic signal.

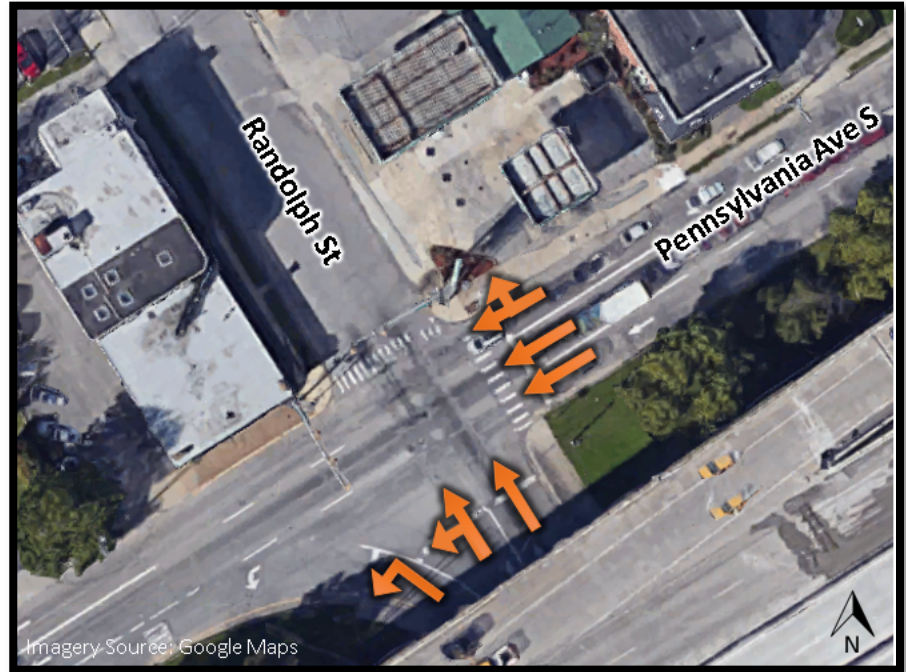
Figure 8: Pennsylvania Ave S and Randolph Street Configuration

The lane configuration for this signalized intersection is summarized in **Figure 8**. Crosswalks and pedestrian signal heads are provided to cross both the north and west legs of the intersection. The LED signal heads on the mast arms are programmable per WVDOH.

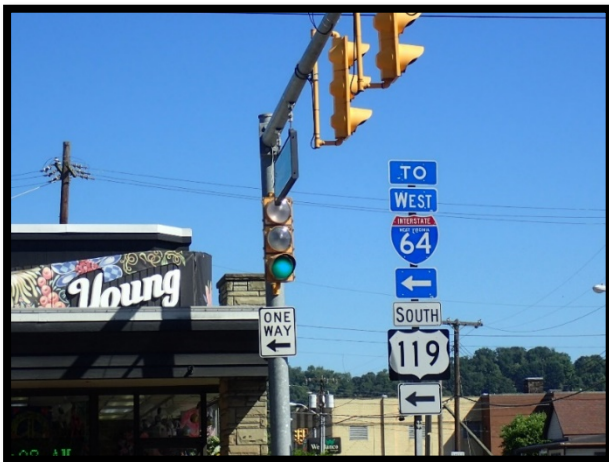
Photo 12: Supplemental Signal Head for Westbound Approach

Photo 12 shows the supplemental signal head present for the westbound approach on the left side of the street. The visors for the red and yellow signals were missing. Push buttons with audible tones are only provided to cross the north leg but were not functioning at the time of the field visit. The crosswalk on the west leg of the intersection is faded and mostly worn away, shown in **Photo 13**. The pavement is in overall good condition.

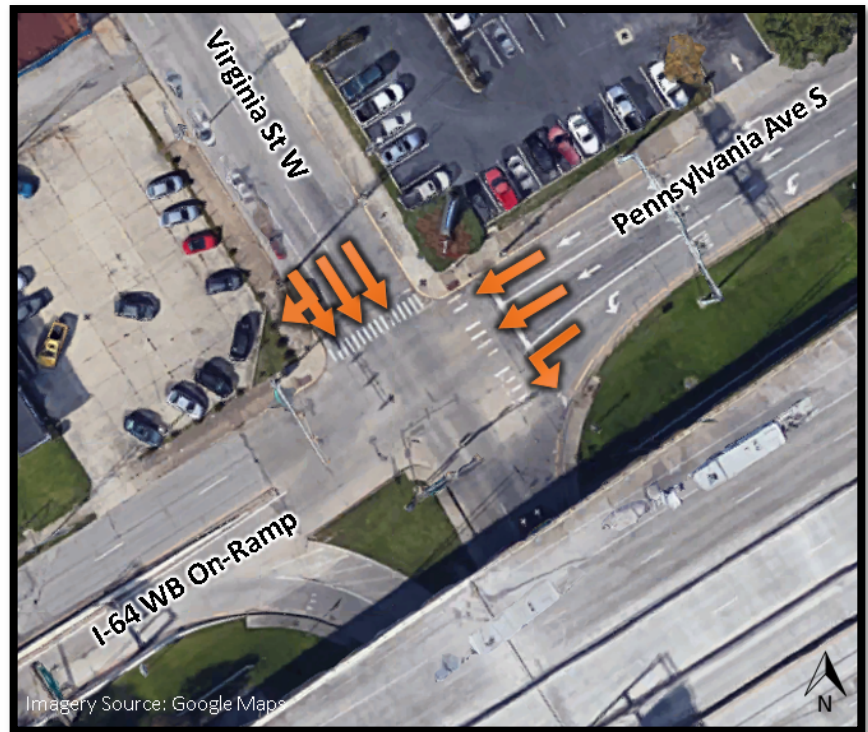
Figure 9: Pennsylvania Ave S and Virginia St W Configuration

The lane configuration for this signalized intersection is summarized in **Figure 9**. Crosswalks and pedestrian signal heads are provided to cross both the north and west legs of the intersection. Push buttons with audible tones are only provided to cross the north leg. The I-64 Westbound On-Ramp is located on the south leg of the intersection and is shown in **Photo 14**. The signal LED heads at this intersection are programmable per WVDOH. Traffic from Pennsylvania Avenue North must yield to the traffic coming from Pennsylvania Avenue South and Virginia Street West before merging onto the I-64 Westbound On-Ramp. Right-turns on red are prohibited on the eastbound approach. A bus stop is located on the southeast corner of the intersection on Virginia Street West. Similar to the previous intersection, the overhead sign for the I-64 Eastbound On-Ramp is obstructed by the mast arm along eastbound approach, shown in **Photo 15**.

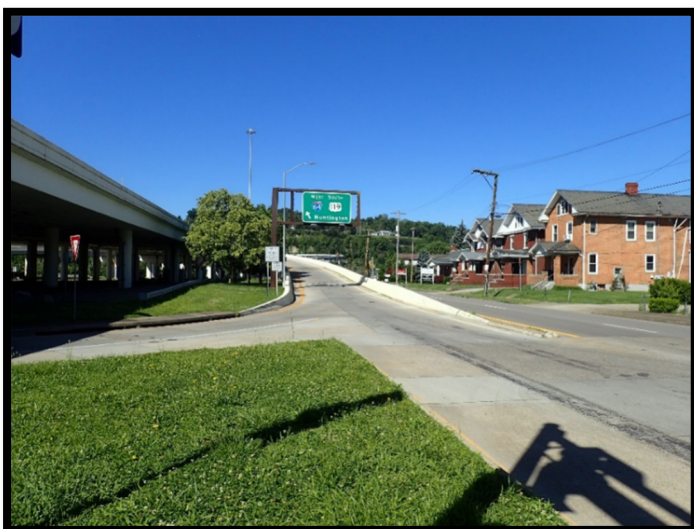
Photo 14: I-64 Ramp at Pennsylvania Ave S and Virginia St W

On the channelized left-turn lane on Virginia Street West that provides access to the I-64 Westbound On-Ramp, three rear ends collisions occurred. Vehicles would look north to merge onto the I-64 Westbound On-Ramp and not realize the car in front of them has stopped. Several angle crashes also occurred because of red-light running on both approaches.

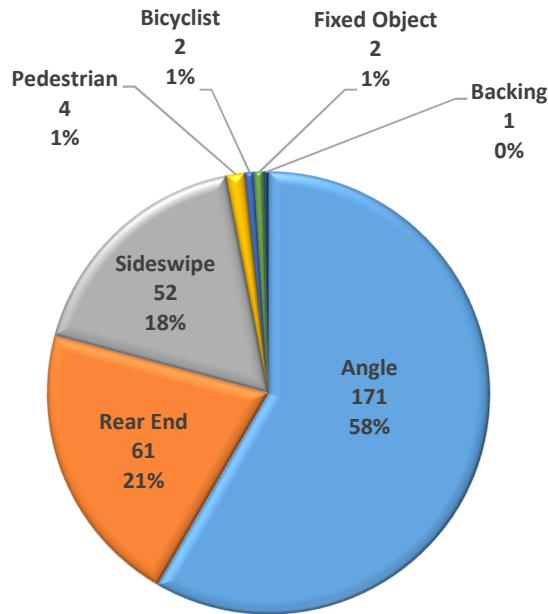
Figure 11: Crash Frequency by Crash Type

Figure 11 illustrates the breakdown of crashes in the study area by crash type. Angle collisions (58 percent) were attributed most often to red-light running at the signalized intersections. The majority of collisions occurred in the daylight (83 percent) and on dry pavement (81 percent).

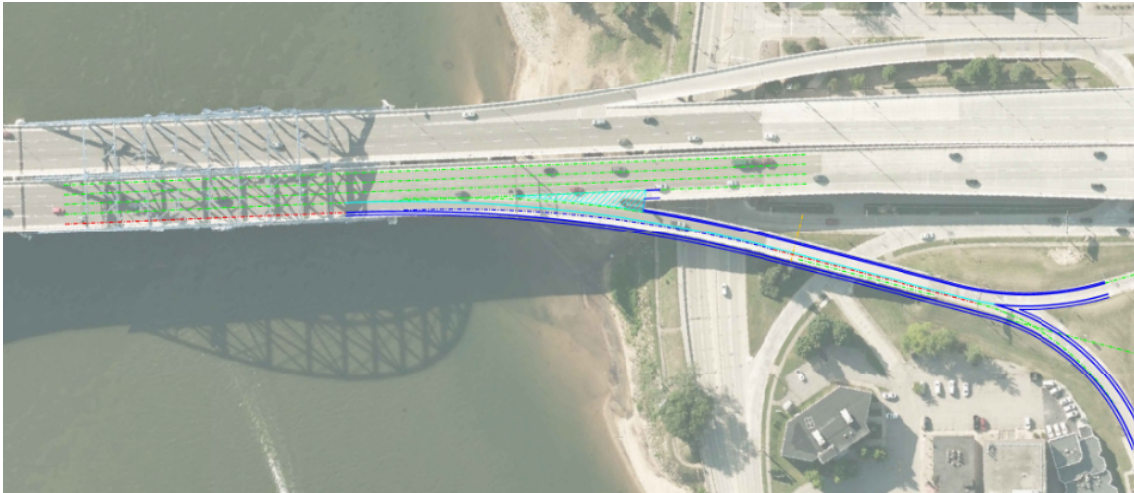
Figure 16: Drop Decision Lane at Virginia Street West Ramp

- Add a drop decision lane at the Virginia Street West Ramp:** As previously discussed, closing the I-64 Eastbound Off-Ramp to Lee Street is not preferred because of the impacts to traffic along eastbound I-64 at the Virginia Street West ramp. To lessen the impacts, a drop decision lane could be implemented (as illustrated in **Figure 16**). This improvement requires that only traffic entering I-64 from US 119 to change lanes. Traffic on eastbound I-64 does not need to change lanes to exit to Virginia Street West. This improvement requires the I-64 Eastbound Off-Ramp at Virginia Street West be widened from one lane to two lanes. This alternative would not completely remove the conflicts created on I-64 eastbound due to weave, but it would reduce the current number of vehicles weaving to exit onto Virginia Street West. As stated previously, the I-64 bridge over the Kanawha River would need to be widened to significantly improve the weave along eastbound I-64.

- Recalculate and implement new clearance intervals at all signalized intersections.
- Evaluate the feasibility of installing backplates at all signalized intersections.
- Install LED signals at all signals (without LED indications) and programmable signal heads at least along Randolph Street and upgrade the signals that are currently programmable.
- Install advanced warning signs for the upcoming signals before Virginia Street West on Pennsylvania Avenue North and before Washington Street West on Pennsylvania Avenue South.
- Redesign and reconstruct the signal for the I-64 Eastbound Off-Ramp at Lee Street to enhance signal head visibility for traffic on the off-ramp.
- Work with WVDOT to program a long-term project to widen the I-64 Eastbound Off-Ramp to Virginia Street West to provide a drop decision lane.
