# WASHINGTON STREET BETWEEN DOOLEY LANE AND PATRICK STREET ROAD SAFETY ASSESSMENT Regional Intergovernmental Council

Figure 1: Study Area

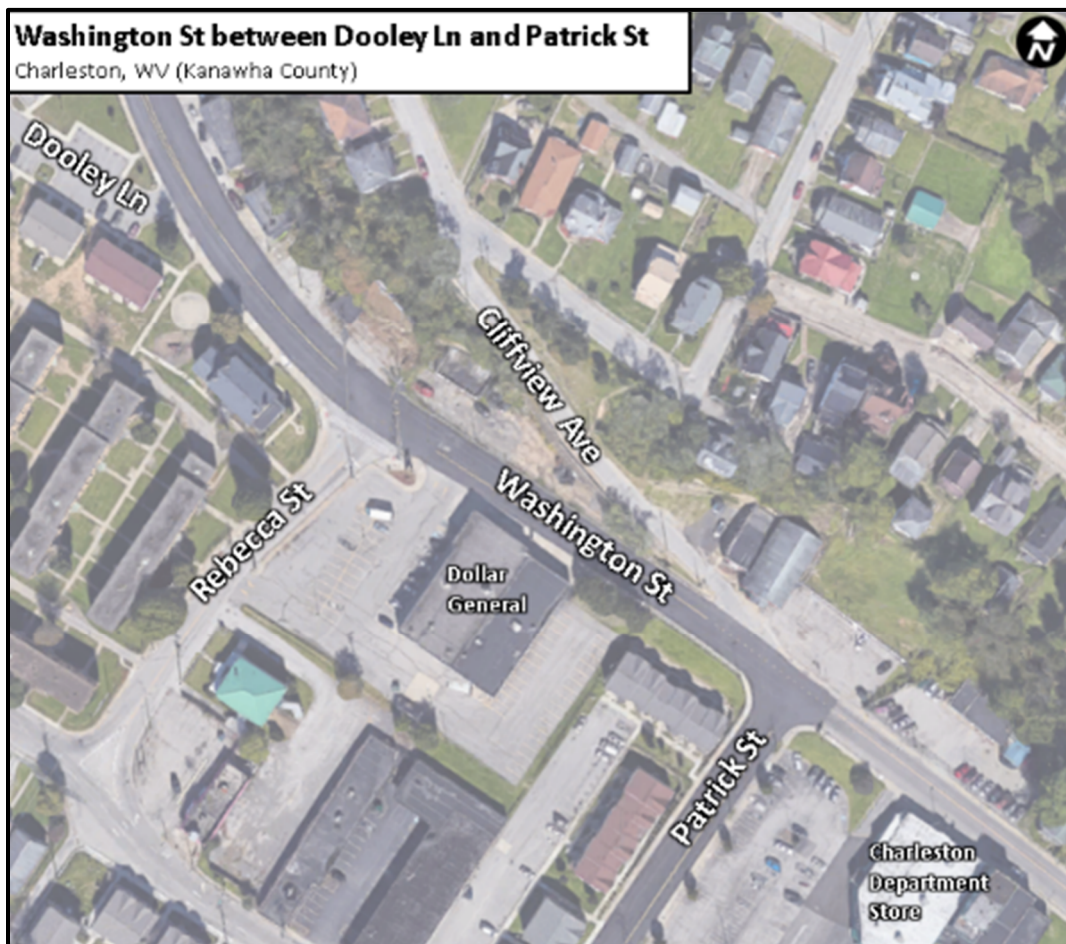
The purpose of this study is to analyze the existing safety conditions and to determine potential countermeasures to reduce crash frequency along Washington Street between Dooley Lane and Patrick Street in Kanawha County, West Virginia. A particular focus of this study is safety for vulnerable road users. The study area is shown below in **Figure 1**.

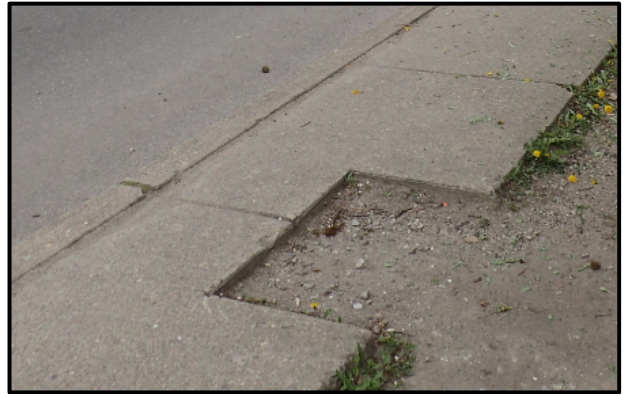
**Photo 1: Missing Sidewalk East of Dollar General**

- **Repair the sidewalk near the Dollar General.** The sidewalk on the south side of Washington Street is missing a large piece, just east of the Dollar General. Repairing the sidewalk will improve accessibility for disabled pedestrians in the area. Furthermore, trucks use the sidewalk, which is flush with the roadway, to unload. Modifications are recommended to provide curbing and direct trucks for unloading.

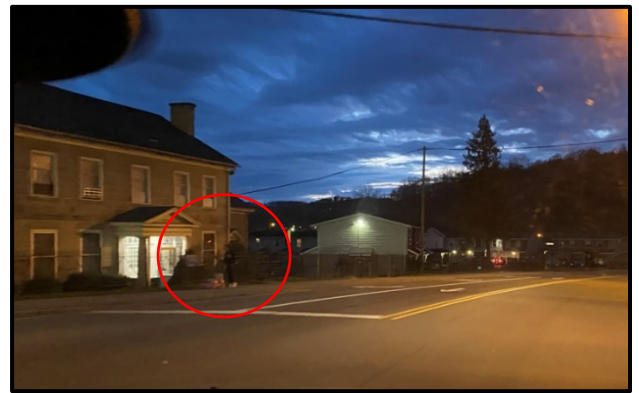
**Photo 2: Inadequate Lighting Conditions at Intersection**

- **Coordinate with WVDOT to enhance lighting along Washington Street.** B&N drove the corridor at night and observed that the lighting on the sidewalk on the south side of Washington Street was very poor. Enhancing the lighting in the corridor is recommended. Pedestrian level lighting could be added to improve pedestrian and bicycle safety in the area due to the high pedestrian volume. Two of the pedestrian collisions in the corridor occurred in dark lighting conditions.

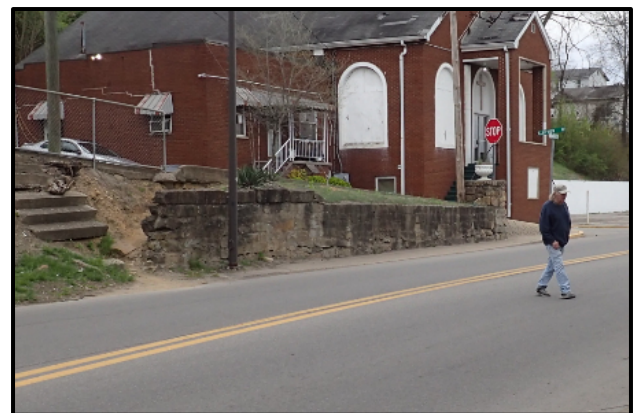
**Photo 3: Pedestrian Crossing Midblock**

- **Construct midblock crossing with an RRFB just west of Cliffview Avenue.** A midblock crossing with an RRFB is recommended slightly west of Cliffview Avenue where the pedestrian stairs are located. An RRFB would be used in combination with pedestrian warning signs to alert drivers to the potential of pedestrians crossing Washington Street in the area. Pedestrians were observed traveling to the Dollar General and the KRT bus stop that is located across Washington Street from the stairs during the site visit. The layout is included in **Figure 8**.

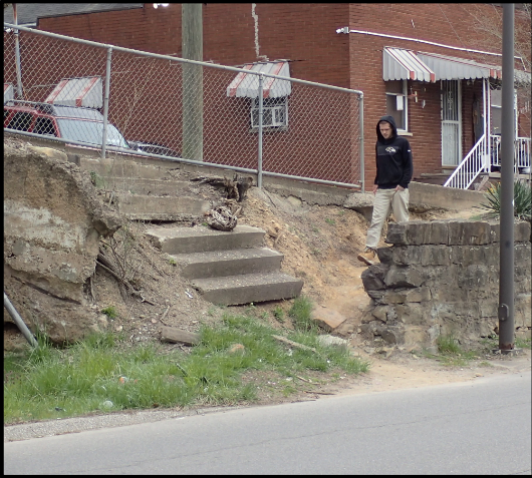
**Photo 4: Pedestrian Stairs and Pedestrian Path**

- The pedestrian stairs would need to be repaired/stabilized to allow people to travel more easily down the hill. Additionally, a section of sidewalk would need to be constructed on the northern side of Washington Street to facilitate the midblock crossing curb ramps.

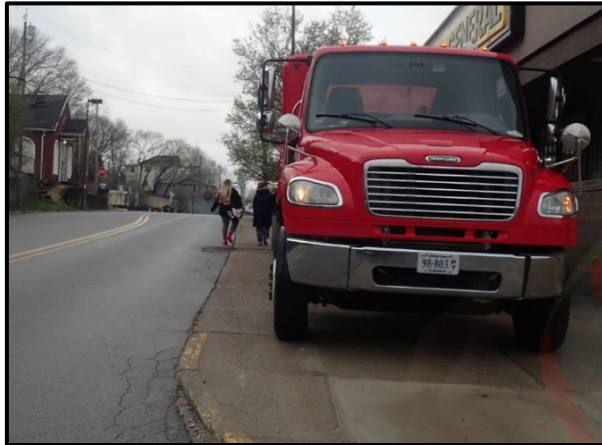
**Photo 6: Truck Blocking Sidewalk at Dollar General**

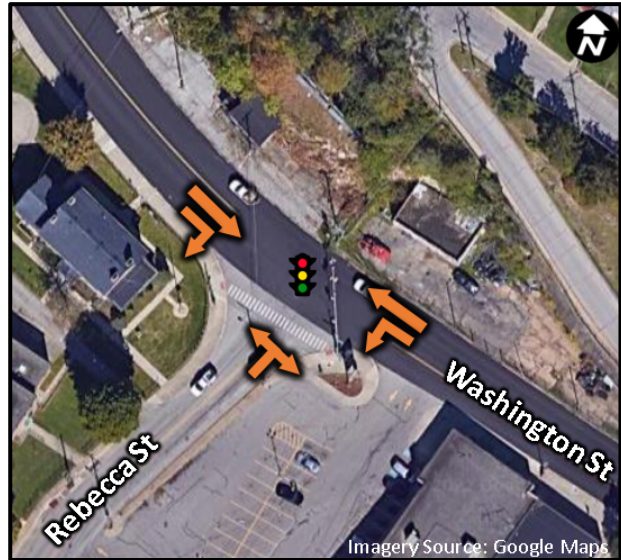
The lane configuration for this signalized intersection is illustrated in **Figure 2**. All signal heads are mounted on a single mast arm. The westbound approach has protected/permissive left-turn operations. Pedestrian push buttons, signal heads and a high visibility crosswalk are provided to cross the northbound approach of Rebecca Street. The crosswalk lines were faded during the field visit, shown in **Photo 7**. Overhead lighting is provided at the intersection.

**Figure 2: Rebecca Street Lane Configuration**

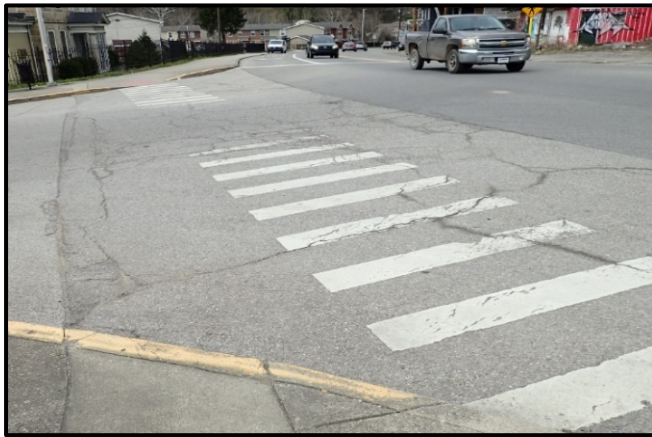
**Photo 7: Faded Crosswalk Lines**

- **Restripe high visibility crosswalk at Rebecca Street.** The high visibility crosswalk was faded at Rebecca Street. Restriping the high visibility crosswalk on the northbound approach of Rebecca Street is recommended to improve pedestrian safety and alert drivers to the presence of pedestrians.

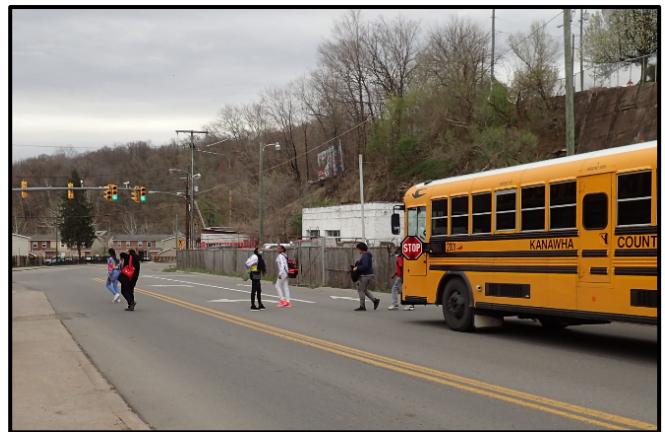
A number of school bus stops were noted in the study area; however, one bus was observed dropping students off in the westbound direction just east of Rebecca Street along a roadway segment without sidewalks, shown in **Photo 8**. The children were observed walking across Washington Street where there are no pedestrian crossings.

**Photo 8: School Bus Stop Location**

- **Coordinate with Kanawha County Schools to relocate school bus stop.** While performing the site review, a westbound school bus dropped students off on the north side of Washington Street, just east of Rebecca Street where there is no sidewalk provided. Students were observed crossing Washington Street between the bus stop and Rebecca Street to reach the public housing community on the northwest corner of the Rebecca Street intersection. Relocating the school bus stop to a location with a sidewalk is recommended.

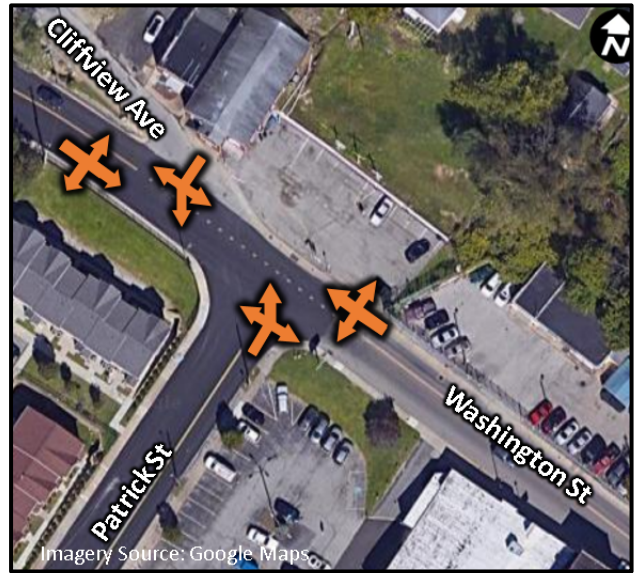
The lane configuration for this two-way stop-controlled intersection is illustrated in **Figure 3**. A large black fence blocks the view from northbound vehicles on Patrick Street to eastbound vehicles traveling through the intersection, shown in **Photo 9**. Drivers have to pull into the intersection to see vehicles traveling eastbound, shown in **Photo 10**. The Patrick Street approach is located on a hill, causing the crossing location across Patrick Street to be on a slope. Crosswalks are not provided at the intersection. Overhead intersection lighting is provided at the intersection.

Cliffview Avenue is located to the west of Patrick Street, intersecting Washington Street on a steep grade and at a skew. As a result of the grade and the skew, sight distance is obstructed for vehicles traveling on Cliffview Avenue towards Washington Street. Drivers have to look over their shoulder to see vehicles approaching from the west. Additionally, drivers were observed using both lanes (even the oncoming northbound lane) to turn right from southbound Cliffview Avenue and sometimes encroached on the eastbound lane on Washington Street to complete the turn.

**Figure 3: Patrick Street Lane Configuration**

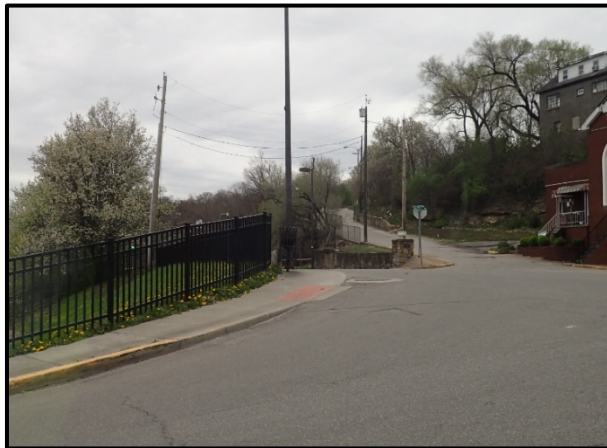
**Photo 9: Sight Distance Issue at Patrick Street**

The main crash pattern at this intersection was angle collisions. Three of the seven angle collisions involved vehicles on Patrick Street failing to yield to eastbound vehicles, likely due to the sight distance issues at the intersection. Rear end collisions also occurred on the northbound approach to the intersection, likely due to the starting and stopping of drivers on Patrick Street waiting for an adequate gap in traffic on Washington Street.

- **Consider prohibiting left turns from Patrick Street.** Due to the amount of angle collisions and lack of sight distance caused by the fence on the southwest corner, left turns could be prohibited from Patrick Street. Left-turning traffic will be diverted to northbound Rebecca Street. A channelizing concrete island is recommended to reinforce the left-turn prohibition at Patrick Street. Operational analysis is provided in **Section 8.2** of the report. A layout of this improvement is shown in **Figure 11**.

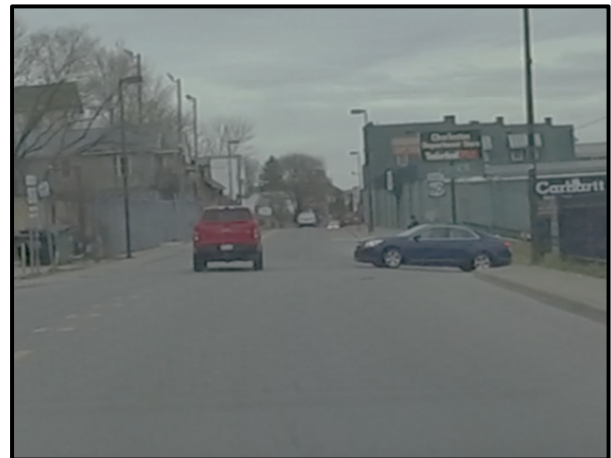
**Photo 10: Vehicle Waiting to Turn out of Patrick Street**

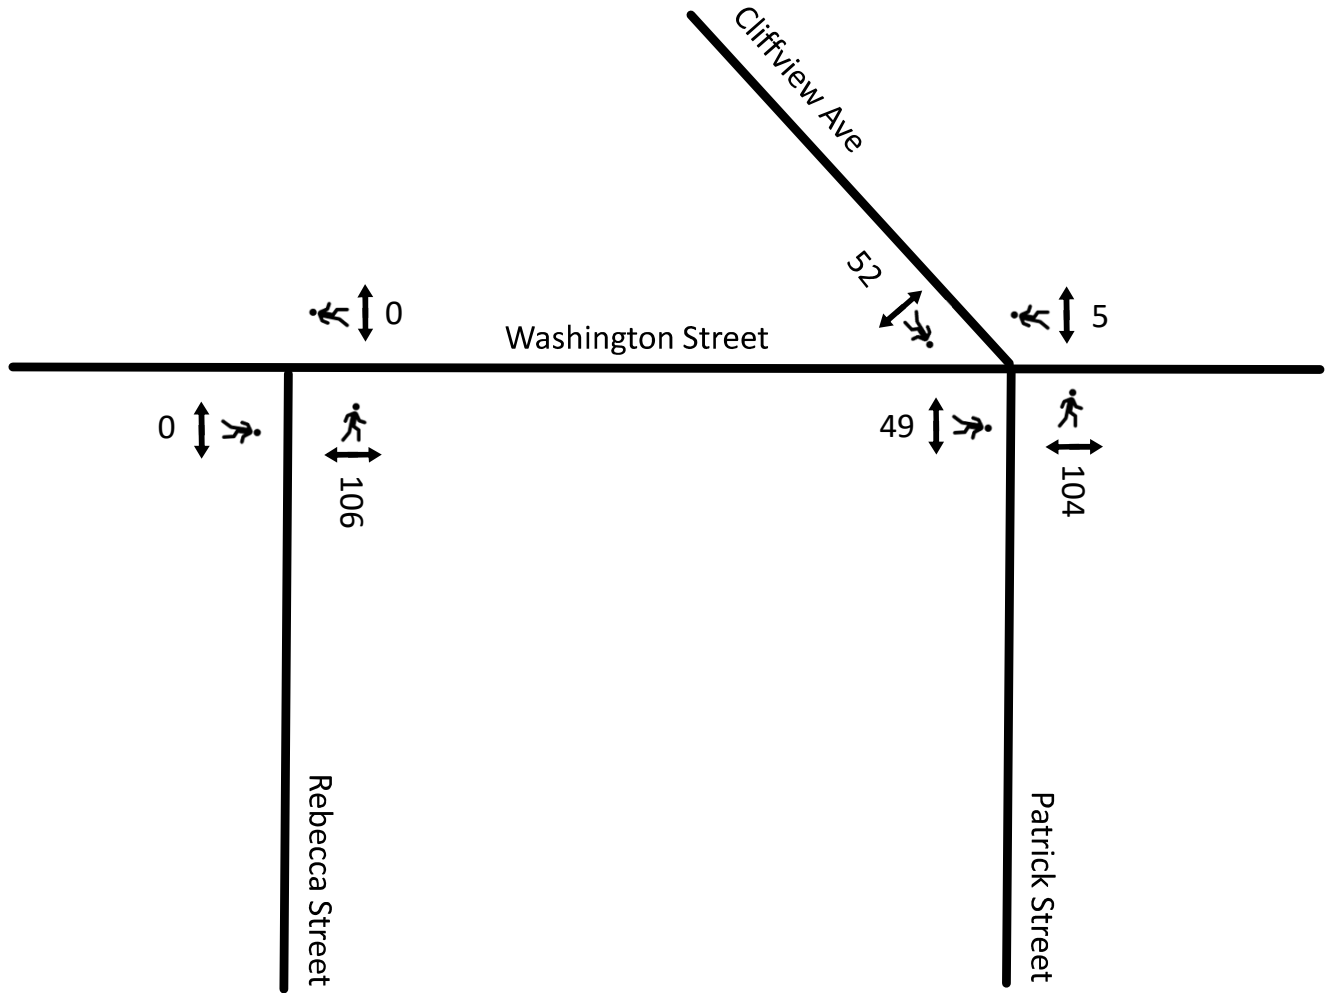
# 12-Hour Pedestrian Counts

XX : 2022 12-Hour Pedestrian – 6:00 AM – 6:00 PM

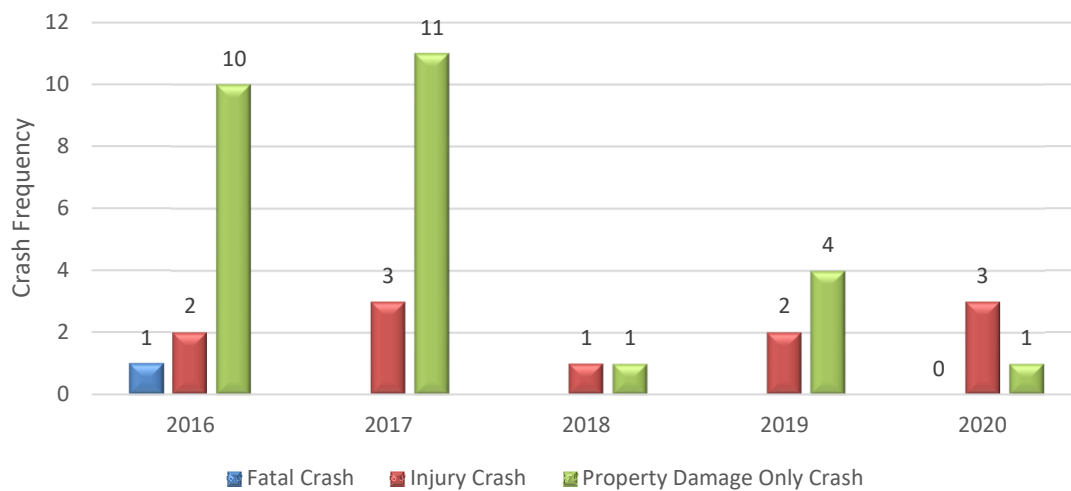
Crash data from January 1, 2016 through December 31, 2020 was downloaded from the ReportBeam website. Each crash report was reviewed to determine potential factors contributing to crashes. A collision diagram that shows crash patterns by illustrating the approximate location of each reported crash is provided in **Appendix C**. In the five-year study period, there were 39 crashes with 12 (31 percent) resulting in injury and one fatality. The fatality occurred on July 2<sup>nd</sup>, 2016, at 12:37 PM, when a two-year old child was running across Washington Street from a building on the north side of the roadway and was struck by a westbound vehicle near Dooley Lane. **Figure 6** shows the frequency of crashes by severity per year. Property damage collisions have decreased since 2016, while injury collisions have stayed relatively constant.

**Figure 6: Frequency of Crashes by Year and Severity**

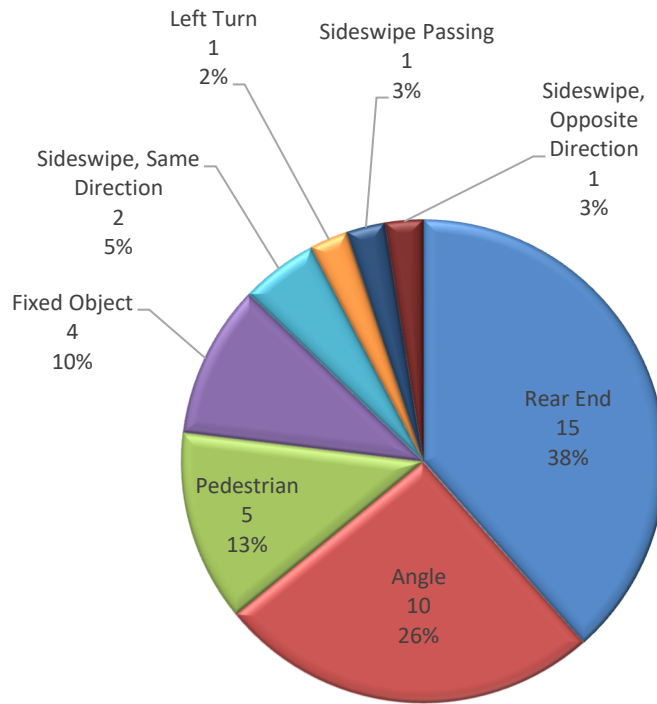
**Figure 7** shows the crash frequency in the study area by the crash type. Rear end collisions were the most prominent crash type accounting for 15 crashes with three (20 percent) resulting in injury. Angle collisions were the second most frequent crash type with 10 crashes and three (30 percent) resulting in injury.

Figure 7: Frequency of Crashes by Year and Severity

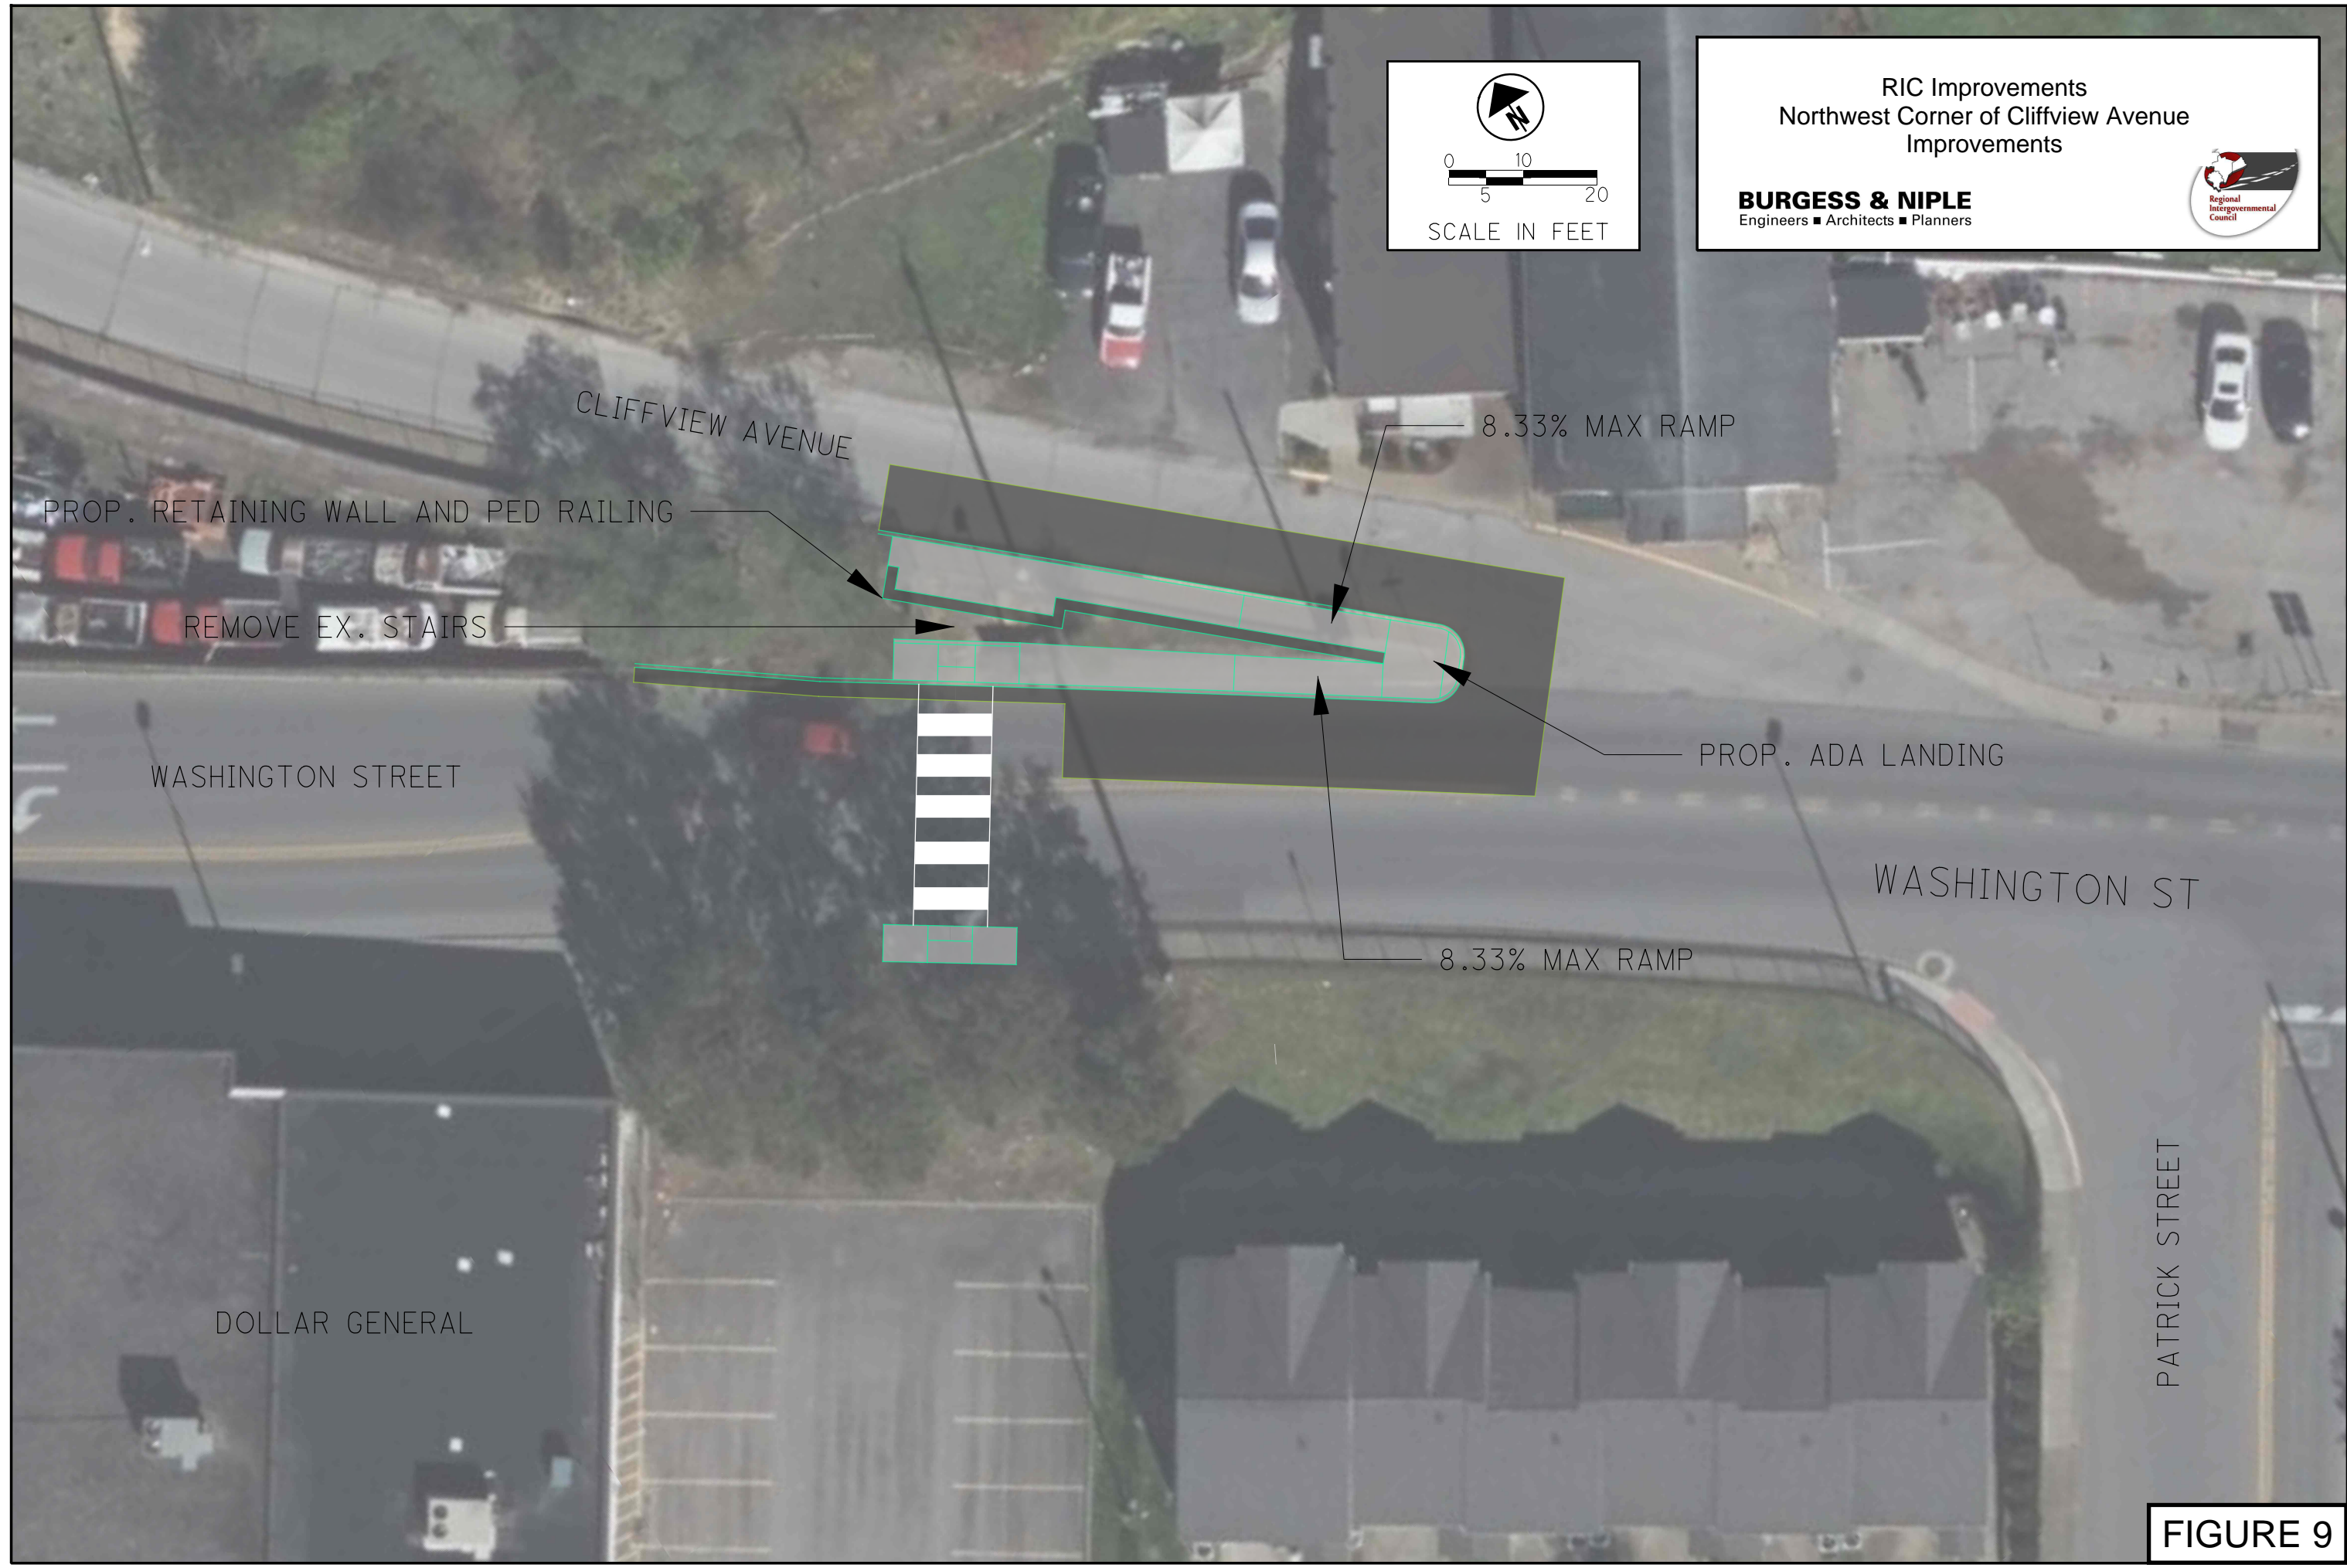
FIGURE 9

RIC Improvements  
Northwest Corner of Cliffview Avenue  
Improvements

- **Improve ADA accessibility on the northwest corner of Washington Street and Cliffview Avenue.** The corner could be rebuilt to meet ADA requirements by widening the sidewalk along the northwest corner of the intersection. The improvement would include widening the sidewalk, adding an ADA accessible landing on the corner and adding a retaining wall and pedestrian railing. With these improvements, the

pedestrian stairs would need to be removed as there would not be enough room to maintain them between the two sidewalks. This improvement is shown in **Figure 9**.

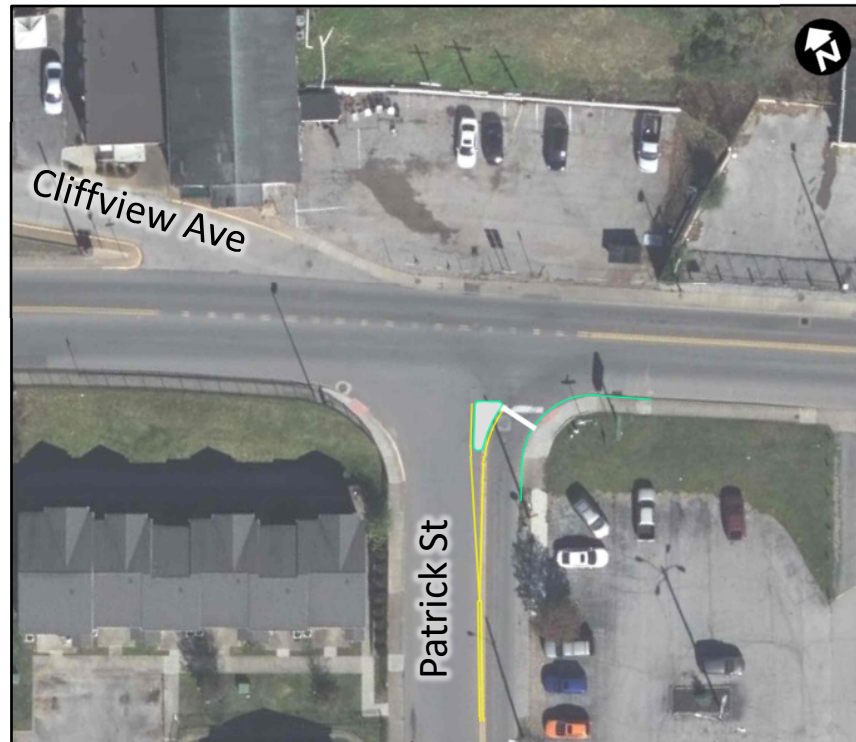
Figure 11: Prohibit Left-Turns at Patrick Street

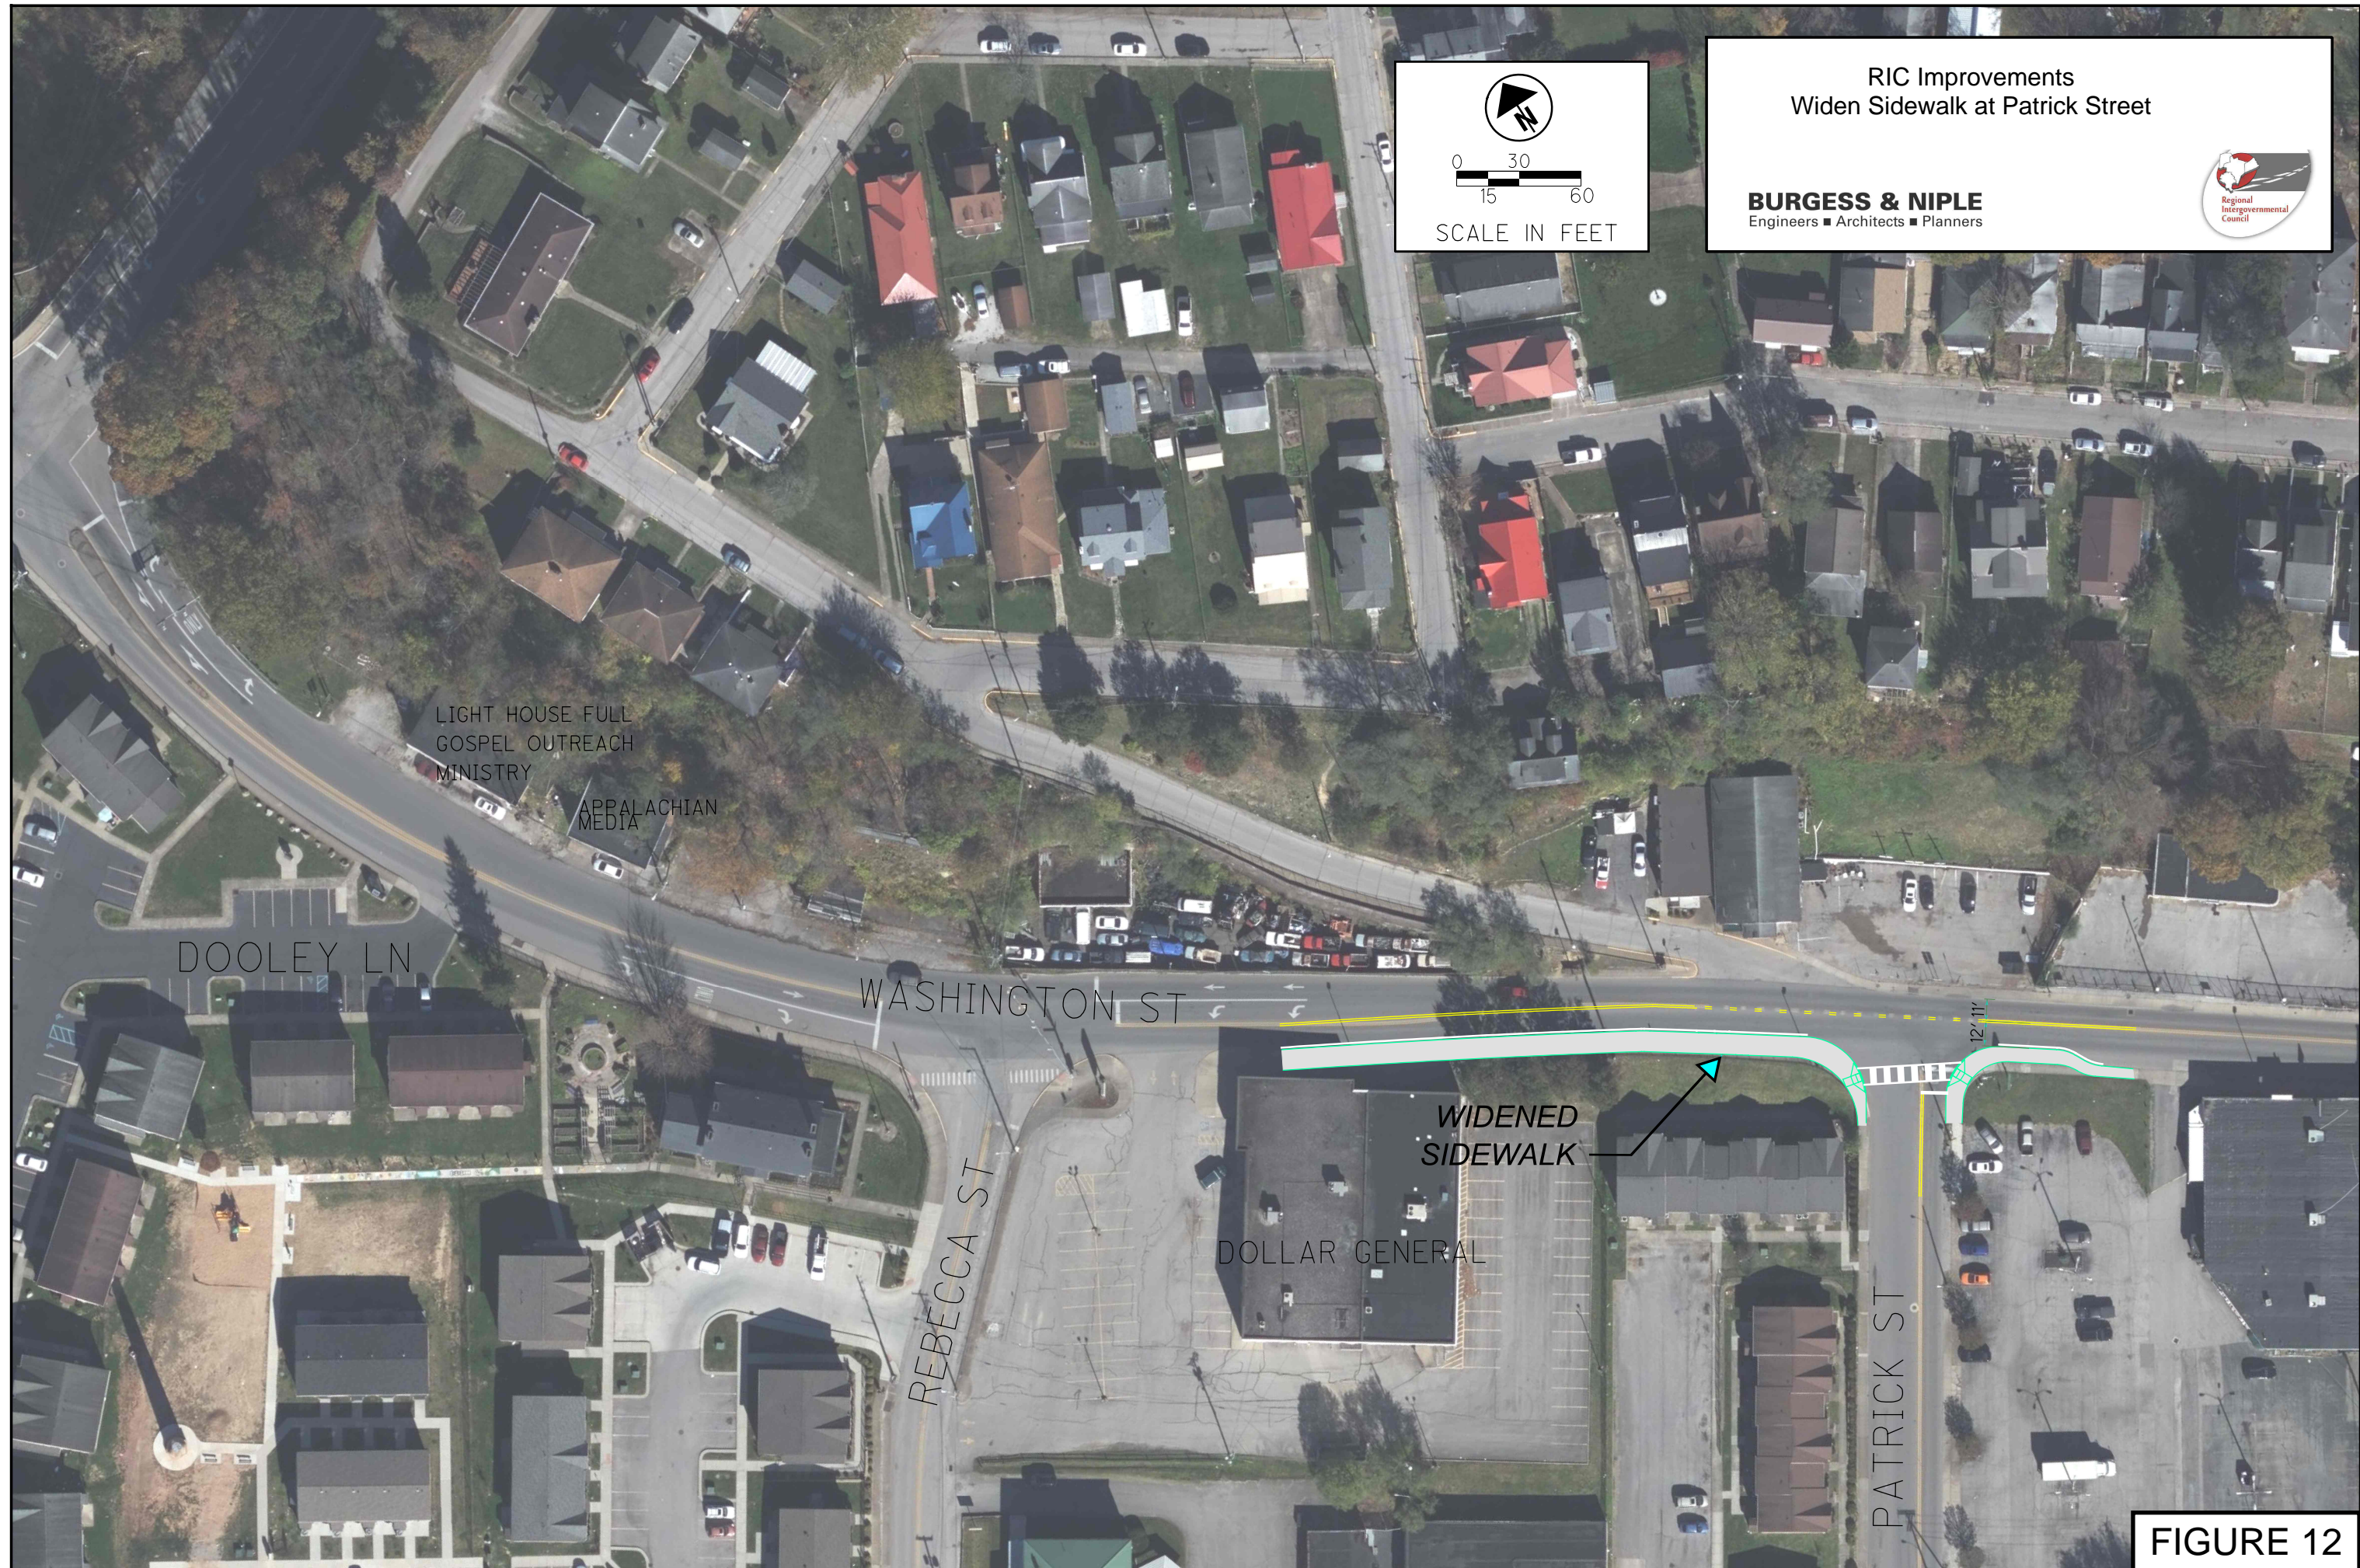
FIGURE 12

RIC Improvements  
Widen Sidewalk at Patrick Street

- **Widen the sidewalk on the southern side of Washington Street between the Dollar General and Patrick Street.** This modification would provide a more level crossing for pedestrians at Patrick Street. The sight distance would also be improved by moving eastbound traffic further from the fence that is creating the obstruction. Additionally, vehicles on Patrick Street could pull into the intersection to see around the fence but be buffered by the wider sidewalk. The layout of this improvement is shown in **Figure 12**. This improvement could be combined with the midblock crossing to the west of Cliffview Avenue or could be completed as a separate project.
