US 60 AND CAMPBELLS CREEK DRIVE

ROAD SAFETY ASSESSMENT

Regional Intergovernmental Council

June 2022

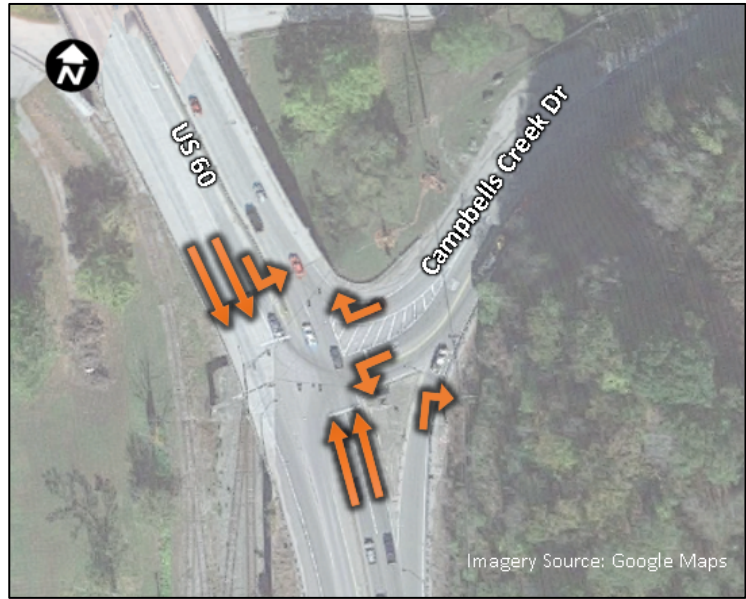
Figure 2: Lane Configuration

The lane configuration for this signalized intersection is illustrated in **Figure 2**. The current signal has backplates on the northbound and southbound approaches of US 60. A new signal has been designed and is currently under construction. The intersection operates as a “Green-T” intersection, with the right-most southbound lane operating as a free-flowing movement, shown **Photo 1**. The southbound approach has protected left-turn signal phasing. The northbound right-turn movement is yield controlled. According to the Kanawha Valley Regional Transportation Authority (KRT), a bus stop is located on the northbound right-turn channelizing island, shown in **Figure 3**. Pedestrian facilities (i.e., crosswalks, pedestrian push buttons, pedestrian signal heads) are not provided at the intersection. The speed limit signage around the intersection is shown in **Figure 4**. Intersection ahead warning signs are present on both the northbound and southbound approaches. The majority of the intersection is constructed on bridge structure.

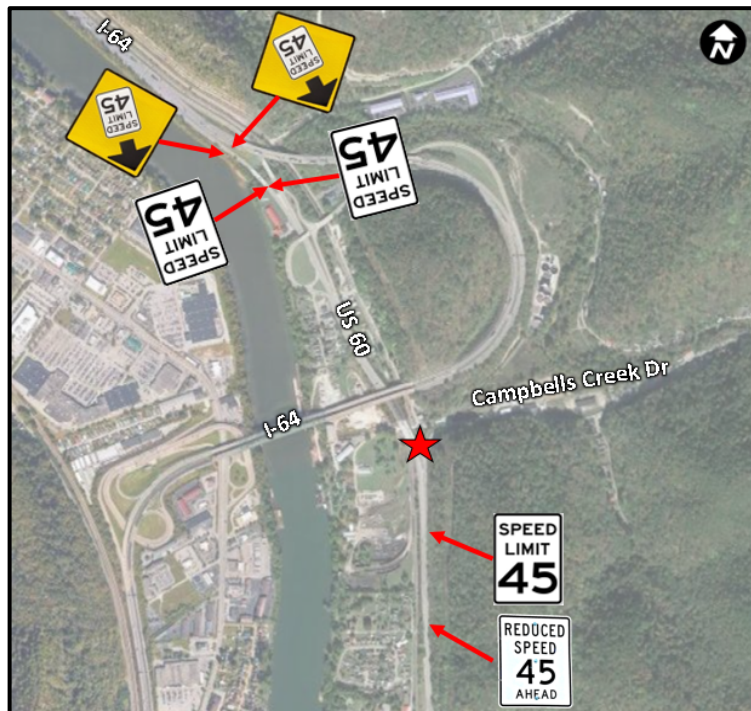
Figure 4: Speed Limit Signage

US 60 is classified as a trunkline roadway with a posted speed limit of 45 mph. Campbells Creek Drive is classified as an essential arterial with a posted speed limit of 40 mph. US 60 is a four-lane two-way divided roadway and Campbells Creek Drive is a two-lane two-way undivided roadway. Sidewalks are not provided along either roadway. Overhead lighting is sparse along US 60 and is not provided along Campbells Creek Drive. However, there is lighting at the intersection. The land use along Campbells Creek Drive is mainly residential, with occasional commercial businesses located along the roadway. An interchange to I-64 is located approximately half a mile north of the intersection.

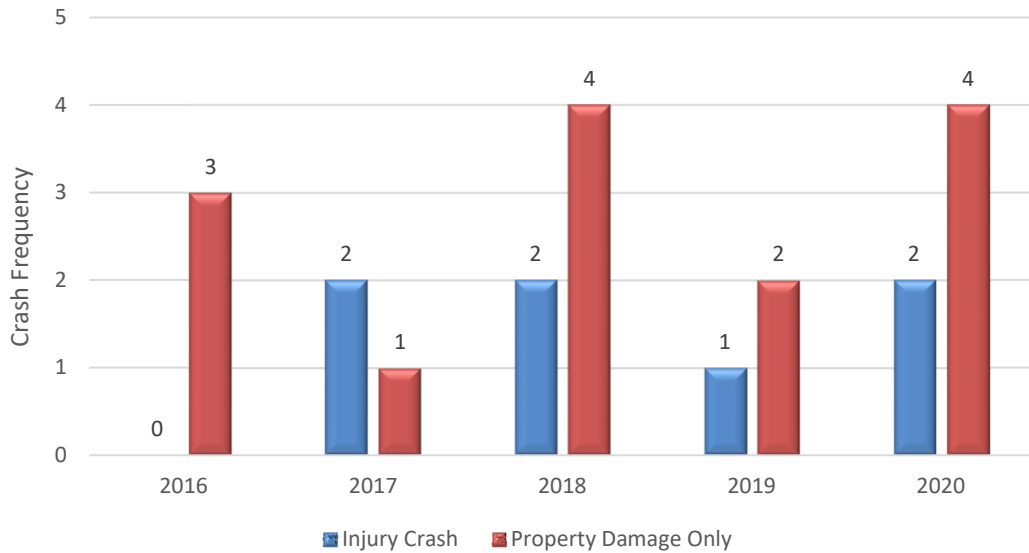
Figure 6: Frequency of Crashes by Year and Severity

Crash data from January 1, 2016 to December 31, 2020 was downloaded from the ReportBeam website. Each crash report was reviewed to determine potential factors contributing to crashes. A collision diagram that shows crash patterns by illustrating the approximate location of each reported crash is provided in **Appendix C**. In the five-year study period, there were 21 crashes with seven (33 percent) resulting in injury. No fatalities were reported at the intersection. **Figure 6** shows the crash frequency by year and severity.

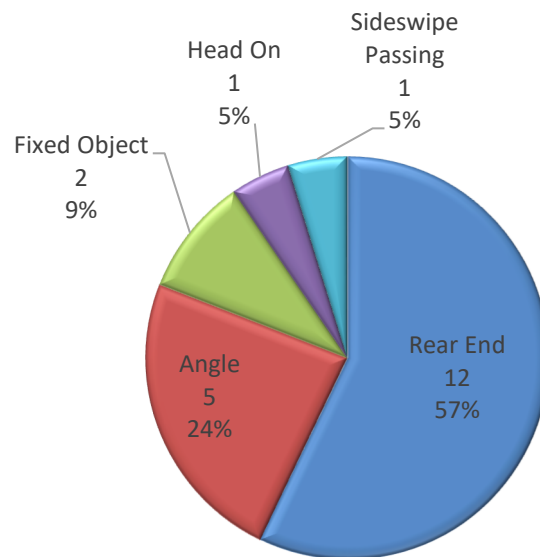
Figure 7: Frequency of Crashes by Crash Type

Figure 7 shows the crash frequency in the study area by the crash type. Rear end collisions were the most prominent crash type accounting for 12 total crashes with three (25 percent) resulting in injury. Angle collisions were the second most frequent crash type with five total crashes of which three (60 percent) resulted in injury.

The highest crash patterns in the study area were rear end collisions in the northbound and southbound direction, likely due to both the high-speed at which drivers are traveling through the intersection and driver inattention.

Out of the five angle collisions, two occurred when southbound left-turning vehicles struck a vehicle waiting in the westbound left-turn lane on Campbells Creek Drive. The two fixed object crashes that occurred in the study area were due to wet road conditions causing vehicles to lose control and strike the median barriers and rock wall along the roadway.
