10th Street between Myers Ave and Grosscup Ave

ROAD SAFETY ASSESSMENT

Regional Intergovernmental Council

September 2022

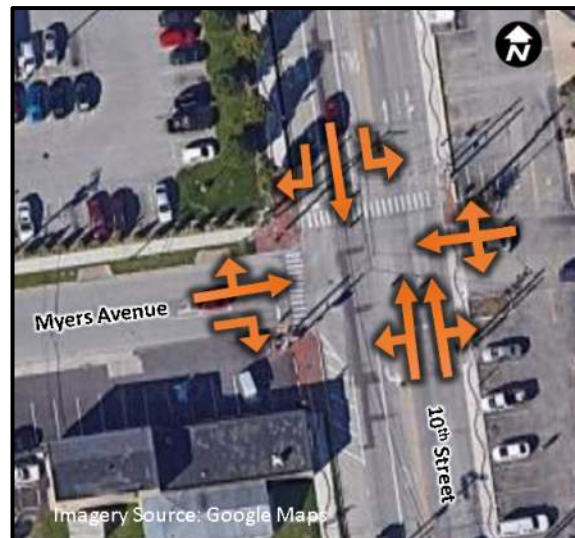
Figure 2: 10th Street and Myers Avenue Lane Configuration

The lane configuration for this intersection is illustrated in **Figure 2**. All signal heads are suspended on span wire. There are high-visibility crosswalks on the northern and western sides of the intersection. The crosswalk lines on the western side of the intersection were faded during the field visit, as shown in **Photo 4**. The lighting provided at the intersection illuminates the northern crosswalk very well, as shown in **Photo 5**. The lighting is not as bright for the western crosswalk. All approaches have permissive-only left-turn operations. Auditory pedestrian push buttons and pedestrian signal heads are provided to cross both the western and northern legs of the intersection. Lane use signage is not provided at the intersection except for a “Right Lane Must Turn Right” sign approximately 125 feet north of the intersection on the southbound approach.

- Consider adding "Yield to Pedestrian" signage at 10th Street and Myers Avenue on the span wire of the signal:** Adding "yield to pedestrian" signage is recommended for the eastbound approach due to four pedestrian crashes that occurred in the crosswalk on the northern approach of 10th Street. Future structural analysis will need to be performed to determine if the signal can handle the additional loading.

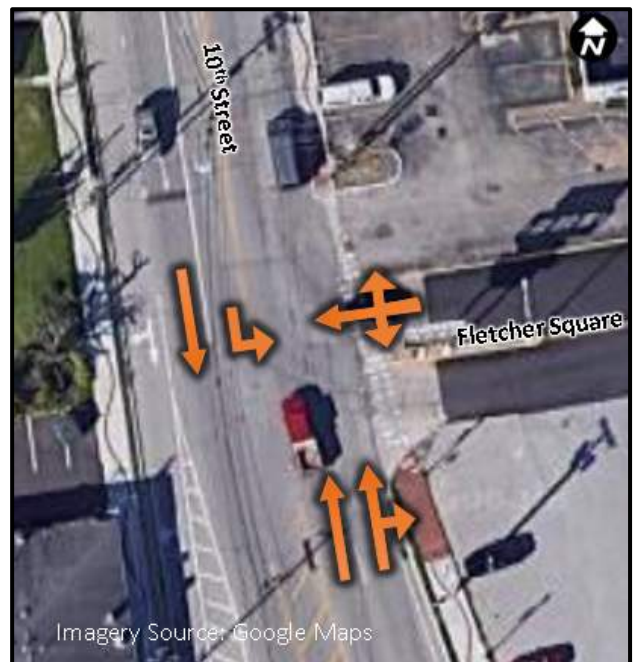
Figure 3: 10th Street and Fletcher Square Lane Configuration

The lane configuration for this intersection is illustrated in **Figure 3**. The intersection is a minor stop-controlled three-legged intersection providing access to the Dunbar Village Plaza shopping center. The crosswalk across Fletcher Square was very faded at the time of the field visit. A concrete median separates the entrance and exit of Fletcher Square, containing the sign for the shopping center. Vehicles can turn left or right out of the shopping center, but longer delays were observed for those trying to turn left onto 10th Street. During the field visit, vehicles were observed creating two different turn lanes to exit Fletcher Square due to the wide width of the exit (18 feet). Another driveway is located just north of the entrance/exit to Fletcher Square, shown in **Photo 6**, creating additional conflict for those attempting to turn right out of Fletcher Square.

- Consider closing McDonald's driveway/Dunbar Village Plaza driveway:** There is currently a crash pattern of angle collisions at this location due to vehicles turning out of this driveway and failing to yield to vehicles on 10th Street. Currently, there is a "Right Turn Only" sign at the driveway, but drivers often disregard this sign and turn left onto 10th Street. Vehicles arriving and departing from McDonald's have access to the intersection of 10th Street and Fletcher Square to the north which allows for better sight distance than at the McDonald's Driveway when turning onto 10th Street. This driveway also had a low volume in the AM and PM peak hours during the traffic counts, meaning a large number of drivers will not be affected by this closure. A layout of this improvement is shown in **Figure 9**.

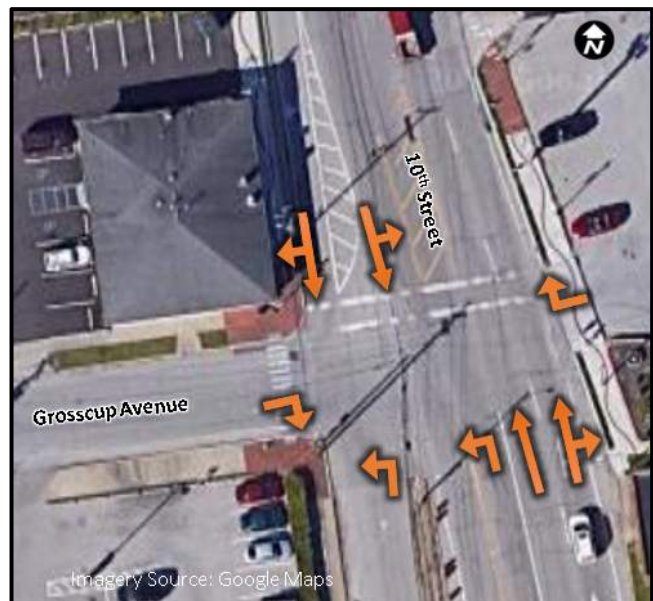
Figure 4: 10th Street and Grosscup Avenue Lane Configuration

The lane configuration for this intersection is illustrated in **Figure 4**. The intersection is a minor stop-controlled four-legged intersection. There is high visibility crosswalk striping on the northern and western legs of the intersection. The crosswalk across 10th Street on the northern side of the intersection does not connect to the sidewalk with a curb ramp, as shown in **Photo 7**. The full crosswalk length is 77 feet across 10th Street. Generally, vehicles would not stop for pedestrians in the crosswalk. Instead, pedestrians had to be very vigilant while crossing 10th Street. A pedestrian was observed crossing 10th Street slowly during the site visit, as shown in **Photo 8**. Vehicles on the westbound approach on the McDonald’s/Shopping Center driveway are only permitted to turn right at the intersection. Some vehicles were observed turning left onto the Dunbar Toll Bridge illegally.

Vehicles on the eastbound approach of Grosscup Avenue can turn right onto 10th Street or the Dunbar Toll Bridge. Vehicles traveling northbound on 10th Street to the left of the Dunbar Toll Bridge are only permitted to turn left onto westbound Grosscup Avenue.

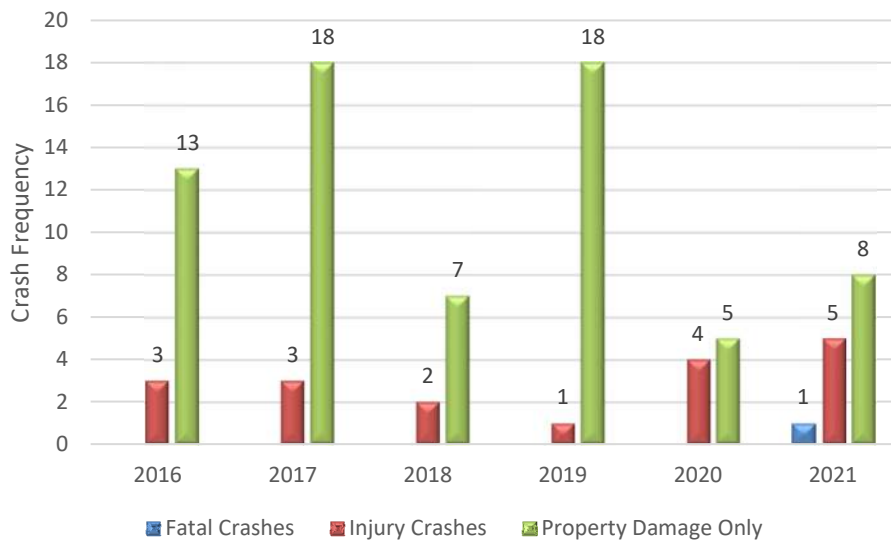
Figure 6: Crash Frequency by Severity and Year

Crash data from January 1, 2016 through December 31, 2021 was downloaded from the ReportBeam website. Each crash report was reviewed to determine potential factors contributing to crashes. A collision diagram that shows crash patterns by illustrating the approximate location of each reported crash is provided in **Appendix C**. In the six-year study period, there were 88 crashes with 19 (22 percent) resulting in injury and one fatality. The fatality occurred on May 19, 2021, at 11:13 AM when a pedestrian was illegally crossing 10th Street just north of the Myers Avenue intersection and was struck by a vehicle turning out of the City Bank Driveway to go southbound on 10th Street. **Figure 6** shows the frequency of crashes by severity per year. Injury collisions have been increasing in recent years.

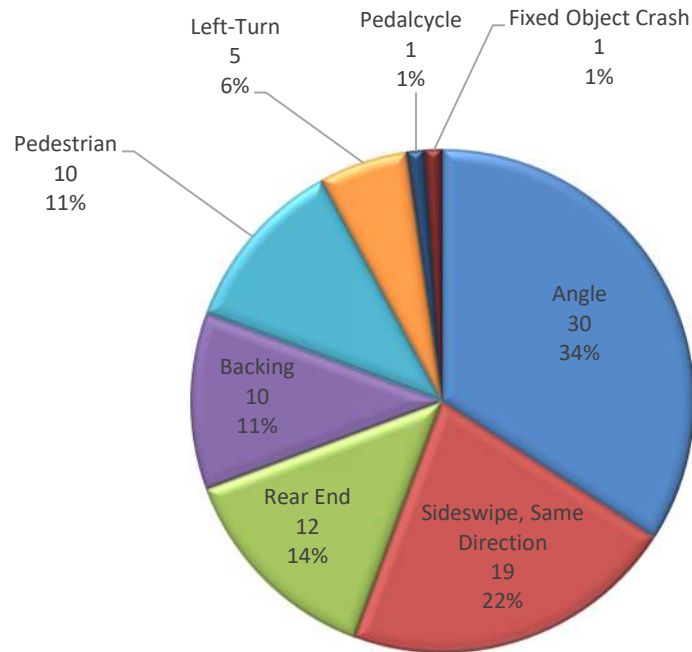
Figure 7: Crash Frequency by Crash Type

Figure 7 shows the crash frequency in the study area by the crash type. Angle collisions were the most prominent crash type, accounting for 30 total collisions with seven (23 percent) resulting in injury. Pedestrian collisions were also prevalent in the study area with 10 pedestrian collisions occurring in the last six years. All of these pedestrian collisions resulted in injury, and one resulted in a fatality.
