TEAYS VALLEY ROAD AND MOUNT VERNON ROAD

ROAD SAFETY ASSESSMENT

Regional Intergovernmental Council

BURGESS & NIPLÉ

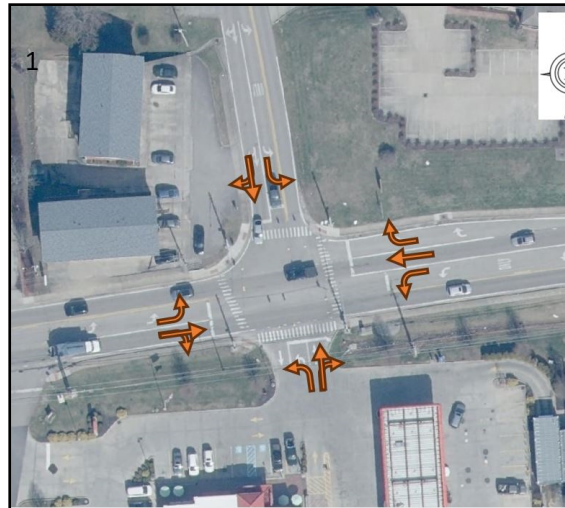
Figure 2: Lane Use Configuration

The lane configuration for this signalized intersection is illustrated in **Figure 2**. Mount Vernon Road is the north leg of the intersection while the Sheetz Driveway is the south leg. Pedestrian facilities (i.e., crosswalks, pedestrian push buttons, pedestrian signal heads) are provided across all legs of the intersection. Overhead lighting is provided at the intersection. Backplates are provided on the eastbound and westbound approaches.

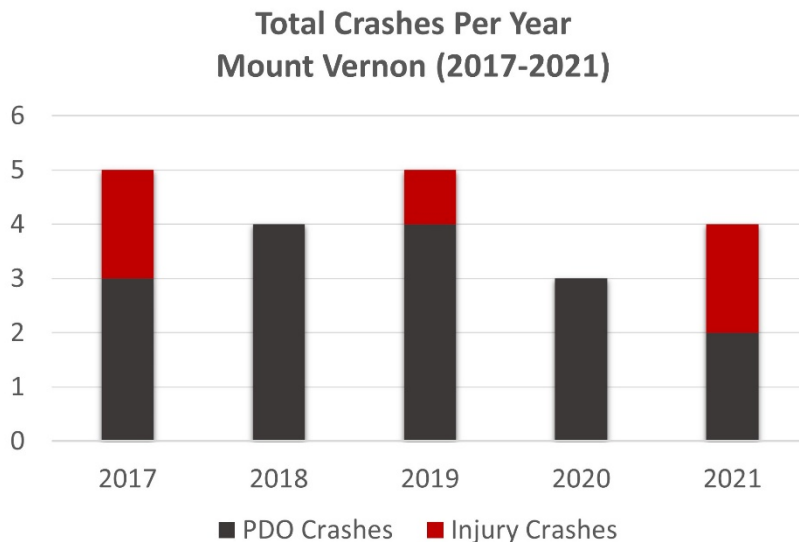
Figure 4: Frequency of Crashes by Year and Severity

Crash data from January 1, 2017 through December 31, 2021 was downloaded from the AASTHOWare Safety and the crash reports were obtained through ReportBeam. Each crash report was reviewed to determine potential factors contributing to crashes. A collision diagram that shows crash patterns by illustrating the approximate location of each reported crash is provided in **Appendix C**. In the five-year study period, there were 21 total crashes with five (24 percent) resulting in injury. No fatalities were reported in the study area. **Figure 4** shows the frequency of crashes by severity per year. There were no injury collisions at this intersection in 2018 or 2020.

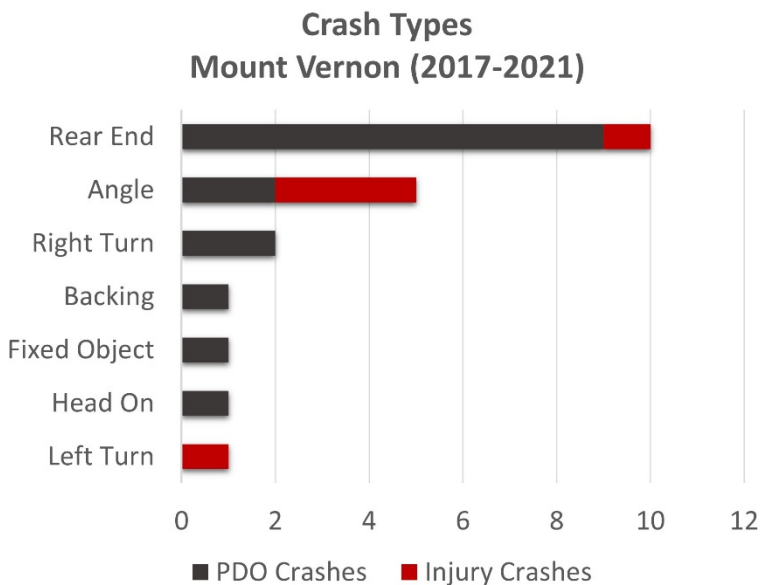
Figure 5: Frequency of Crashes by Type

Figure 5 shows the crash frequency in the study area by the crash type. Rear end collisions were the most prominent crash type, accounting for 10 collisions with one (10 percent) resulting in injury. All of the rear end collisions occurred along Teays Valley Road, with the highest crash pattern occurring on the westbound approach of the intersection. The rear end crashes occurred due to inattentive drivers and sun glare during the afternoon/evening commute.

Angle collisions were the second most frequent crash type with five crashes and two injury collisions. Three out of the five angle collisions occurred at the Sheetz driveway entrance.
