# WASHINGTON STREET AND LEE STREET ROAD SAFETY ASSESSMENT Regional Intergovernmental Council

March 2024

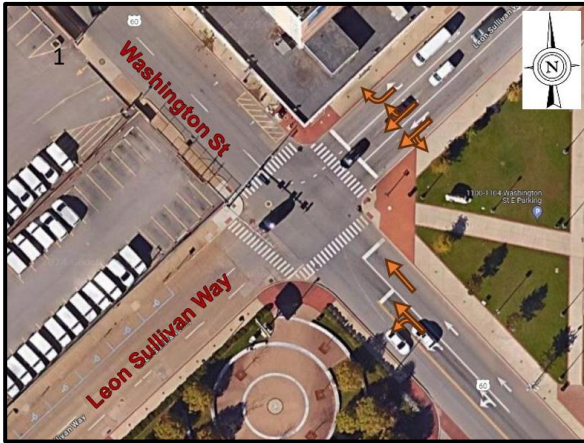
Figure 2: Washington Street and Leon Sullivan Way Lane Configuration

The lane configuration for this signalized intersection is illustrated in **Figure 2**. All signal heads are mounted on mast arms. Without backplates or reflective borders, the signal heads can be difficult to see, especially in the northwestbound direction with other visual clutter (buildings, etc.) is present as illustrated in **Photo 3**. Pedestrian push buttons, signal heads and high visibility crosswalks are provided on each corner of the intersection. Pedestrians are served through an exclusive phase if the push button is actuated. Overhead lighting is not provided at the intersection.

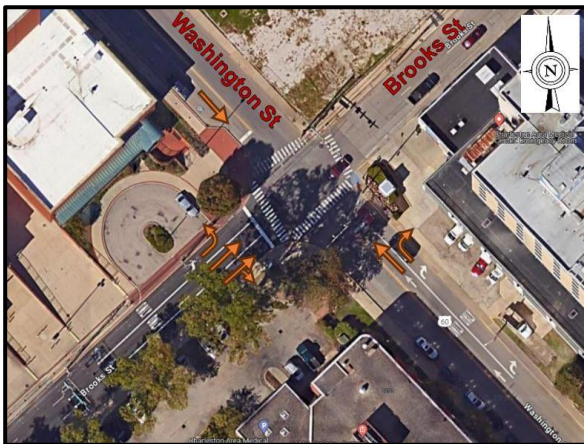
Figure 3: Washington Street and Brooks Street Lane Configuration

The lane configuration for this signalized intersection is illustrated in **Figure 3**. All signal heads are mounted on mast arms. Sun glare obscured the view of the signal heads, particularly those for the Brooks Street approach as shown in **Photo 4**. Backplates are not provided on any of the signal heads. Pedestrian push buttons, signal heads and high visibility crosswalks are provided on each corner of the intersection. An exclusive pedestrian phase is provided within the current signal timing plan. Overhead lighting is provided. While it is a viable movement, left-turns are not permitted from southeastbound Washington Street onto Brooks Street as indicated through signage. Signs also prohibit right-turn on red from Brooks Street.

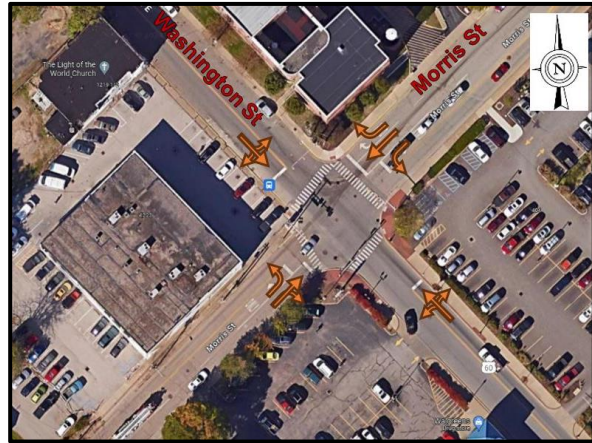
**Figure 4: Washington Street and Morris Street Lane Configuration**

The lane configuration for this signalized intersection is illustrated in **Figure 4**. All signal heads are mounted on mast arms and do not have backplates. The Morris Street approaches have protected/permissive left-turn operations. Pedestrian signal heads and high visibility crosswalks are provided on each corner of the intersection. The pedestrian phases are automatically served with the adjacent vehicle phases; therefore, pedestrian push buttons are not provided. Pedestrian-level lighting is provided at the intersection.

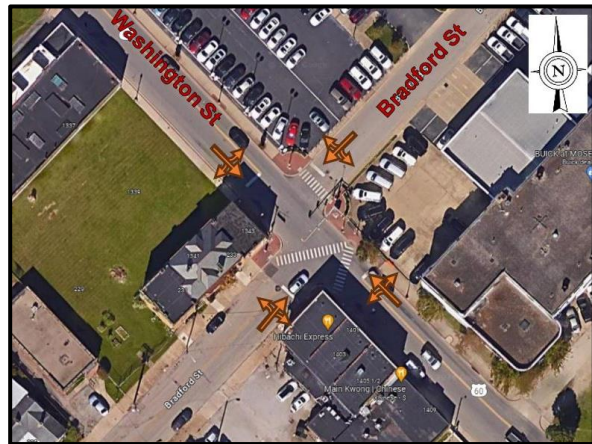
**Figure 5: Washington Street and Bradford Street Lane Configuration**

The lane configuration for this signalized intersection is illustrated in **Figure 5**. All signal heads are mounted on mast arms and do not have backplates. Pedestrian-level lighting is provided at the intersection. Pedestrian push buttons, signal heads and high visibility crosswalks are provided to cross Washington Street and the northeast leg of Bradford Street. The signal is programmed for an actuated exclusive pedestrian phase. The signal is currently programmed to serve both legs of Bradford Street concurrently. Nearby buildings coupled with the offset Bradford Street approaches creates sight distance obstruction and results in driver confusion when vehicles are on both Bradford Street approaches. Additionally, the sun glare reduces the conspicuity of the signal heads as illustrated in **Photo 5**.

approaches make this intersection a good candidate for split-phasing. Each Bradford Street approach would be provided an exclusive phase and will not conflict with any other vehicular movements. This modification would reduce driver confusion and may even enhance the efficiency of the signal. Operational analysis should be conducted prior to implementing new signal timings to ensure that the signal can be coordinated with the adjacent intersections to maintain efficient traffic flow in the corridor.

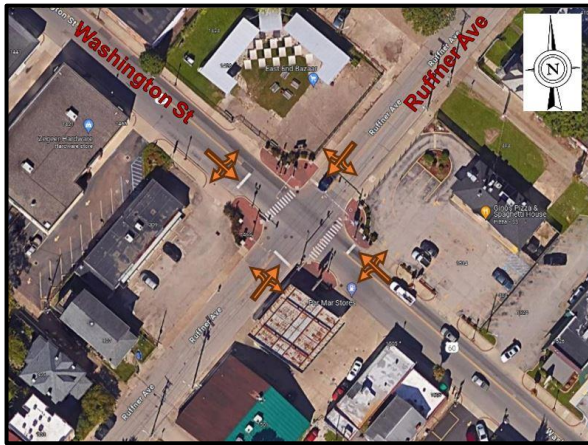
**Figure 6: Washington Street and Ruffner Avenue Lane Configuration**

The lane configuration for this signalized intersection is illustrated in **Figure 6**. All signal heads are mounted on mast arms and do not have backplates. Sun glare and resulting signal head visibility was also noted to be a challenge at this intersection. All left-turns operate under permissive phasing. Pedestrian push buttons, signal heads and high visibility crosswalks are provided to cross the Washington Street approaches. No pedestrian facilities are available to cross Ruffner Avenue as shown in **Photo 6**. Pedestrian-level lighting is provided at the intersection.

- **Provide pedestrian accommodations to cross Ruffner Avenue at the intersection with Washington Street.** Currently, pedestrian accommodations (crosswalks, signal heads, push buttons, curb ramps, etc.) are not provided to cross Ruffner Avenue. Given the amount of pedestrian traffic in the corridor and the pedestrian crash that occurred at the intersection, these improvements are recommended.

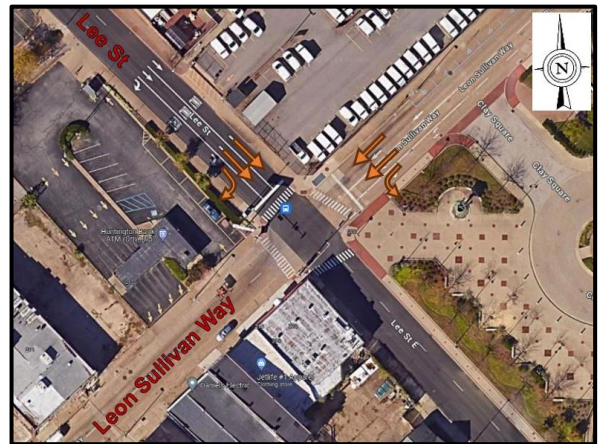
**Figure 7: Lee Street and Leon Sullivan Way Lane Configuration**

The lane configuration for this signalized intersection is illustrated in **Figure 7**. All signal heads are mounted on mast arms and backplates are not provided. Pedestrian push buttons, signal heads and high visibility crosswalks are provided on each corner of the intersection. The signal timings include an exclusive pedestrian phase when actuated through the push buttons. Overhead lighting is provided at the intersection. The fence at the United States Postal Service (USPS) lot obstructs sight distance for motorists to see oncoming traffic from the opposing approach. The left-turn lane from Leon Sullivan Way to Lee Street is very narrow (approximately nine feet wide) and the curb on this corner of the intersection has several tire marks.

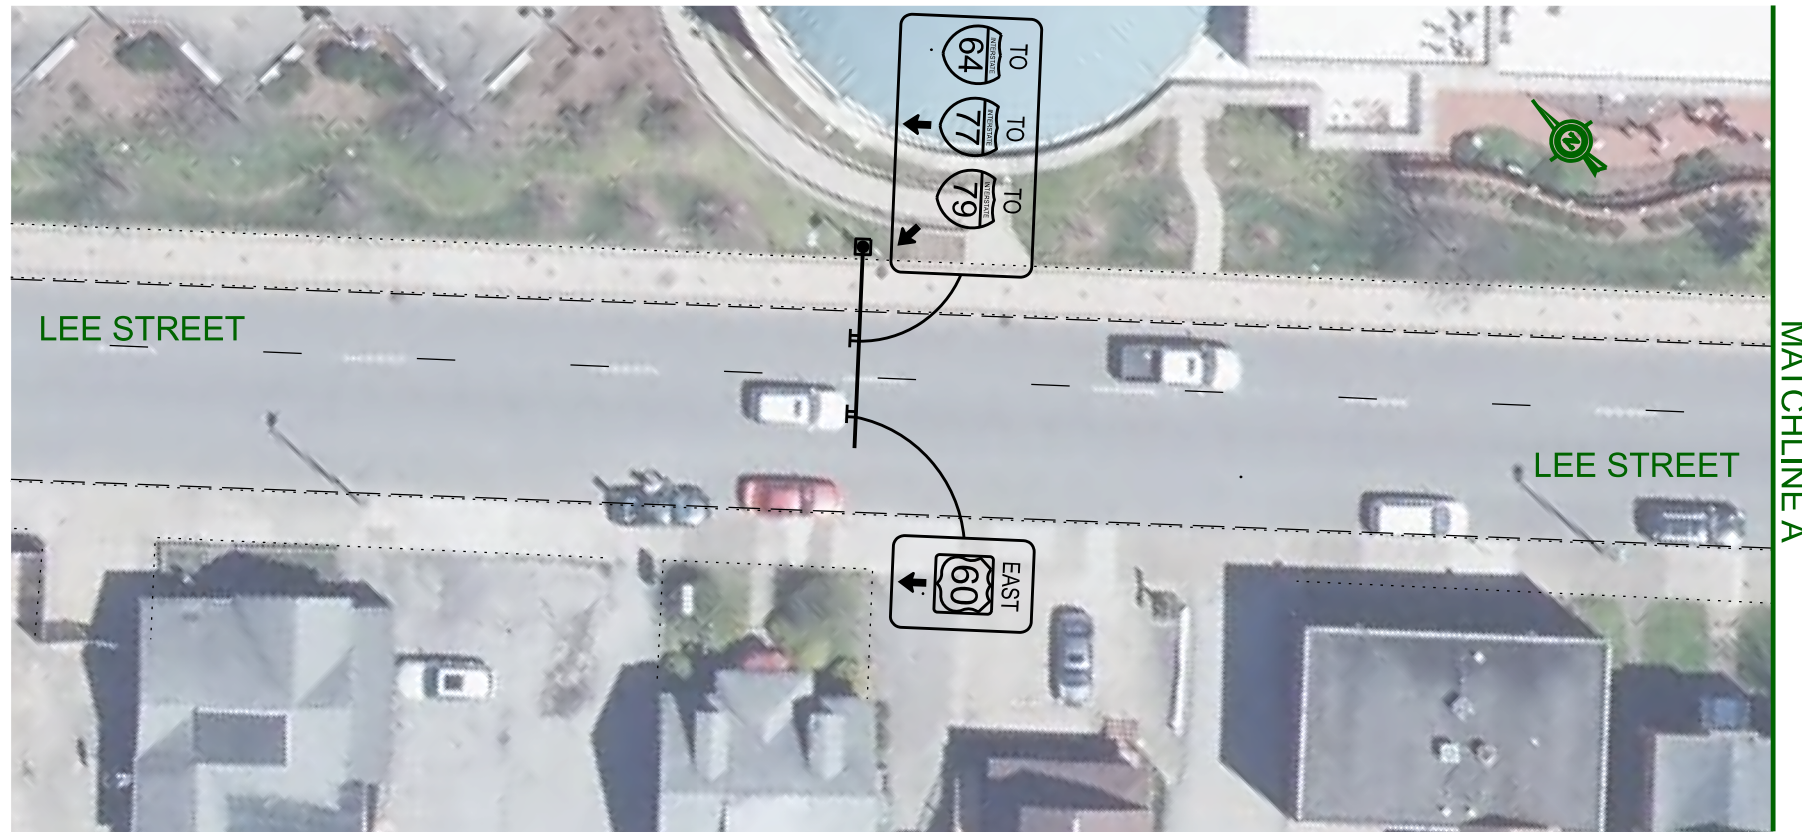
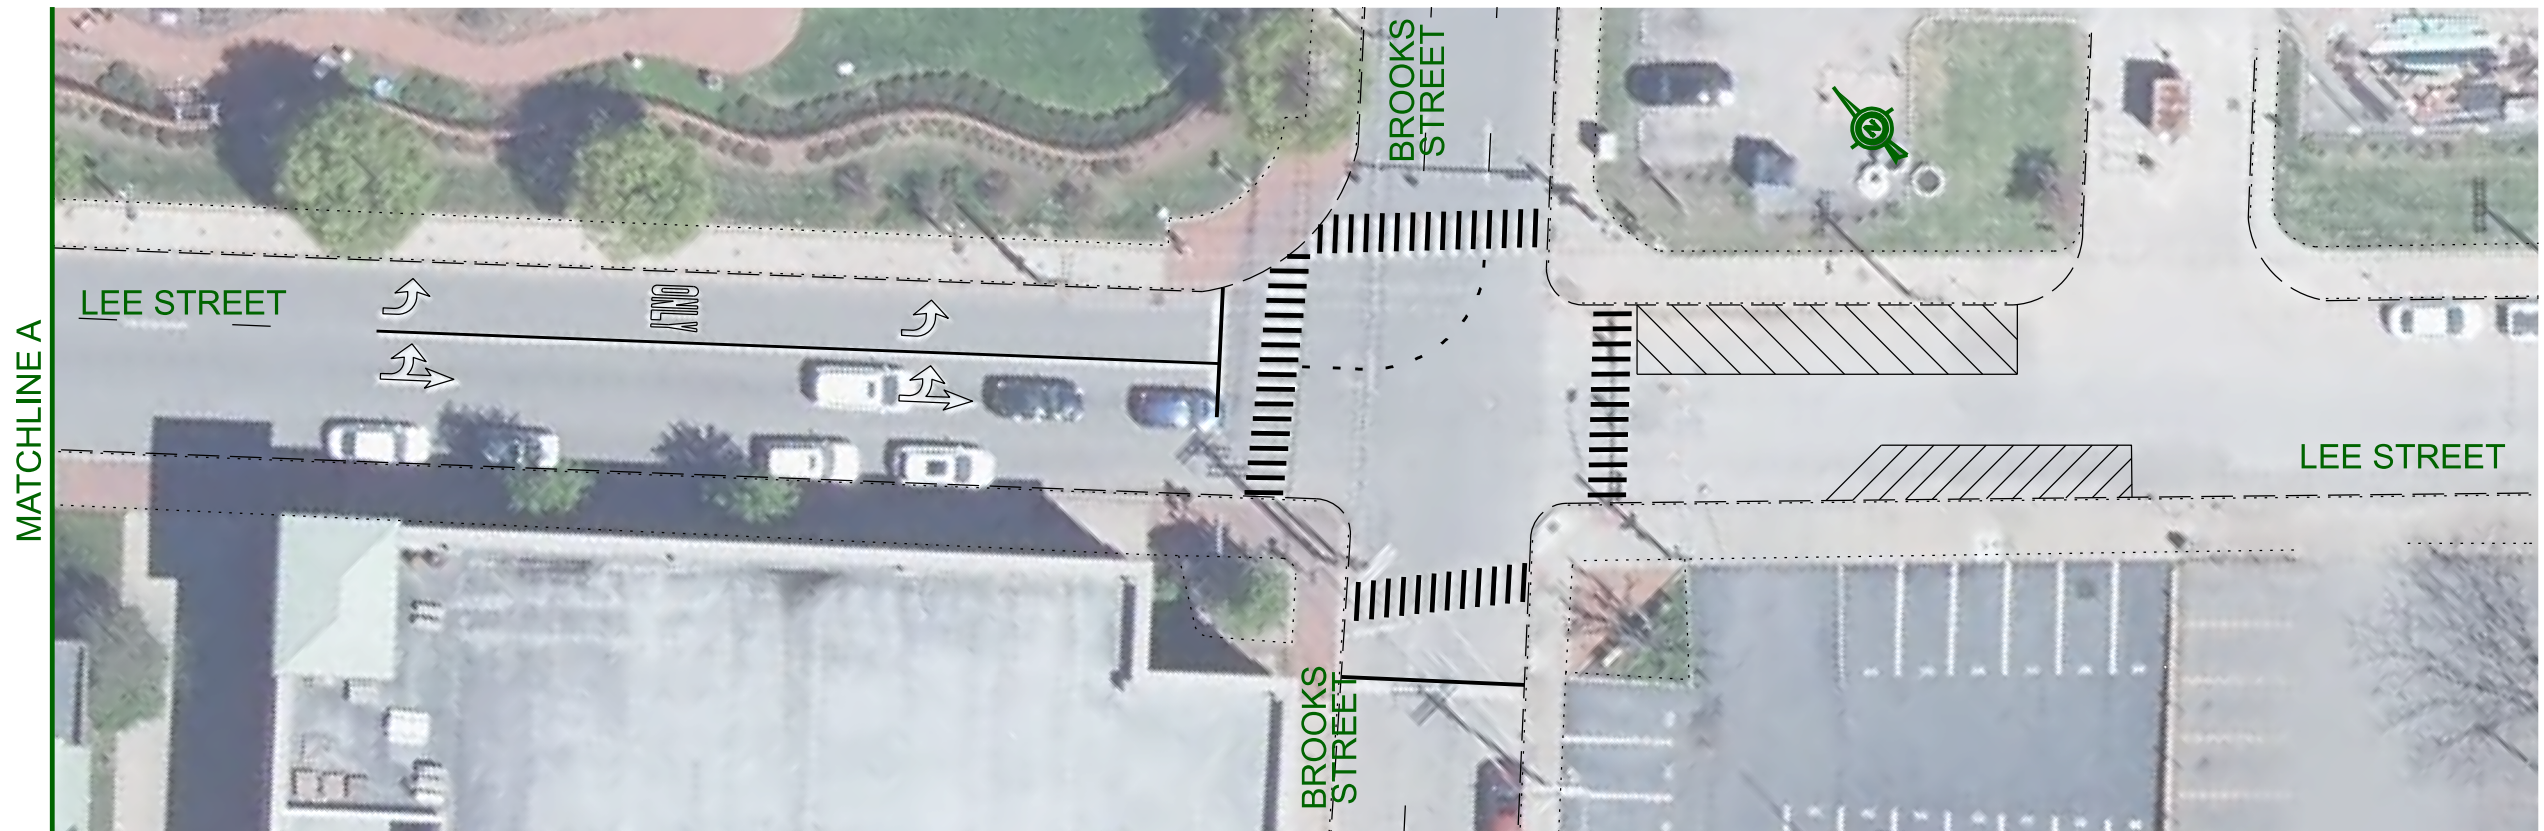
**Figure 13: Overhead Advanced Signing at Lee Street and Brooks Street**

In total, ten sideswipe crashes occurred at this intersection, none of which resulted in injury. In all instances, the crashes were caused by vehicles turning left from Lee Street onto Brooks Street. With two turn lanes and three receiving lanes, drivers are not maintaining their lane through the turn because of confusion regarding appropriate lane configurations. Three of these crashes involved vehicles changing lanes on the approach, prior to making the turn, which can also be a sign of driver confusion.

- **Install overhead directional signing along Lee Street in advance of Brooks Street to inform motorists of the upcoming lane configurations.** This improvement will supplement the additional striping. A concept layout is provided in **Figure 13**. Given the amount of visitors in the area from the CAMC and Clay Center, these overhead signs will provide additional direction to drivers as they navigate the downtown roadways toward the interstate. These signs could be mounted via a cantilever over the roadway. Appropriate sign placement should be determined so to provide adequate distance for lane changes before the intersection and to not block the view of the signal heads at Brooks Street.
