US 60 BETWEEN MILE BRANCH RD AND HULL AVE

ROAD SAFETY AUDIT

Regional Intergovernmental Council

BURGESS & NIPLE

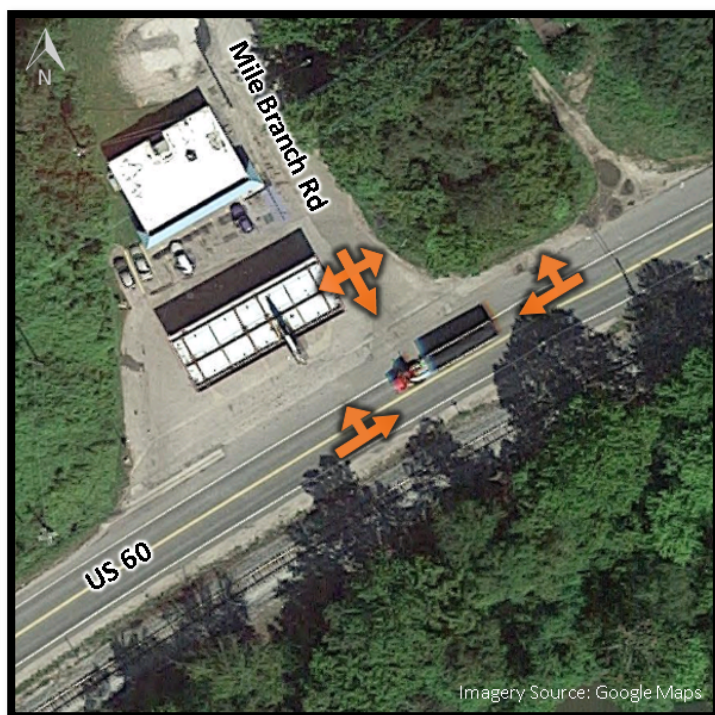
Figure 2: US 60 & Mile Branch Rd. Lane Configuration

The intersection of US 60 and Mile Branch Road is a three-leg, minor road stop-controlled intersection. The lane configuration is shown in **Figure 2**. There is no stop sign located at Mile Branch Road, and the entrance is slightly hidden by the Go-Mart gas station located on the northwest corner of the intersection. The driveway for the Go-Mart does not have a clearly defined exit or entrance as illustrated in **Photo 2**. The pavement along the road is cracked and damaged in areas along the driveway. The intersection is not lit. Trees on either side of Mile Branch Road obstruct visibility of the intersection and gas station from US 60.

- **Construct a right-turn lane on US 60 and Mile Branch Road.** Several rear end crashes were the result of vehicles slowing down in the through lane along US 60 to turn right into Go-Mart or Mile Branch Road. By constructing an exclusive right-turn lane, slowing vehicles are removed from the through lane thus reducing the potential for conflicts. The existing shoulder can likely accommodate the new turn lane. However, the pavement will likely need to be replaced and built to full depth to accommodate the additional traffic load.

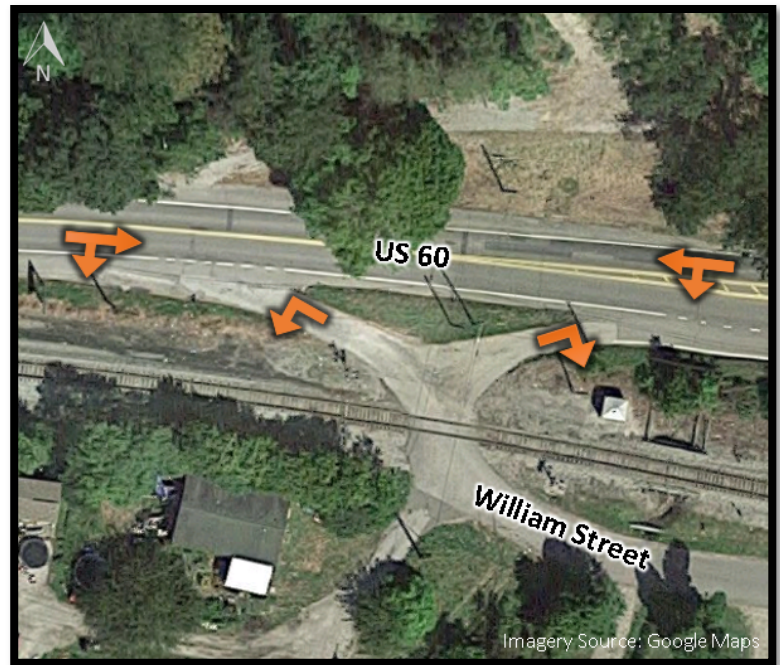
Figure 3: US 60 & William St. Lane Configuration

The lane configuration for the unsignalized intersection of US 60 and William Street is shown in **Figure 3**. Railroad tracks are located just south of the intersection on William Street as illustrated in **Photo 3**. The uneven asphalt between US 60 and Hull Avenue creates a rough transition between the two roads. Warning lights are provided at the railroad crossing and overhead lighting is located at the intersection. There are no turn lane pavement markings, stop signs or yield signs provided. Vehicles were observed to block the west leg of William Street while waiting to turn left onto US 60. Both entrances/exits on William Street are wide enough for only one vehicle, which increases the potential for conflicts at the intersection. However, observations showed that most drivers were familiar with the area and this condition and yielded to other vehicles. There is also poor sight distance for vehicles attempting to turn left due to the skewed angle of the intersection and the steep grade from Hull Avenue to US 60. The add lane from the east leg of William Street creates a weave along US 60 between William Street and Hull Avenue. Field observations showed very low traffic volumes along this segment which reduces the potential of conflicts created by the weave.

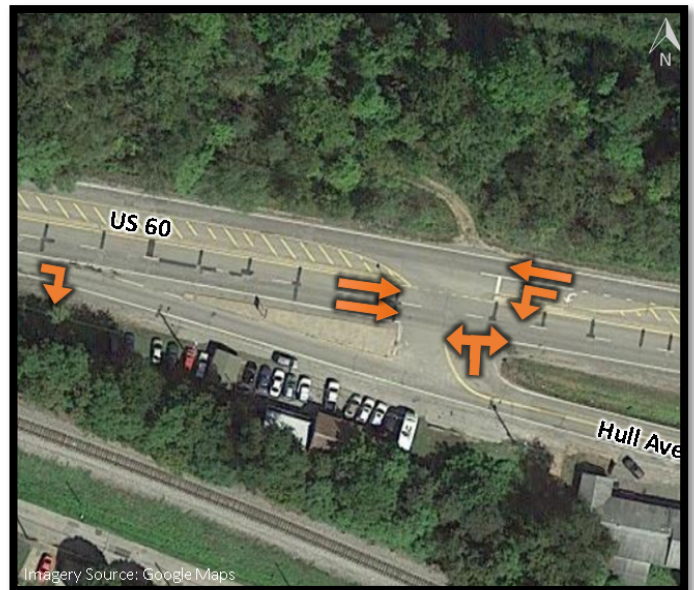
Figure 4: US 60 & Hull Ave Lane Configuration

US 60 and Hull Avenue is a three-leg, minor-road stop-controlled intersection with the lane configuration shown in **Figure 4**. The eastbound right-turn lane is channelized with a raised concrete island. The movement is presumed to be yield-controlled but there is no signage or pavement markings that indicate this condition. The speed limit on Hull Avenue is 25 mph and provides access to a residential area in the town of Cedar Grove. There is poor sight distance for vehicles turning left onto US 60 from Hull Avenue due to the angle of the northbound approach as shown in **Photo 4**. A three-foot concrete median separates travel directions along US 60. The pavement and pavement markings are in good condition. There is no overhead lighting present at the intersection. US 60 widens to two lanes in the eastbound direction about 500 feet west of the intersection. Field reviews and stakeholder comments indicated that faster moving vehicles speed up to pass slower vehicles as soon as the second lane is formed on US 60. As a result, the vehicles in the right through lane obstruct the sight distance to vehicles in the left through lane for vehicles on Hull Avenue.

- A.) Maintain one eastbound lane for right turn to find gap then bump out lane to Hull Ave to remove existing weave
- B.) Maintain one eastbound lane through Hull intersection to avoid speed increase; Can stripe out pavement, remove pavement, or extend existing concrete median
- C.) Can maintain existing condition for right turn/exit to Hull or keep parallel to eastbound US-60 lane and square up with Hull for more conventional intersection

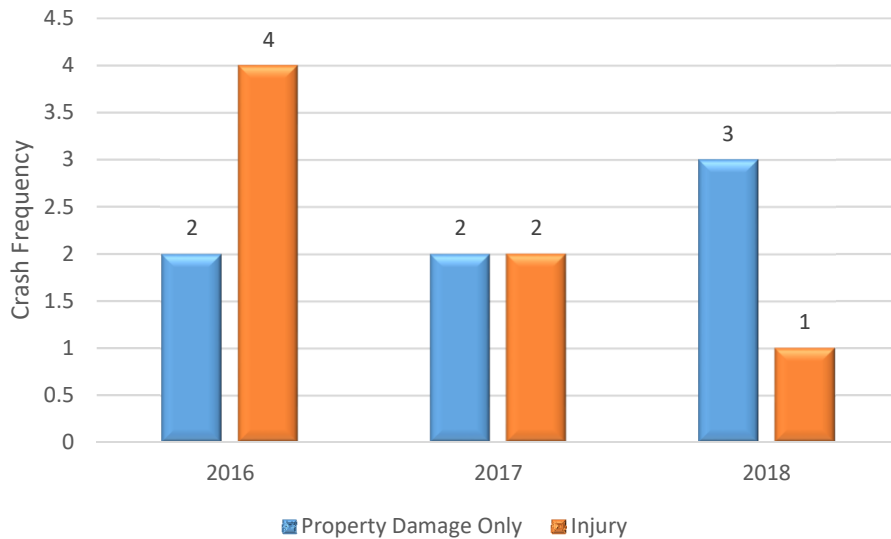
Figure 6: Frequency of Crashes by Year and Severity

Crash data from January 1, 2016 to December 31, 2018 was downloaded from the ReportBeam website. Each crash report was reviewed to determine potential factors contributing to crashes. A collision diagram that shows crash patterns by illustrating the approximate location of each reported crash is provided in **Appendix B**. In the three-year study period, there were 14 crashes with seven (50 percent) resulting in injury. The high-speed limit (50 mph) on US 60 is likely a contributing factor to the high injury percentage. No fatalities occurred in the study period. The majority of crashes (86 percent) occurred on dry pavement. **Figure 6** shows the crash breakdown per year by severity. The number of injury crashes has been decreasing over the past three years.

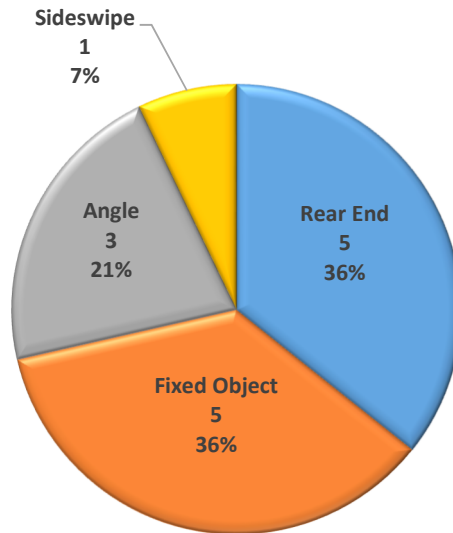
Figure 7: Crash Frequency by Crash Type

Figure 7 illustrates the crash frequency by type of crash. The majority of the rear end collisions occurred near the intersection of US 60 and Mile Branch Road. These crashes occurred when vehicles slowed in the through lane to turn into the Go-Mart or on Mile Branch Road and were rear ended by the vehicle behind them. One of these rear end collisions resulted from a school bus stopping to pick up children from the neighborhood north on Mile Branch Road. The majority of the fixed object collisions (80 percent) also occurred around the area of Mile Branch Road. These crashes happened when drivers lost control and landed in the ditch on the side of the roadway. One fixed object crash occurred when a vehicle hit a rock that had fallen off the cliff and into the roadway.
