WV 34 FROM I-64 TO GREAT TEAYS BOULEVARD

ROAD SAFETY AUDIT

Regional Intergovernmental Council

November 2020

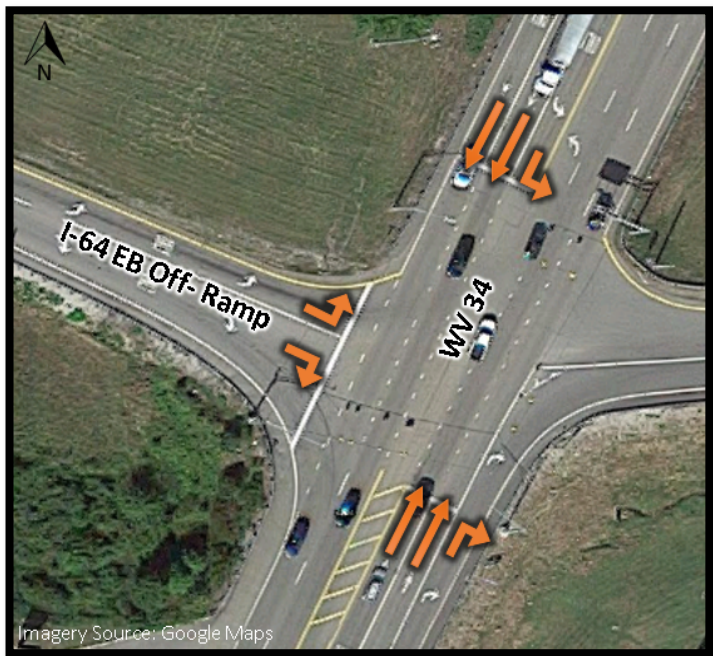
Figure 3: WV 34 & I-64 Eastbound Ramps Lane Configuration

The ramp terminal intersection of WV 34 and the I-64 Eastbound Ramps is a signalized intersection. The lane configuration is shown in **Figure 3**. The box-span signal provides backplates on the signal heads for all approaches. There are no pedestrian facilities or sidewalks provided at this intersection. The rightmost signal head on the southbound approach was out of alignment at the time of the field visit. The northbound right-turn lane is free-flowing onto the I-64 Eastbound On-Ramp.

The main crash pattern at this intersection involved southbound left-turning vehicles and northbound through vehicles. As previously mentioned, the left-turn arrow did not seem to be properly functioning during the field review and traffic counts which results in an increase in delays and driver frustration. When drivers are frustrated or delayed, they are more likely to select inadequate gap, resulting in a collision. Left-turning vehicles were also observed to clear the intersection during the yellow or red clearance intervals. There were also several sideswipe crashes on the westbound and southbound approaches. Abrupt and unsafe lane changes as well as the number of driveways within the functional area of the intersection likely contribute to these crashes.

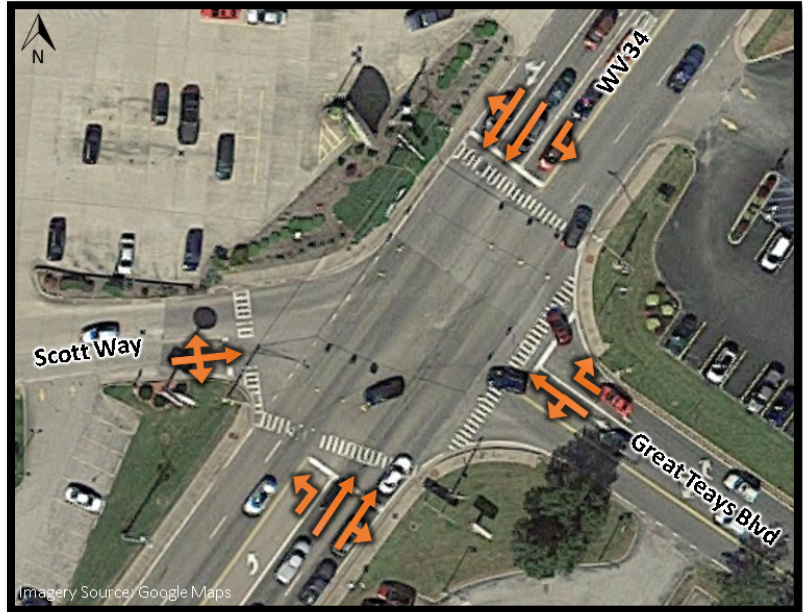
Figure 4: WV 34, Scott Way, & Great Teays Boulevard Lane Configuration

The intersection of WV 34 and Great Teays Boulevard is a four-legged signalized intersection with a box span configuration. Backplates are on all the signal heads at the intersection. The lane configuration is shown in **Figure 4**. The eastbound and westbound approaches are split phased due to the skewed geometry of the intersection and resulting path overlap for left-turning vehicles. The southbound left-turn movement has a five-section signal head to support protected-permitted left-turn phases. However, during review of the footage from the cameras used to collect traffic counts, the southbound protected-permitted left-turn phase operated as permitted-only and never provided the left-turn arrow during the AM and PM peak hours. A right-turn overlap is provided for the westbound right-turn movement so that this movement can run concurrently with the southbound left-turn movement when the green arrow (protected phase) is provided. The southbound left-turn movement operates under permissive-only phasing. Crosswalks are provided on all legs of the intersection and all but the east leg of the intersection have pedestrian signal heads. Pedestrian push buttons were present for crossing the north and south legs. During the field review it was observed that the pedestrian signal head for crossing the east leg was not operating correctly as the walk symbol never appeared. It was also observed that the push buttons on the northeast and southeast corner did not trigger the walk sign. During the field visit, the southbound left-turn movement to Great Teays Boulevard was observed to queue beyond its storage length. Additionally, when southbound through vehicles were stopped at the signal, the queues were observed to extend past the Taco Bell and Scott Junction driveways, preventing vehicles from turning left into or out of those driveways.

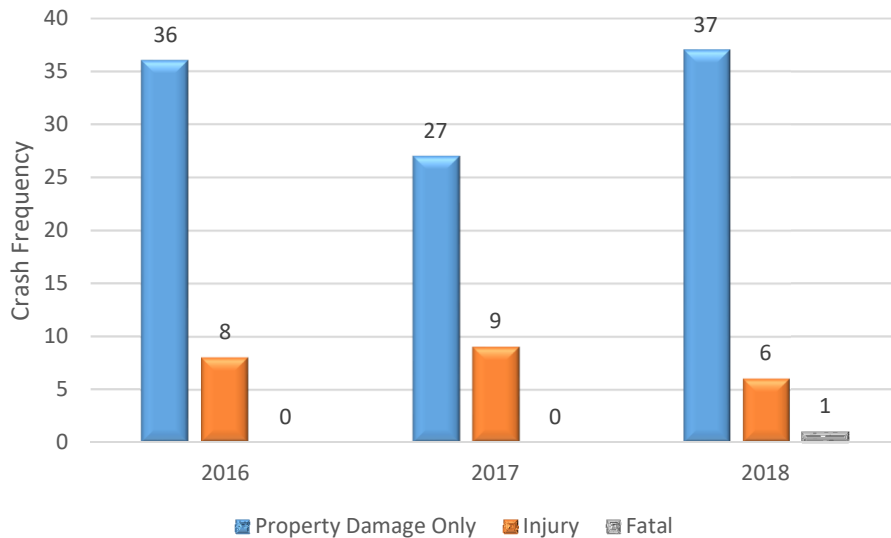
Figure 7: Frequency of Crashes by Year and Severity

Crash data from January 1, 2016 to December 31, 2018 was downloaded from the ReportBeam website. Each crash report was reviewed to determine potential factors contributing to crashes. A collision diagram that shows crash patterns by illustrating the approximate location of each reported crash is provided in **Appendix E**. In the three-year study period, there were 124 crashes with 23 (18 percent) resulting in injury. One fatality occurred in the study area when a northbound vehicle was turning left into the KFC and failed to yield to a southbound vehicle. The 53-year-old male passenger of the northbound vehicle passed away at the hospital. **Figure 7** shows the crash frequency by year and severity.

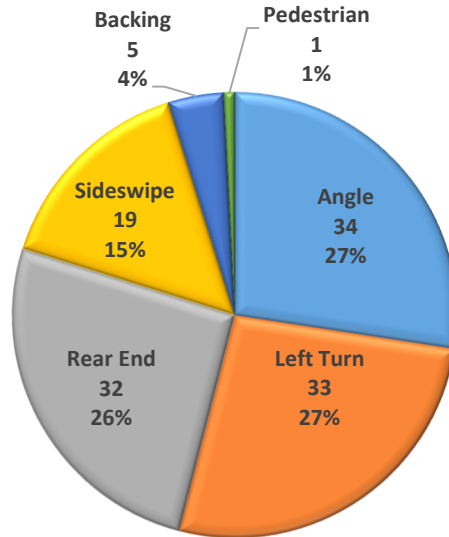
Figure 8: Crash Frequency by Crash Type

Figure 8 shows the crash frequency of the study area by crash type. The majority of the left-turn (27 percent) and angle (27 percent) collisions were related to conflicts at unsignalized intersections and driveways along the corridor. Several crash reports also mentioned that another driver had waved them out while they were waiting to turn, and when they entered the roadway, they were struck by a vehicle approaching in an adjacent lane. Due to the high traffic volume, it is very difficult for vehicles to find gaps to turn into and out of businesses. Additionally, it can be difficult to accurately judge gaps in traffic due to the many vehicles entering and exiting the road from differing locations. The rear end collisions (26 percent) occurred most often on the approaches of the two signalized intersections. There were also several instances of vehicles being rear ended after slowing down to turn into the driveways along WV 34.

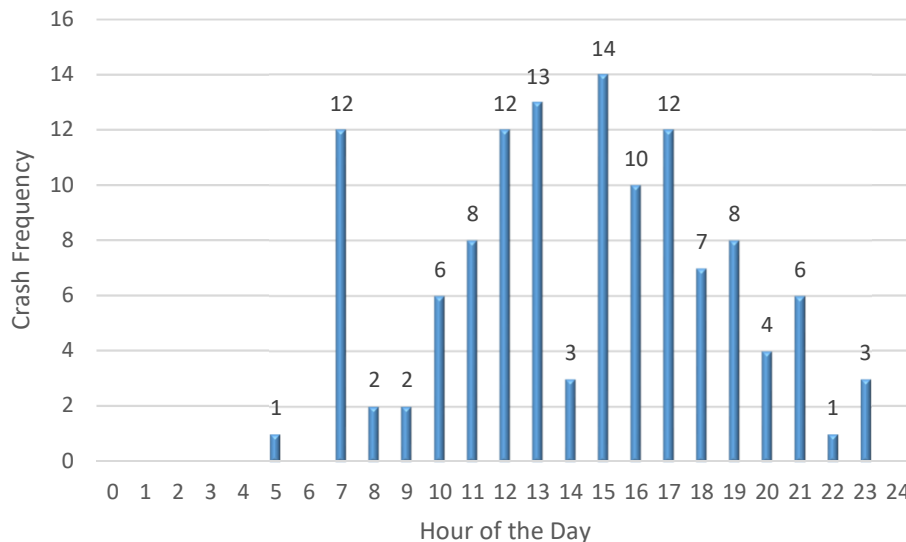
Figure 9: Crash Frequency by Hour of the Day

Figure 9 illustrates the breakdown of crashes in the study area by hour of the day, showing peaks at 7:00 AM, between 11:00 AM and 1:00 PM and between 3:00 PM and 7:00 PM corresponding to the usual peak hours for restaurants. Lack of lighting along the corridor is not a main contributing factor to crashes in the study area as 75 percent of the collisions occurred in the daylight.
